Re: Functional Value Assessment and Stream Corridor Plan Sub-Element of the
Conservation Plan Element
Borough of Lebanon
Deliverable
MC Project No. LEB-012

FUNCTIONAL VALUE ASSESSMENT
and
STREAM CORRIDOR PLAN
A SUB-ELEMENT OF THE CONSERVATION PLAN ELEMENT

SOUTH BRANCH ROCKAWAY CREEK TRIBUTARY
BOROUGH OF LEBANON
HUNTERDON COUNTY, NEW JERSEY

October 2020

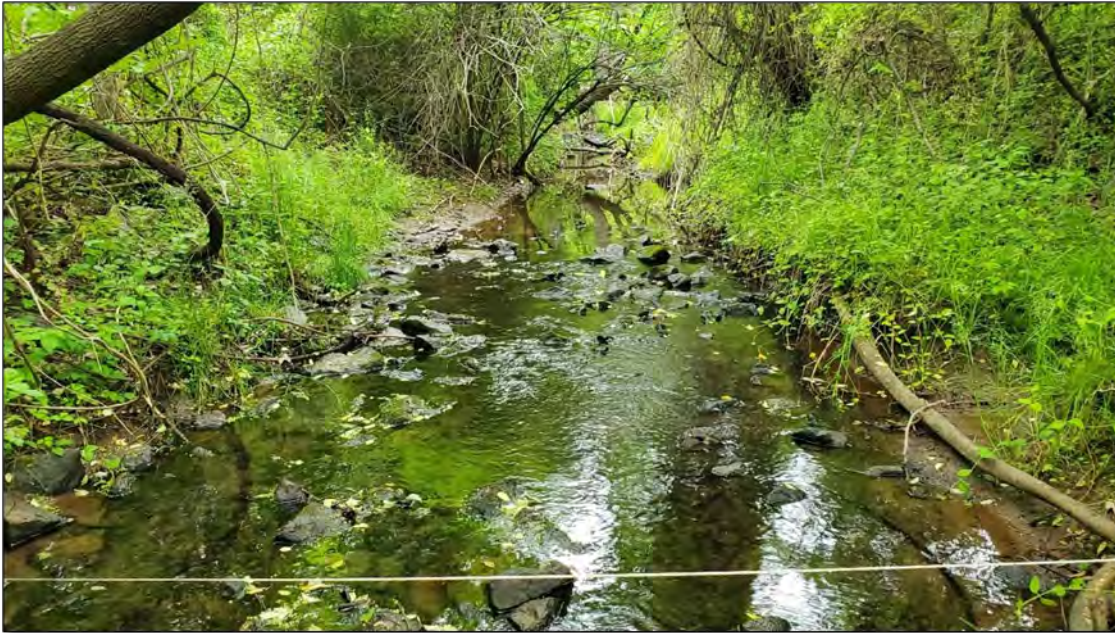
campus including parking and landscaping. The channel has retained its “C/E” stream type with a weak Pool-Riffle streambed (Photo 1).

Photo 1: Typical cross section across a riffle in Reach-01 looking north and upstream.

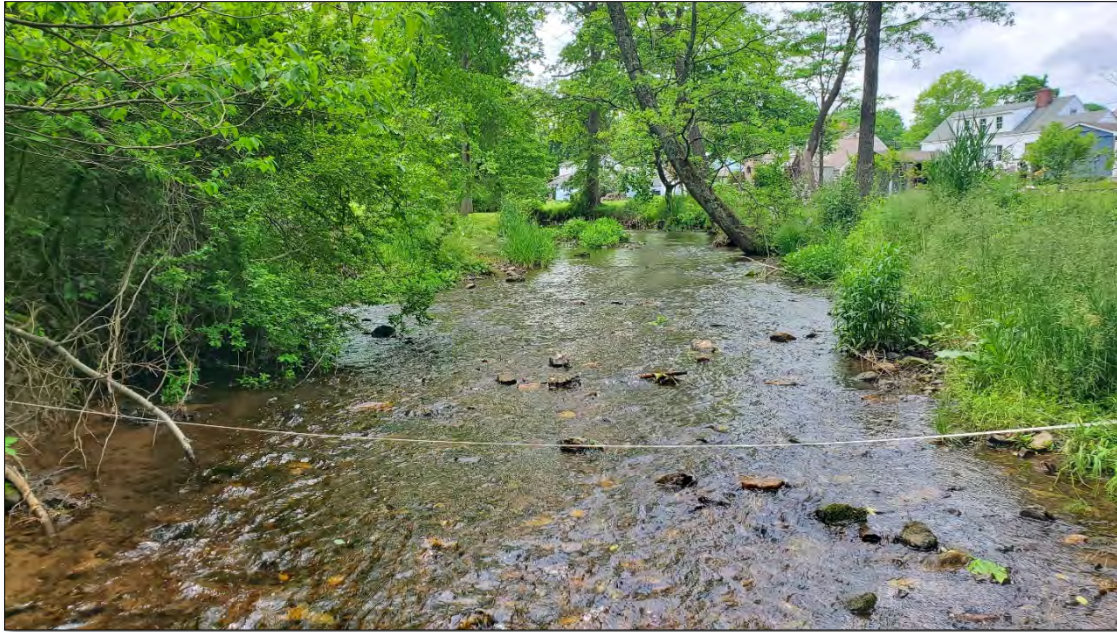
The most important influence on the geomorphic and habitat condition of this reach is the encroachment of residential development in over 75% of the corridor. Downstream of the junction with SB Rockaway Creek main stem is heavily influenced by agricultural cropland. The channel has retained its “C/E” stream type with a weak Pool-Riffle streambed (Photo 2).

Photo 2. Typical cross section across a riffle in Reach-02 looking west and upstream.

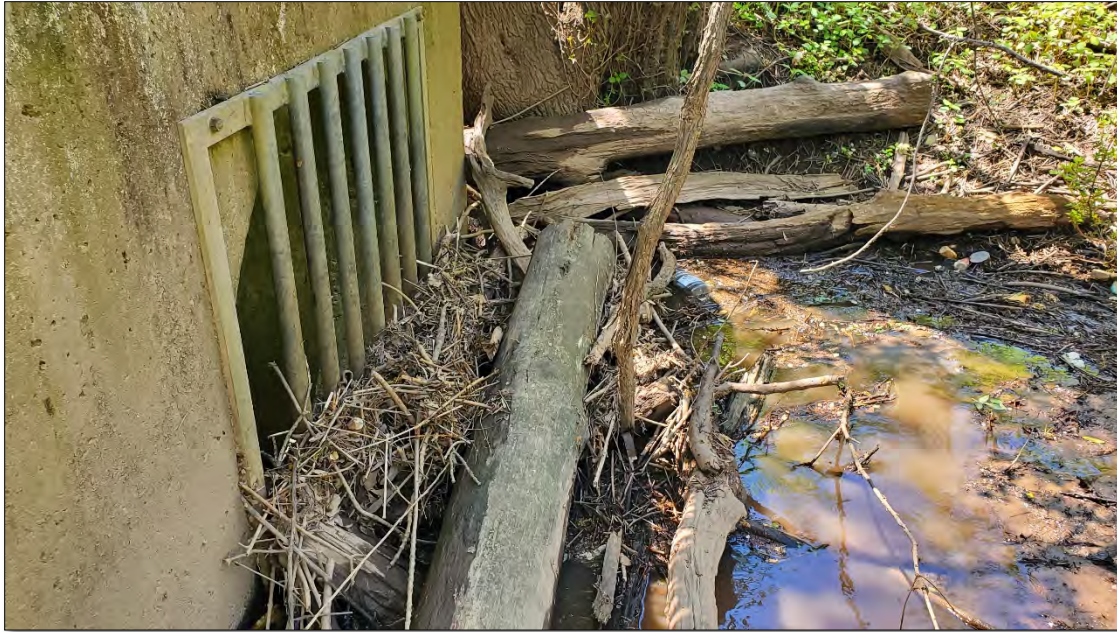
Photo 3: Weir located on upstream side of the US-22 crossing on Reach-01.

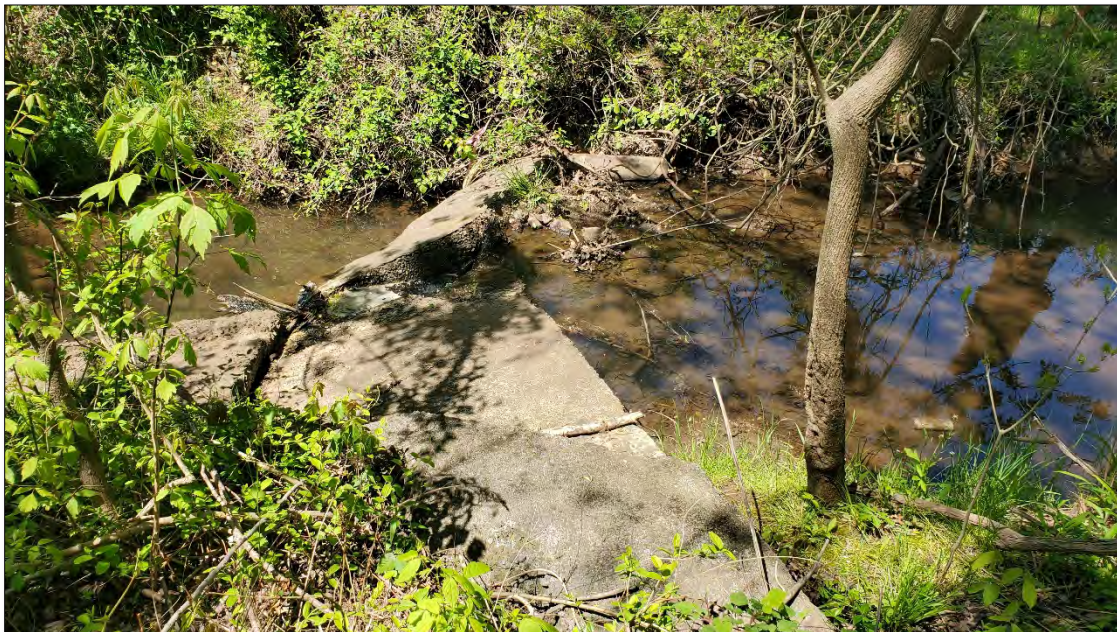
Photo 4: A historic dam observed across the stream bed in Reach-01 south of the I-78 crossing.

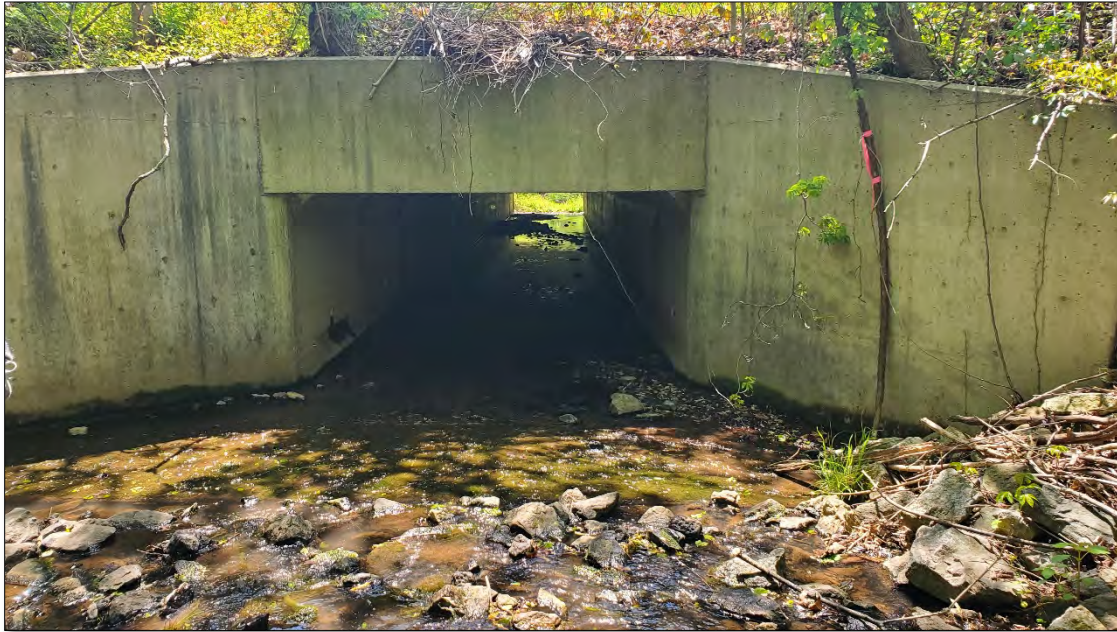
Upstream and/or downstream scour pools and sediment deposition were observed at all these sites, indicating the impacts of the structures on the stream condition.

Photo 5. View south and downstream at an example of an undersized box culvert on Reach-01. Note CPOM deposited at top of culvert.

3. Conduct a bridge and culvert survey of private and public structures to gather specific information about the impacts of stream crossings and stormwater inputs throughout entire Borough and/or the SB Rockaway Creek watershed. Replace undersized and askew structures when opportunities and/or funding become available. Based on the limited scope of this assessment, these may include but aren't limited to the culverts at Route 78, at Corporate Drive south of Route 78, and at Route 22 along Reach-01; and the bridge at Main Street along Reach-02.

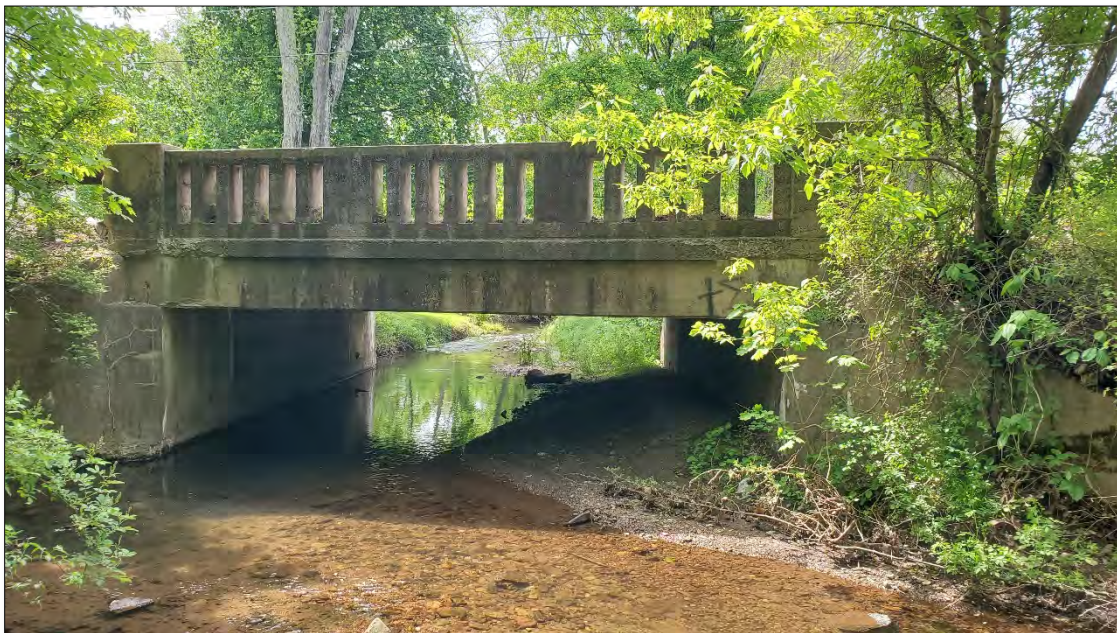
Photo 6: View south and downstream at an example of a bridge across Reach-02 at the Main Street crossing.

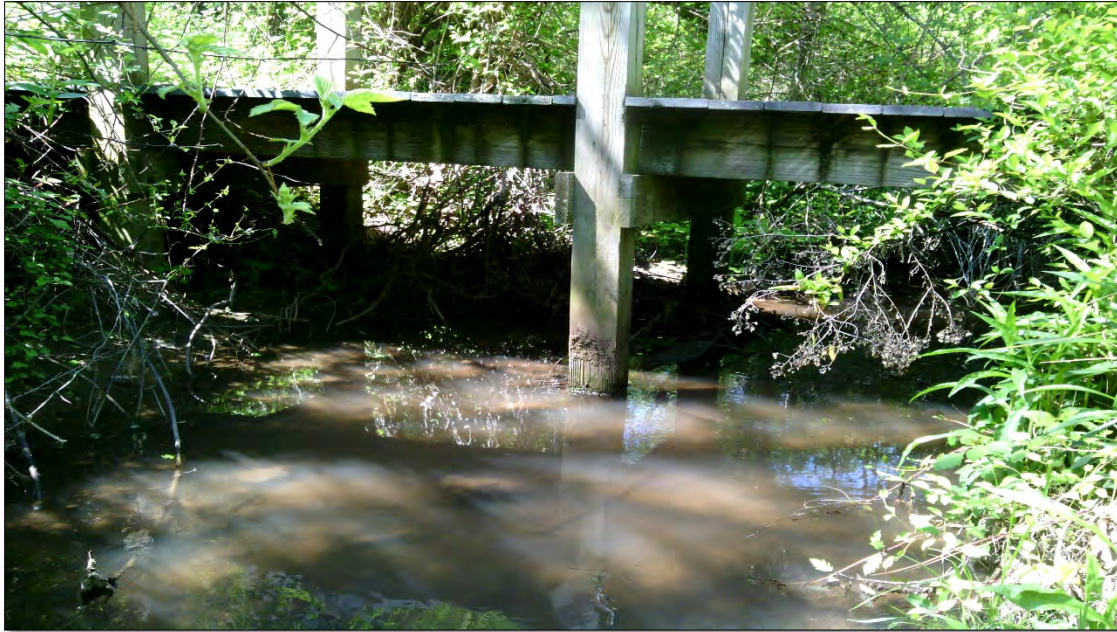
Photo 7: View north and upstream at a footbridge observed across Reach-01 connecting a mown path through open space to a shopping center.

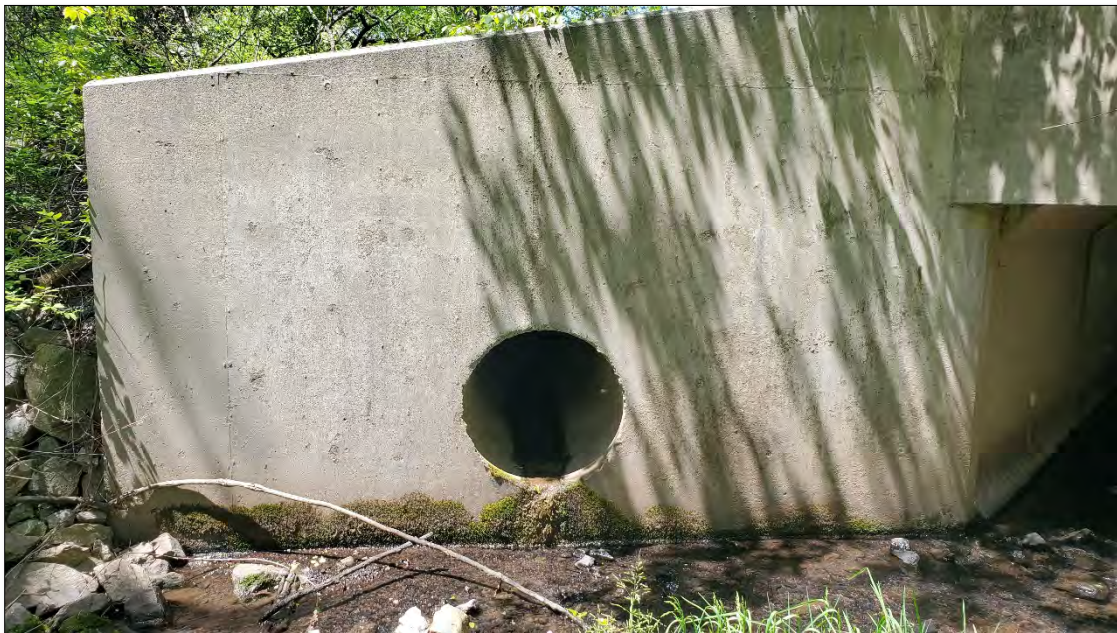
Photo 8: Typical 2-foot diameter cement stormwater pipe observed in both reaches.

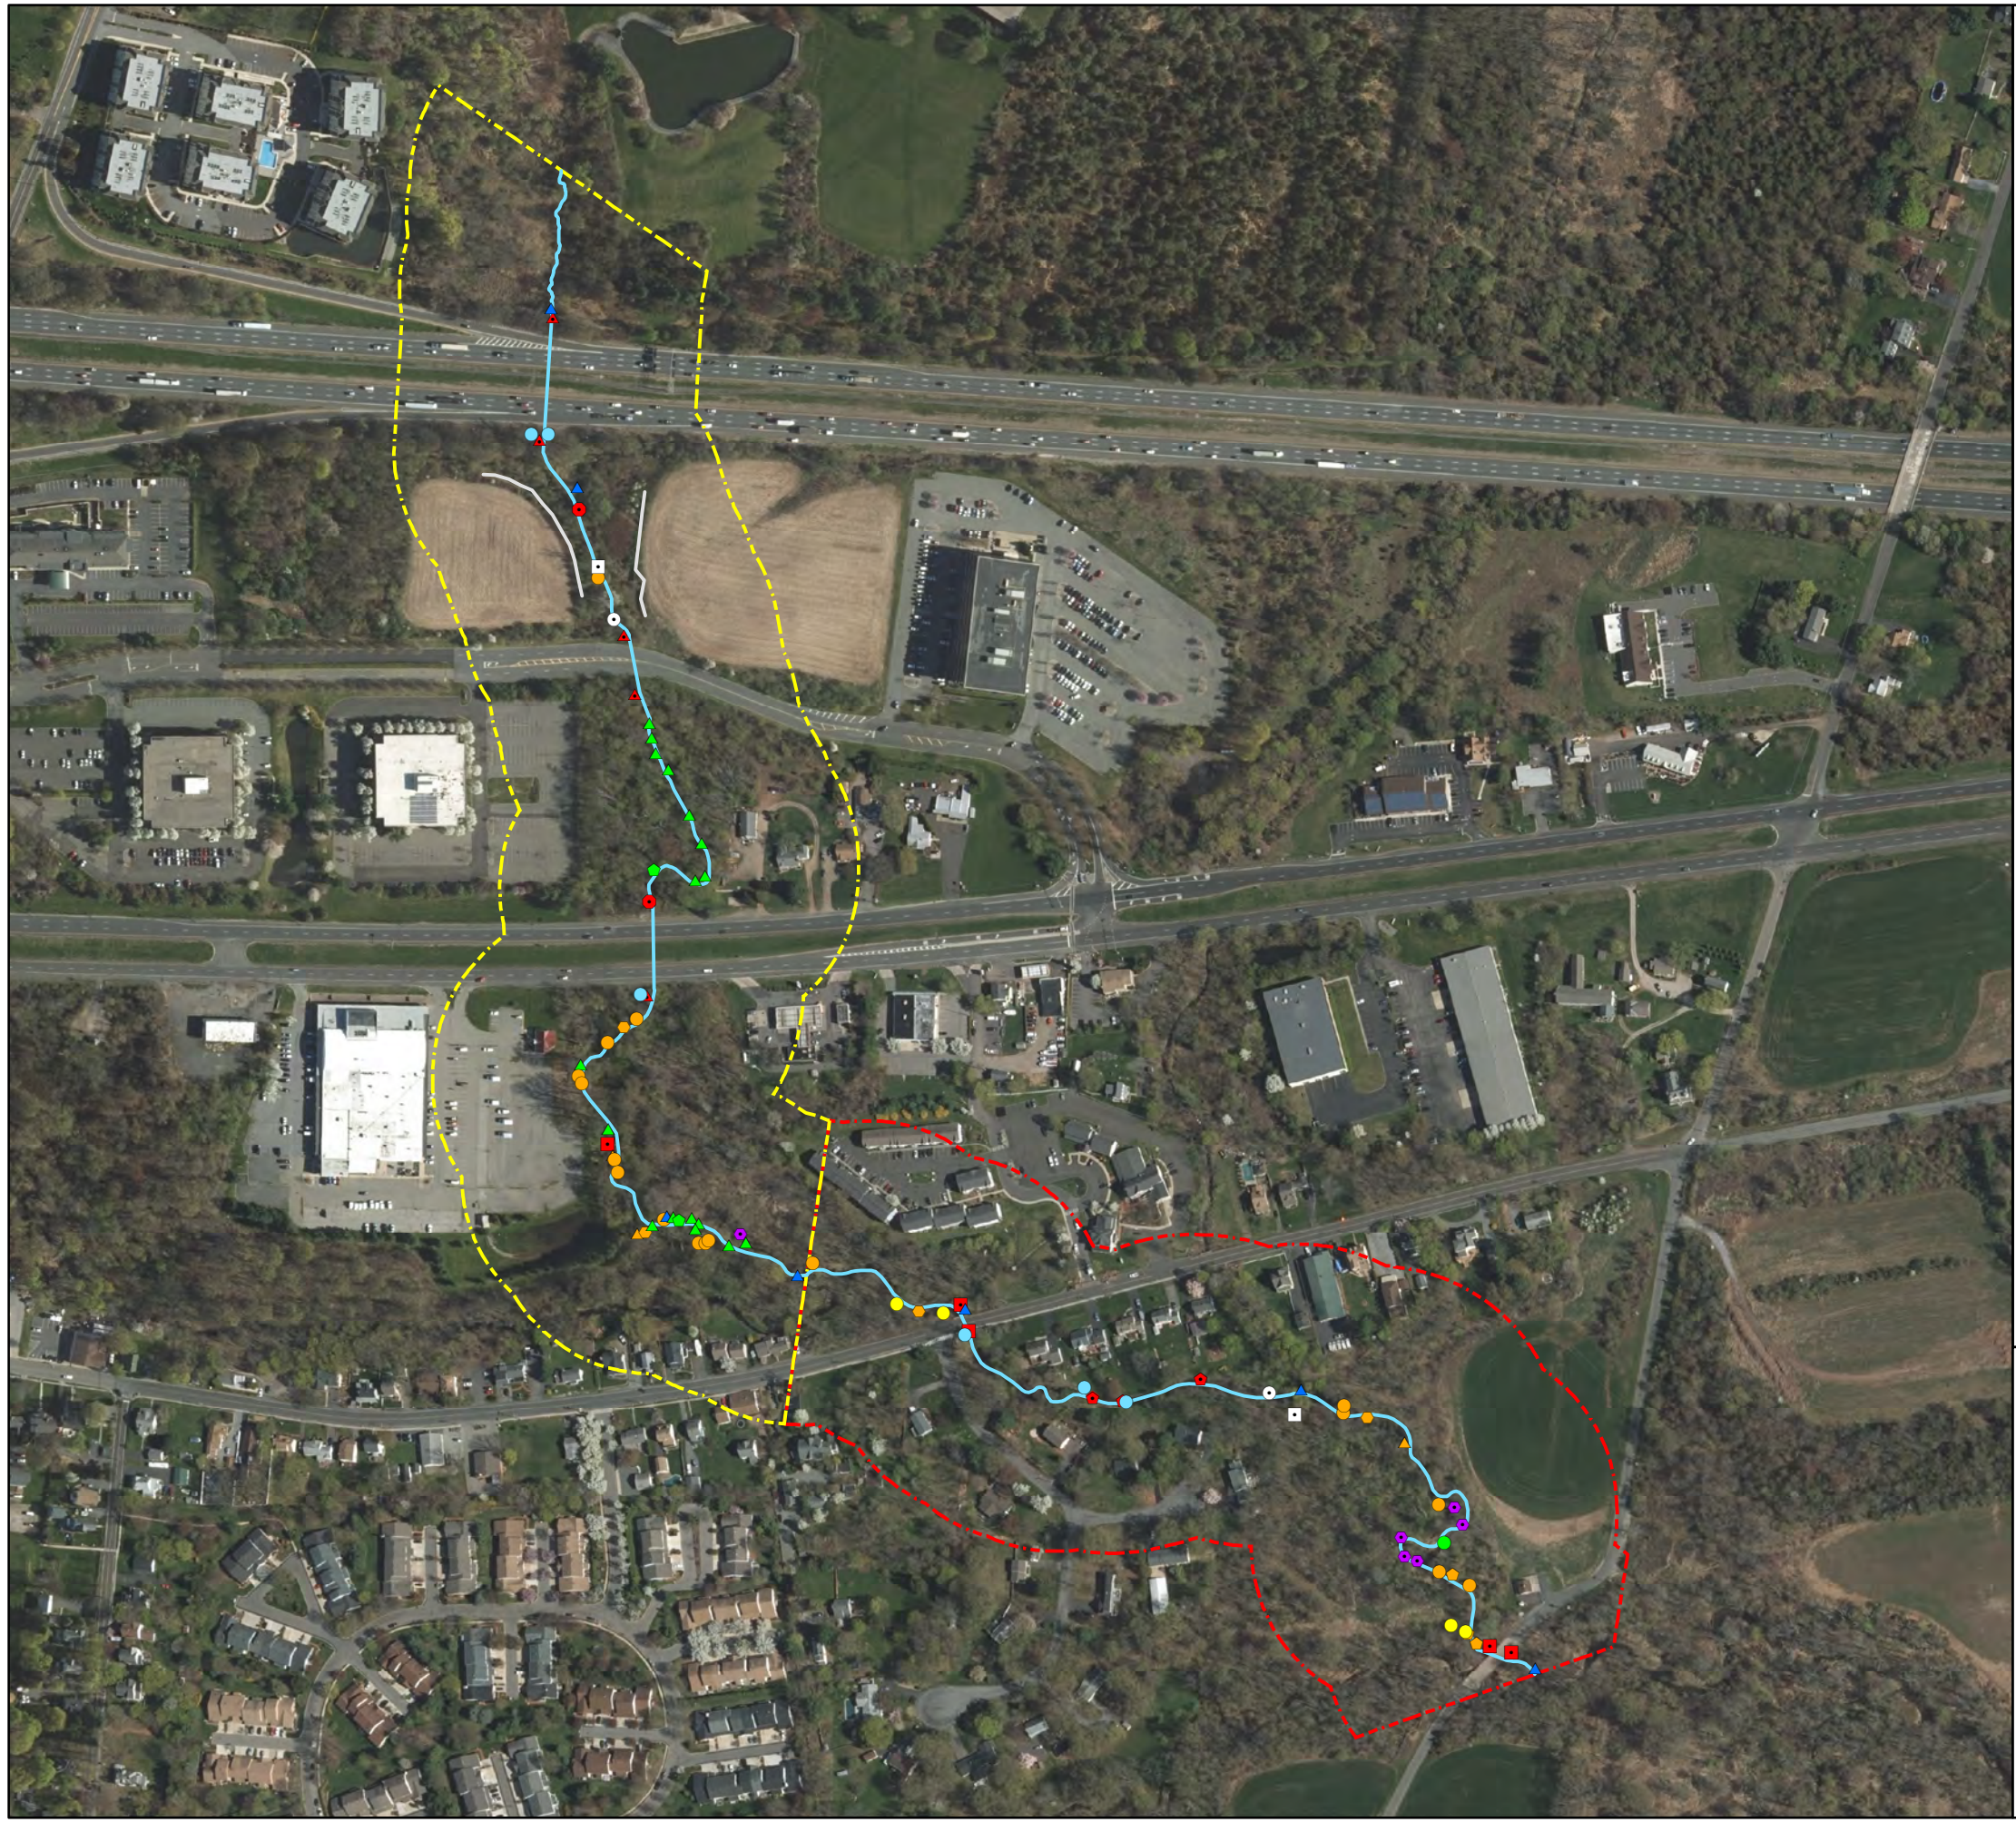
No bedrock outcrops were observed on either reach assessed. No head cuts were observed along Reach-01, however Reach-02 had two headcuts just north of the Main Street bridge, one of which is causing extensive bank erosion leading to the exposure of a sewer man-hole in the streambank (Photo 9). Several complete riffles were identified along both reaches indicating the channels have little aggradation or degradation. Pools greater than 1-foot deep were common and point and lateral sediment bars were the dominant forms along both reaches (Photo 10). Bed substrate composition measurements were taken at the representative cross sections. These measurements are used to characterize the stream's ability to carry different sized sediments. Lastly, numerous debris jams (Photo 11) of vegetative material in the form of large woody debris (LWD) and coarse particulate organic matter (CPOM) were observed along both reaches, which can be indicative of channel instability and excessive erosion.

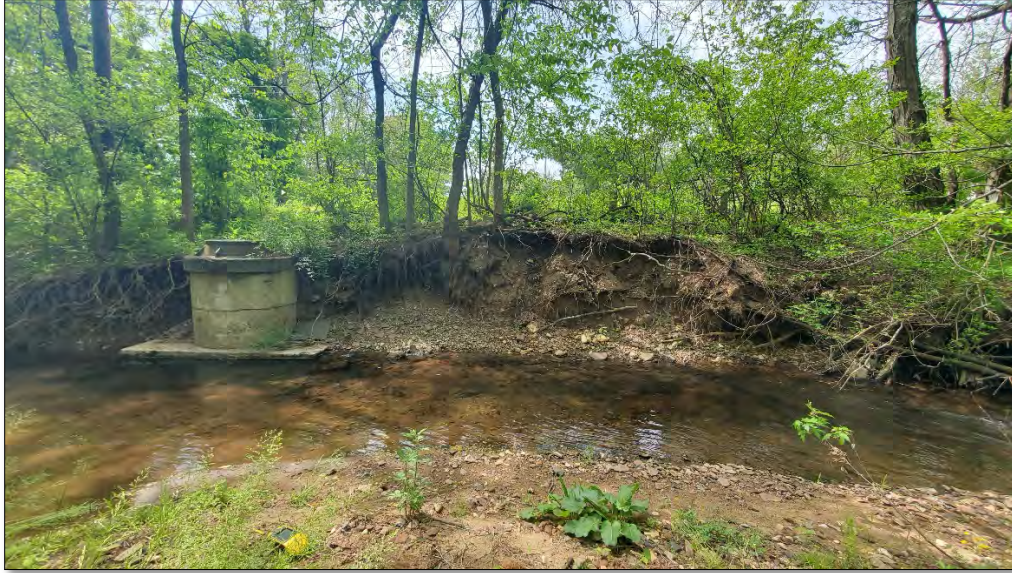
Photo 9: View south at bank erosion on right bank of Reach-02 exposing sewer manhole.

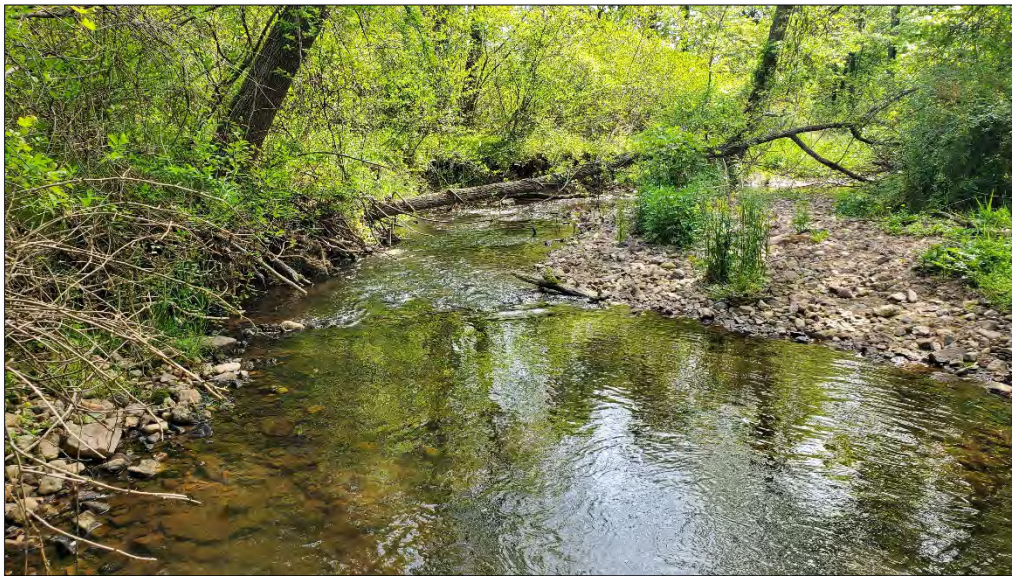
Photo 10: View east and downstream at example of a gravel point bar on Reach-02.

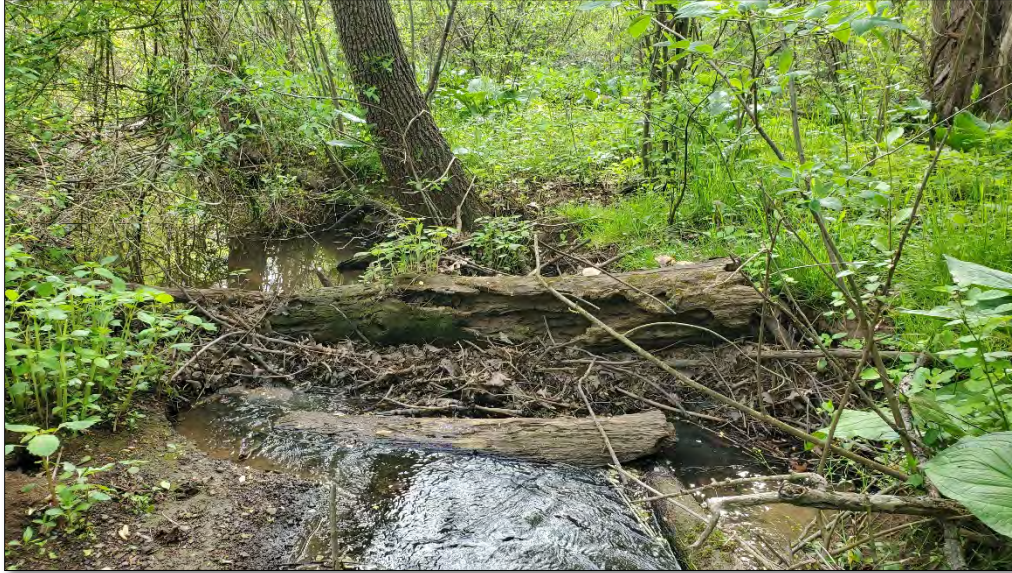
Photo 11: View south and downstream at example of a debris jam found along Reach-01 including LWD and CPOM.

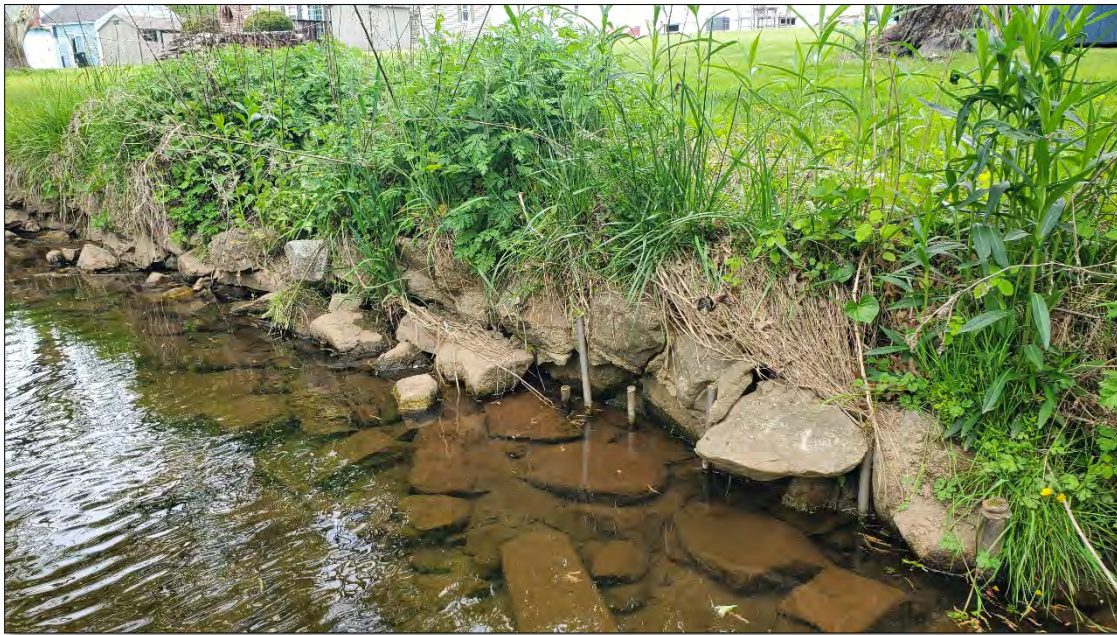
The first three metrics were assessed at the representative cross sections of each reach while the last three were assessed throughout the entire reach. The bank slopes for both reaches were moderately sloped at 30-50%, 3:1 – 2:1 slopes. The banks are comprised of a silt/clay texture with assumed moderate erodibility based on the mixed particle size and cohesiveness. Areas of slumping banks were rarely (1-2 locations) noted in either reach, but undercut banks were observed in several locations along both Reach-01 and Reach-02, indicating more gradual erosion as opposed to active or episodic erosion. Bank vegetation coverage at the Reach-01 representative cross-section was 100% groundcover, 20% understory, and 10% canopy and cross channel shading was closed. Bank vegetation coverage at the Reach-02 representative cross-section was 80% groundcover and 50% understory and cross channel shading was open. Some bank armoring was observed in a short stretch of Reach-02 (Photo 12).

Photo 12: Bank armoring observed along the left bank of Reach-02.
