UPPER MUSCONETCONG RIVER WATERSHED IMPLEMENTATION PLAN

MORRIS AND SUSSEX COUNTIES, NEW JERSEY

NOVEMBER 2020

PRINCETON HYDRO, LLC
1108 OLD YORK ROAD, SUITE 1
P.O. BOX 720
RINGOES, NJ 08551
908-235-5660

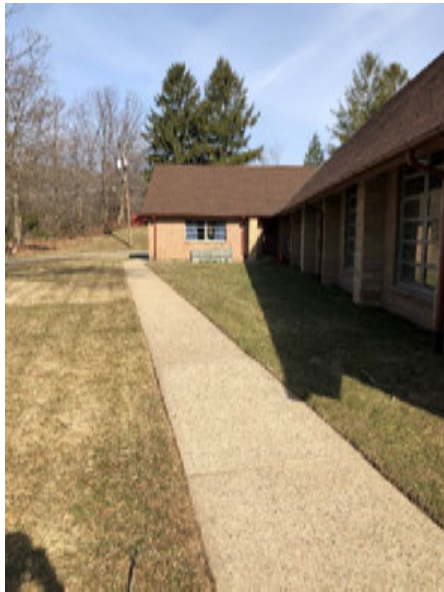
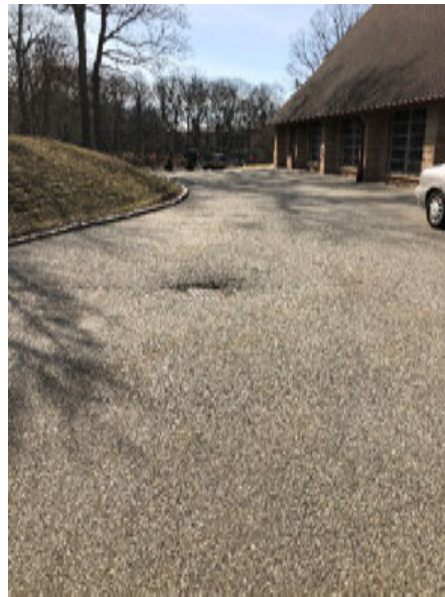
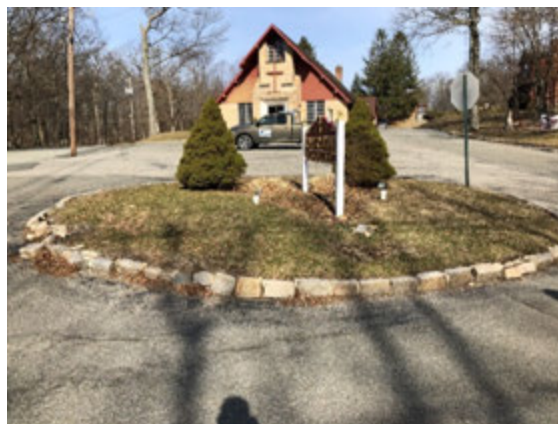
RECOMMENDED RESTORATION MEASURE: Rutgers recommends the installation of bioretention systems in the two grassy areas currently present on site; the small, circular patch of grass at the entrance and the patch of grass located adjacent to the building. These two bioretention systems will capture, treat, and infiltrate rooftop and parking lot runoff. Princeton Hydro also recommends the consideration of porous pavement and/or grassed pavers to increase infiltration. In addition to the bioretention systems, downspout planter boxes can be installed on the opposite side of the building to capture and treat additional runoff from the roof.

ESTIMATED COSTS: The estimated costs provided by the RCEWRP for the installation of approximately 1,305 square feet of bioretention systems and five planter boxes is \$11,525. This includes \$6,525 for the bioretention systems and \$5,000 for the planter boxes. Note these cost estimates were derived from the RCEWRP and are considered low by Princeton Hydro.

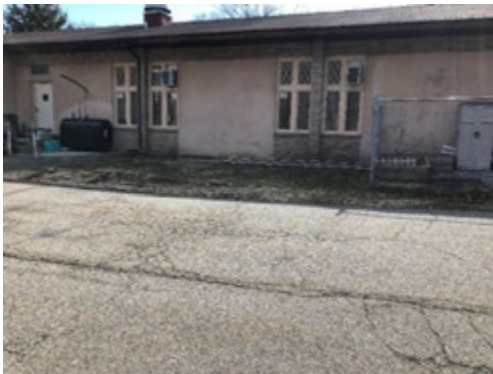
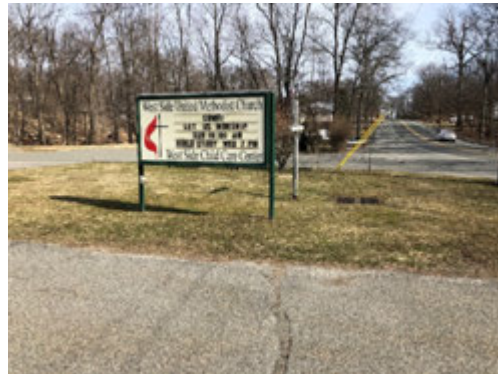
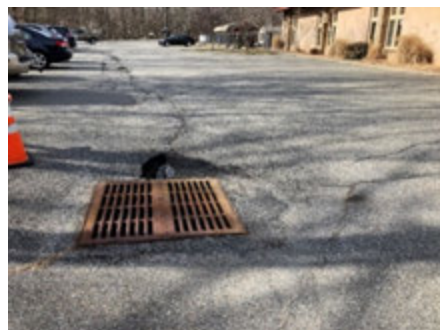
SITE 2: WEST SIDE METHODIST CHURCH (40.9510, -74.6468)

Another site that was selected by the RCEWRP as a candidate for potential BMPs is the West Side Methodist Church. In addition to the BMPs that were suggested by Rutgers, Princeton Hydro recommends a few additional measures that will work to capture and treat the maximum amount of stormwater from this site. Similar to the previous site, the building is situated in the middle of a paved parking lot. A few patches of grass are present along the west side of the building, while the surface along the east side of the building is almost entirely pavement. A grassy area with a storm drain in the center exists at the entrance of the parking lot, downhill from the building and much of the parking lot. A small stream exists on the opposite side of the parking lot on the west side of the site.

Another potential measure includes the implementation of a manufactured treatment device (MTD) in the large catch basin located near the entrance of the parking lot. The pavement around the catch basin is damaged and in need of repair and could be retrofitted with an Aqua-Guardian or similar device to increase the removal of phosphorus. Routine maintenance / clean-outs of the MTD will be required at least 1-2 times per year.

ESTIMATED COSTS: The estimated cost provided by the RCEWRP for the installation of approximately 240 square feet of bioretention system and a 750-gallon cistern is \$2,700. The cost of the additional bioretention system at the entrance of the parking lot would be approximately \$45,000. The installation of a small MTD at the catch basin near the entrance of the parking lot is estimated to cost approximately \$5,000. In total, if all of the recommended measures are to be implemented, the estimated range would be approximately \$50,000 - \$60,000. Again, based on Princeton Hydro's experience, this cost estimate provided by the RCEWRP is too low for implementation.

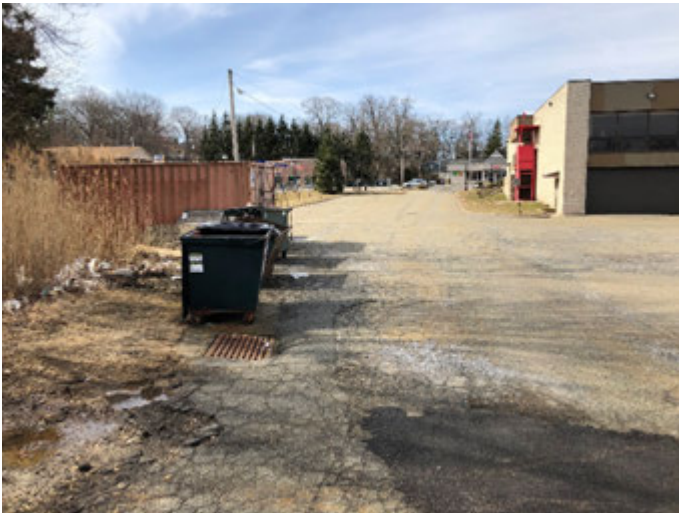
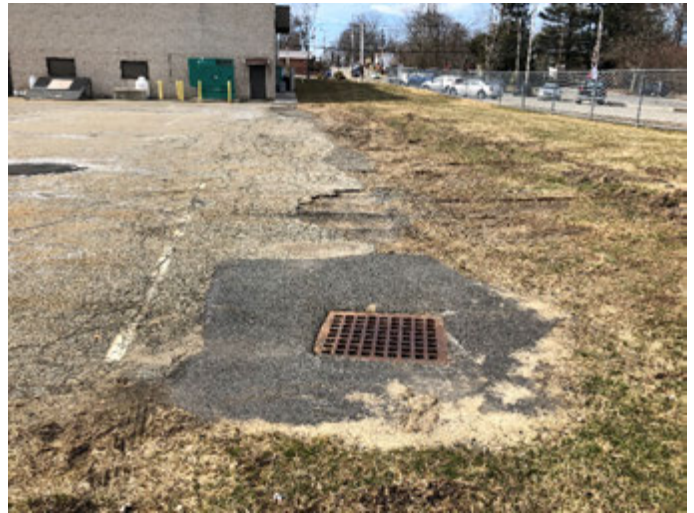
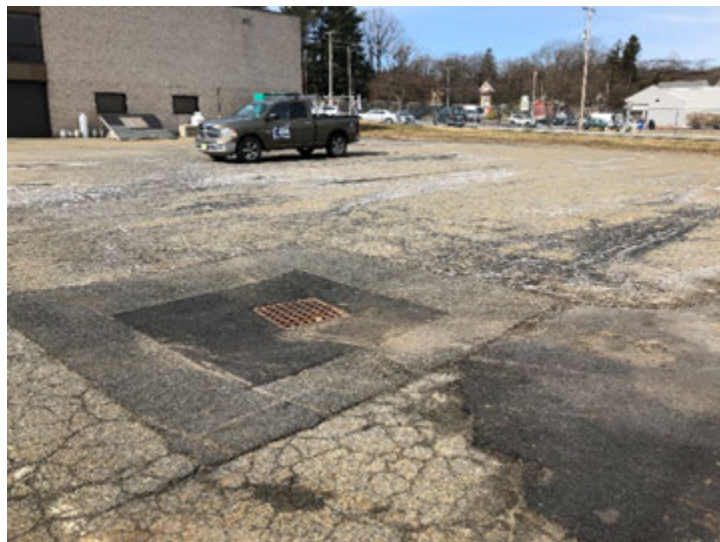
SITE 3: DEFIANCE ENGINE #3 (40.9347, -74.6606)

RECOMMENDED MEASURES: Following a site visit, we recommend a different set of BMPs than did Rutgers, but those recommendations can still be viewed at the link provided at the beginning of this section. The three catch basins at the back of the parking lot could be retrofit with Aqua-Guardians or similar MTDs to increase the removal of phosphorus from the surface runoff. To further enhance the phosphorus removal, the MTDs would include filter media such as Biochar. Alternative measures could include vegetated buffers / swales along with porous pavement

ESTIMATED COSTS: The installation of the MTDs, including the units and a supply of the nutrient filtering media is estimated to cost around \$15,000. The alternative measures of vegetated buffers / swales and/or porous pavement is estimated to cost between \$15,000 and \$30,000.

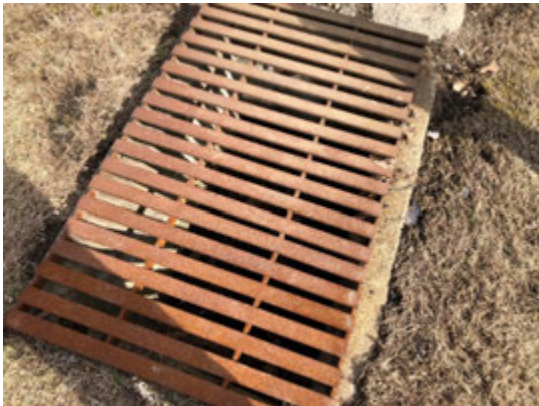
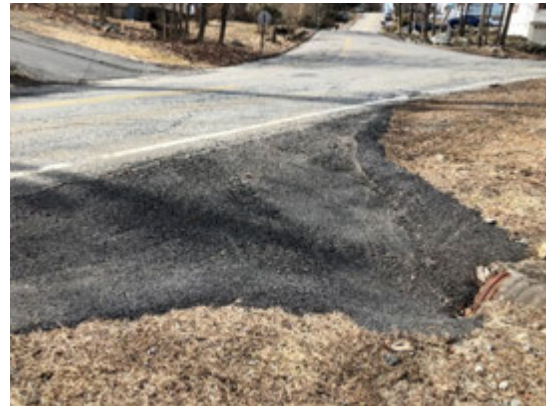
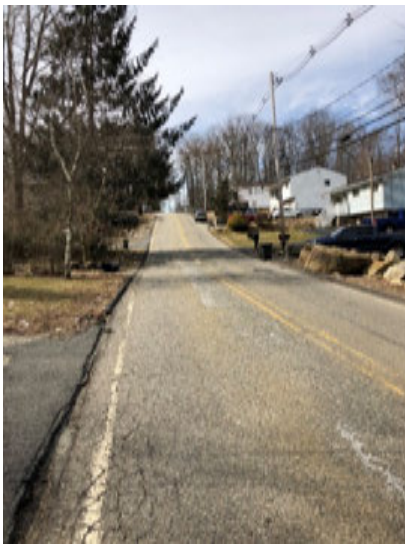
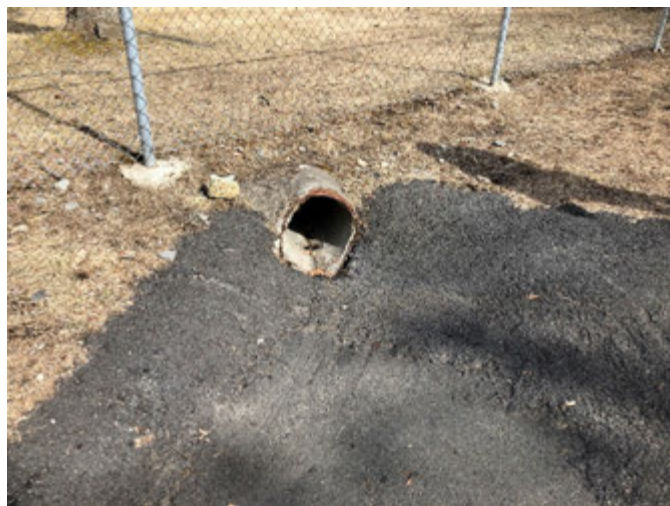
SITE 4: BELL AVENUE (40.9403, -74.6598)

RECOMMENDED MEASURES: Some type of MTD may be installed in one of the catch basins at the end of the Bell Avenue / Crescent Road intersection to capture and treat surface flows from these two streets. If possible, it would be beneficial to modify the current subsurface drainage system in that immediate area in order to divert all stormwater through the MTD before it is discharged into Crescent Cove. The implementation of roadside swales on Bell Avenue and Crescent Road would also be beneficial, but this would require additional investigations into existing easements and right-of-ways. Additionally, these swales may be stabilized and vegetated to enhance pollutant uptake. The swales may also be augmented with Biochar to increase nutrient uptake. Also, it may be possible to daylight the pipe shown below, design it as a vegetated swale.

ESTIMATED COSTS: Additional survey work is required to obtain a reasonable estimate of the costs associated with the design and installation of a MTD and additional vegetated / stabilization efforts that would capture and treat all of the stormwater from this area before it is discharged back into Crescent Cove. Additional work would also be required to give a reasonable estimate for the cost of roadside swales. However, a very preliminary estimate for the installation of the set of recommended measures at the intersection of Bell Avenue and Crescent cove is estimated to cost approximately \$400,000.

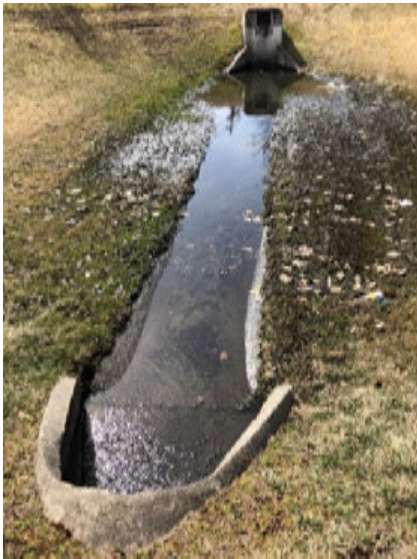
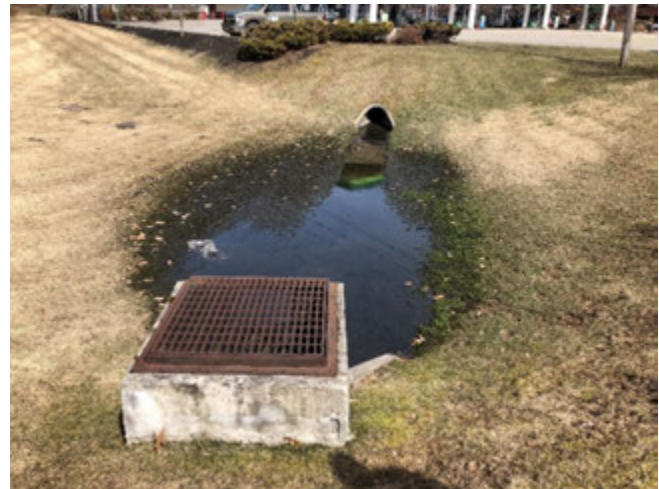
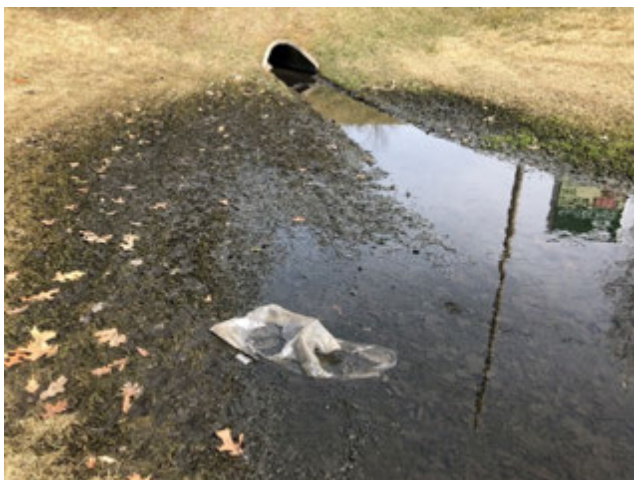
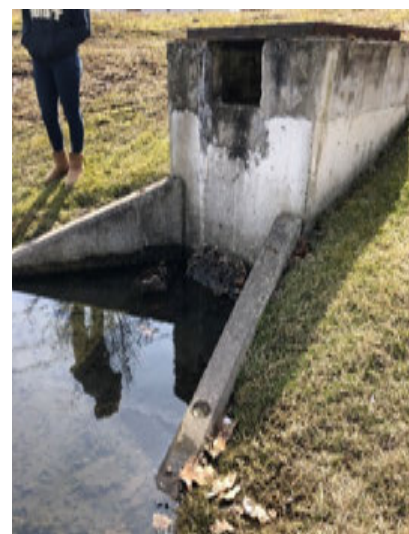
SITE 5: QUICKCHEK DETENTION BASIN (40 LAKESIDE BLVD) (40.9214, -74.6661)

The QuickChek on Lakeside Blvd. has a detention basin located at the south end of the site, between the parking lot and Lakeside Blvd. The basin has a concrete channel, lacks vegetation, and was filled with leaves and other organic matter at the time of the site visit that seems to be causing a partial blockage of the drain. The basin appears to be the primary stormwater treatment for the parking lot and the building. The basin has one inlet that is directly across the concrete channel from the outlet structure. A small amount of water was ponded in the bottom of the basin above the concrete channel and surrounding grass during the site visit. The basin may need a new trash rack and a possible modification of its outlet structure.

RECOMMENDED MEASURES: This detention basin could be retrofitted to enhance the basin's retention time and filtration efficiency. Such a retrofit would focus on the removal of the concrete channel, potential minor re-grading to lengthen the flow path, and a native, naturalized landscaping renovation of the current mowed grass vegetation. These modifications would reduce the sediment and nutrient loading and improve the runoff volume and rate reductions currently provided by the basin.

ESTIMATED COSTS: Retrofitting the existing basin is estimated to cost between \$50,000 and \$100,000.

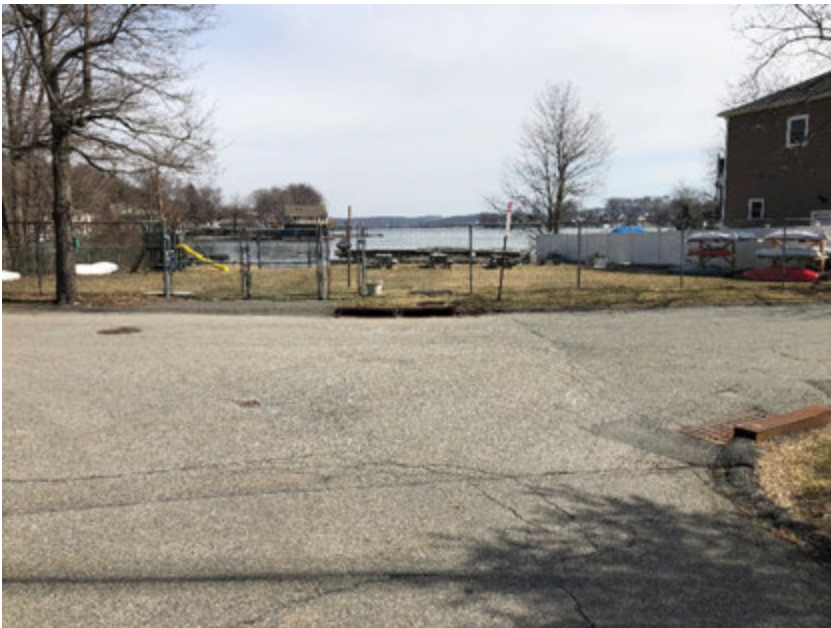
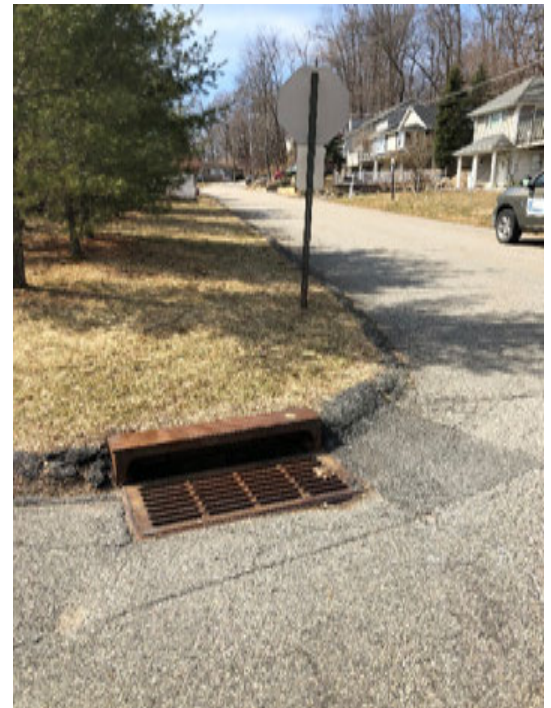
SITE 6: VALE WAY AND COVE ROAD INTERSECTION (40.9251, -74.6608)

RECOMMENDED MEASURES: There are multiple stormwater structures already in place on Cove Road and Vale Way that could potentially be retrofitted with nutrient reducing structures. The area would be an ideal candidate for the implementation of a three chambered nutrient separating baffle box or similar MTD. This MTD would likely capture and treat a large majority of the stormwater from the surrounding neighborhood before it is discharged back into Lake Hopatcong just on the other side of the park.

ESTIMATED COSTS: Depending on the amount of construction that would be required to install the three chambered baffle box or other similar structure, a ballpark estimate for the implementation of the MTD would be between \$150,000 - \$200,000. With some additional vegetated planting and stabilization work, the estimated cost would likely be somewhere between \$200,000 - \$300,000.

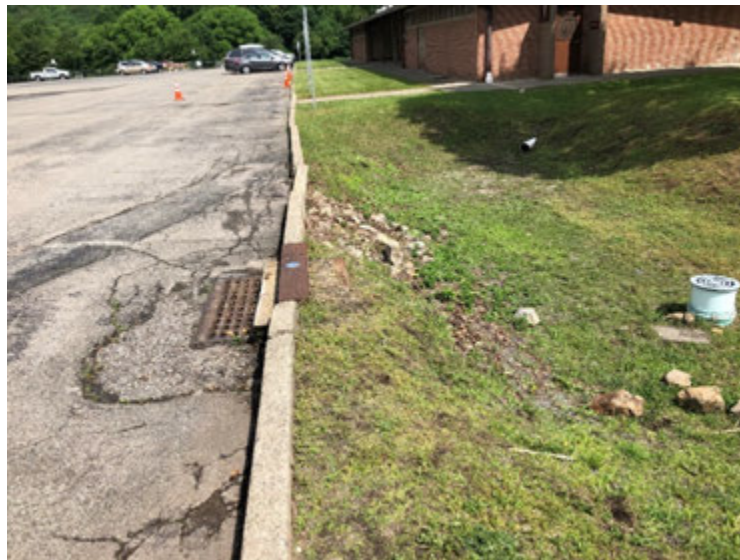
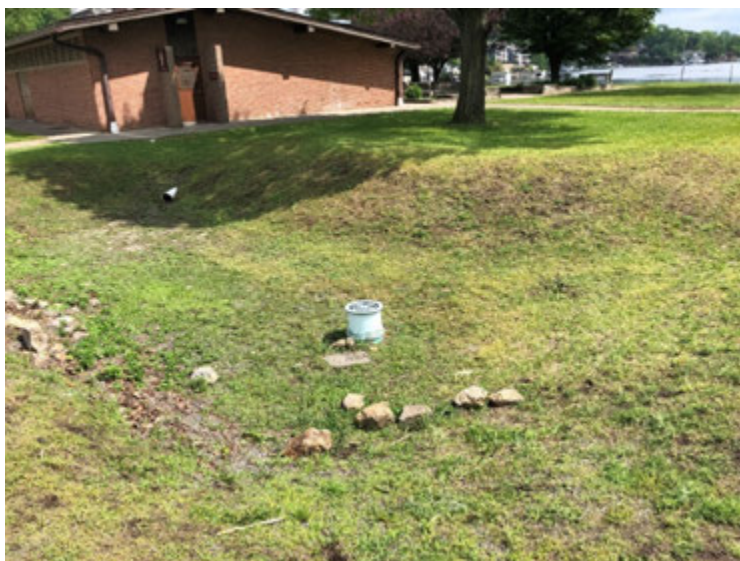
RECOMMENDED MEASURES: The biofiltration basin needs to be revegetated in order to treat the stormwater at its highest level of pollutant removal efficiency. In addition, other measures should be considered at the State Park to reduce the incoming stormwater / surface runoff pollutant loads that flow into the beach area. Such measures may include the use of porous pavement, vegetative filter strips and sewerage the bathroom facility. These additional measures should be considered in more detail in the proposed Beach Restoration Plan for the Hopatcong State Park Beach.

ESTIMATED COSTS: The cost for revegetating the biofiltration basin is estimated to be approximately \$5,000.

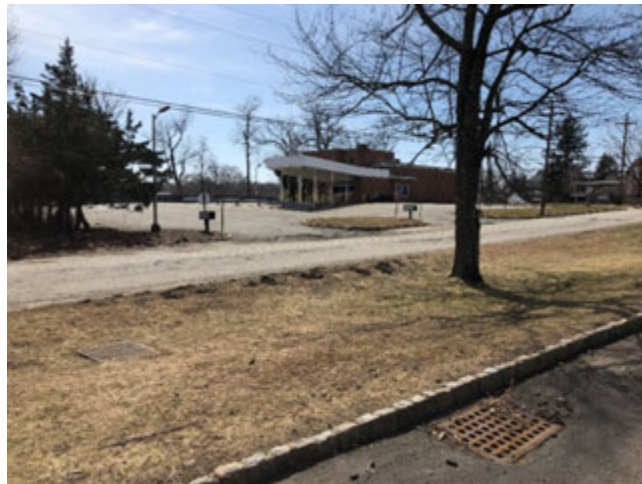
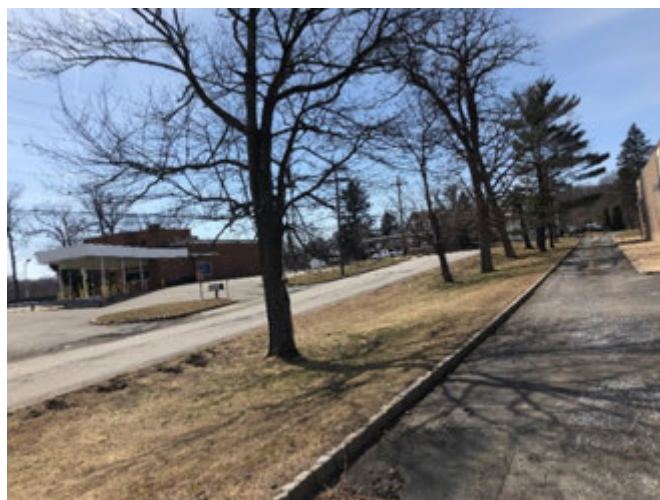
SITE 8: VERIZON BUILDING (LAKE MUSCONETCONG WATERSHED) (40.9070, -74.6644)

RECOMMENDED MEASURES: This grass area would be an ideal candidate for a bioretention system. The installation of any type of BMP in this location would require additional investigation into existing easements and right-of-ways due to the close proximity to the Verizon building. If the installation of a bioretention system is possible, this BMP would be utilized to its maximum potential if runoff from the Verizon building, the parking lot, and the street were all directed to the bioretention system. Additional engineering recommendations include curb cuts for positive drainage to the grate, as well as minimizing the loss of the existing trees.

ESTIMATED COSTS: The estimated cost range for the design and installation of a bioretention system next to the Verizon building would likely be in the range of \$100,000 - \$200,000. This estimate is a ballpark range and would be dependent on the amount of additional work that would be required to direct the maximum amount of stormwater to the basin.

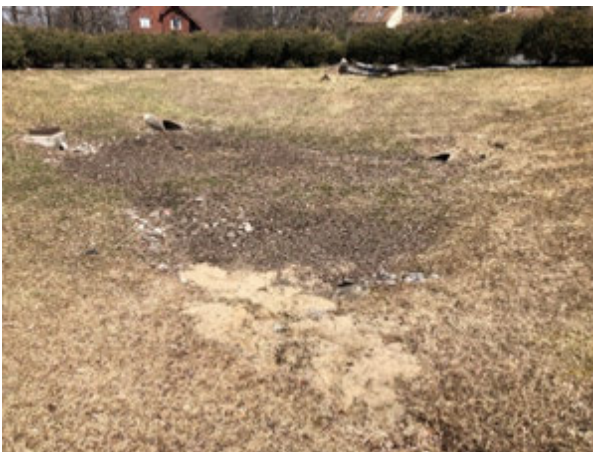
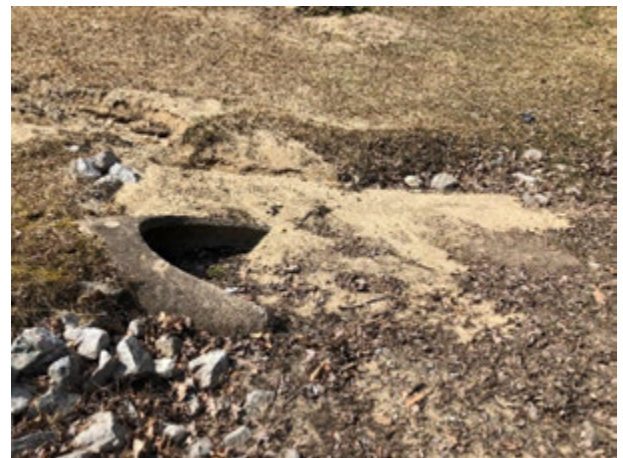
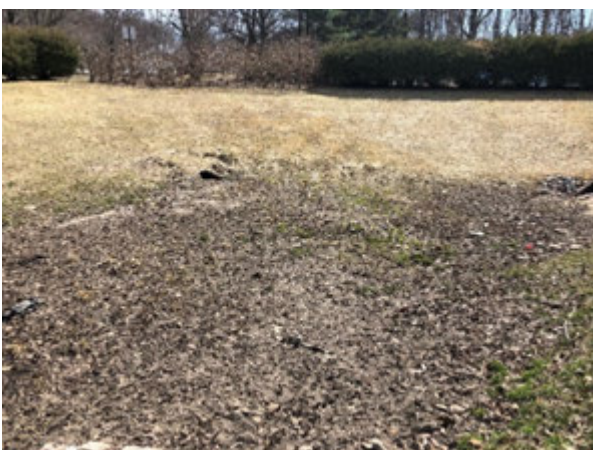
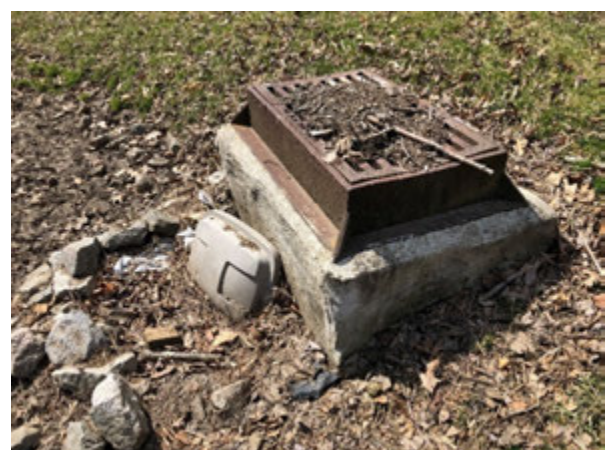
SITE 9: AURIEMMA COURT (40.9186, -74.6526)

RECOMMENDED MEASURES: This site is an ideal candidate for a basin retrofit that would address the major sedimentation issues and associated limited capability of nutrient filtration. The first major component of the basin retrofit would consist of a stabilization of the sediment and revegetation throughout the basin. Note this more than likely will include the removal of accumulated material to restore the capacity of the basin. The revegetation would decrease the rate of sedimentation by stabilizing the soil and would work to increase the assimilation of nutrients. Additional investigations into the structure and function of the inlet and outlet structures are also recommended to determine how efficiently the system is functioning.

ESTIMATED COSTS: An estimated range of cost for the basin stabilization and revegetation is between \$200,000 - \$250,000. Additional investigations into the functionality of the inlet and outlet structures could raise this price substantially depending on any additional work, but a cost for this is not available at this time.

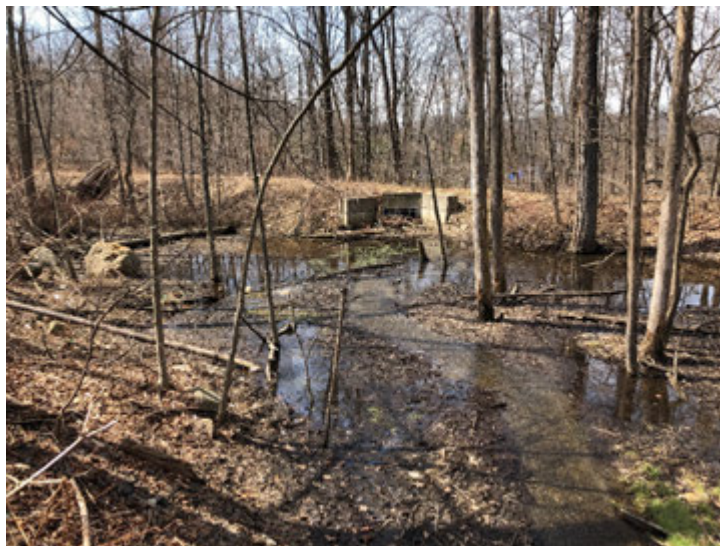
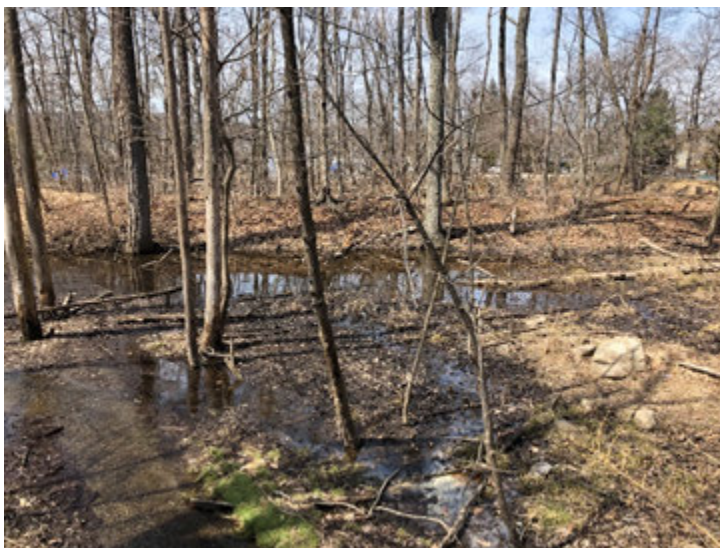
SITE 10: DETENTION BASIN / WET POND (MT. ARLINGTON BLVD.) (40.9188, -74.6457)

There is a stormwater basin located just north of Mt. Arlington Blvd. The basin appears to have one major inlet on the south side, which drains a small creek that runs on the opposite side of Mt. Arlington Blvd, and one outlet structure on the north end of the basin. There was a small amount of water present in the basin during the site visit which comes from the small creek. The basin is likely at least partially wet at all times, but the amount of standing water was minimal. Except for the trees present in the basin, there did not seem to be much additional vegetation, and the drainage in the surrounding area looked poor.

RECOMMENDED MEASURES: The location of this basin at the receiving end of a stream that drains a substantial portion of the surrounding neighborhood makes it an ideal candidate for a basin retrofit. Based on field observations, this basin could potentially be converted into more of a functional wetland basin, which would provide enhanced nutrient removal. However, some additional field investigations would be required. The idea here would be to add emergent vegetation that would sequester nutrients from the standing water before it either infiltrates the soil or is discharged through the outlet structure.

ESTIMATED COSTS: Retrofitting the existing basin into a more functional wetland BMP is estimated to cost somewhere in the range of \$200,000 to \$300,000.

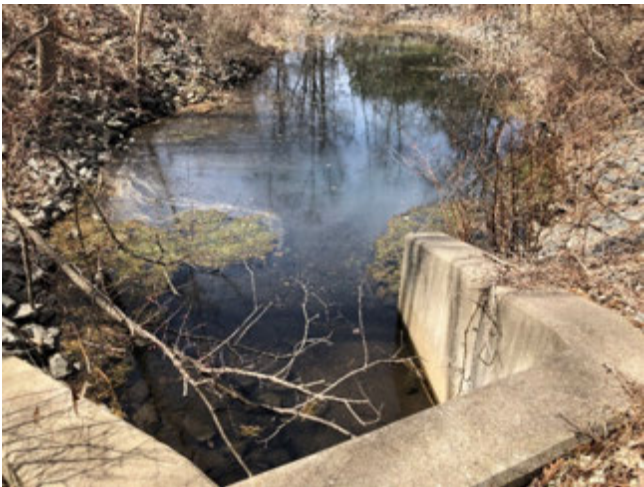
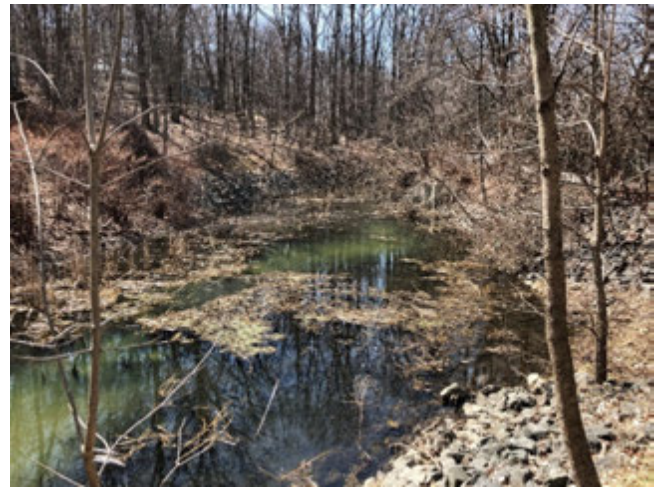
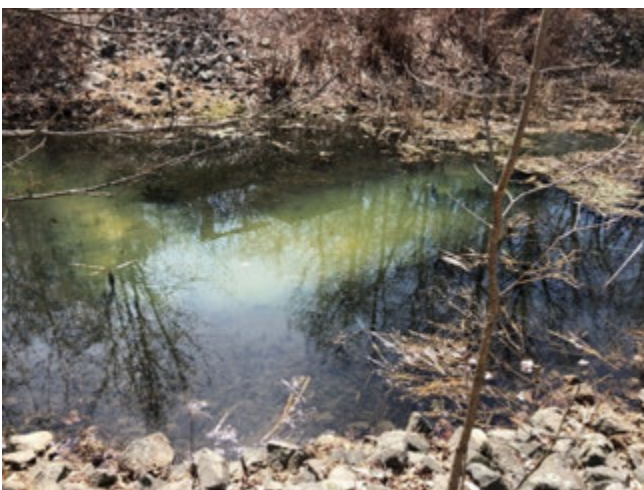
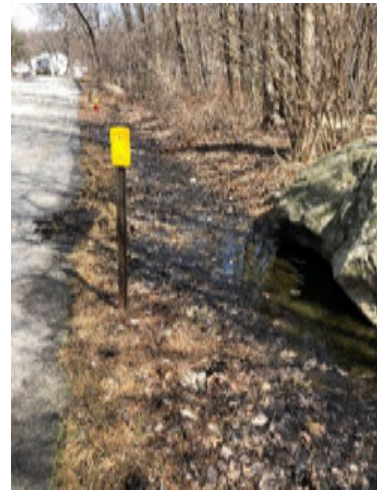
SITE 11: RETENTION BASIN (MT. ARLINGTON BLVD.) (40.9186, -74.6464)

RECOMMENDED MEASURES: Due to the limited spacing in this wooded area, the costs of retrofitting this retention basin may be higher relative to the other basins discussed. The smell, suspicious algae bloom, and white surface film in the water should be investigated further. It is likely that these issues are a result of being located next to the pumping station, but if there is a leak or other failure in the station, it should be addressed prior to upgrading the basin. This site and the previously mentioned detention basin should both be investigated further to determine the best course of action to address both basins. If these basins could be connected and revegetated in some fashion, the assimilation and nutrient sequestration of the stormwater would increase greatly.

ESTIMATED COSTS: Due to the uncertainty of what the major issue behind the water quality in the retention pond, an estimated cost cannot be provided until further investigation. However, excluding any costs associated with repairs necessary for the pump station, retrofitting the basin is estimated to cost between \$200,000 and \$500,000.

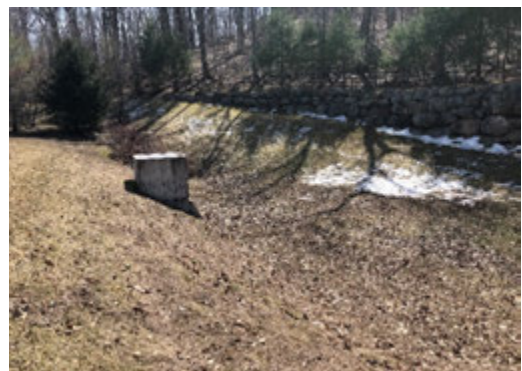
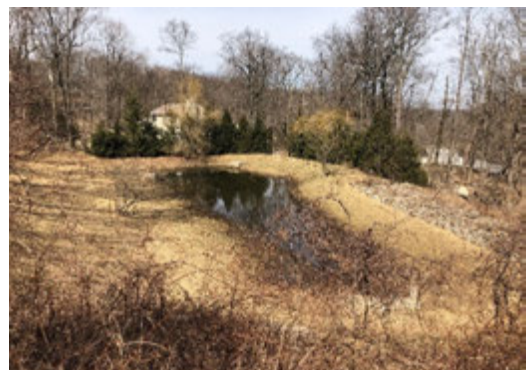
RECOMMENDED MEASURES: The numerous curbside storm drains in the parking lots of this complex make them ideal candidates for tree box biofiltration systems. Depending on which drains receive the greatest volume of stormwater, each small parking lot could be retrofit with at least one curbside storm drain with tree box units. The tree boxes would allow for a large portion of the stormwater in the apartment complex to be treated by the nutrient reducing media before the water is discharged into the detention basins. In addition to the aforementioned units, each of the detention basins could be retrofitted to enhance filtration and retention, further reducing the nutrient loads of the discharged water. The modifications and upgrades to the basins would likely be relatively minor considering neither of the basins contains a concrete channel but would be focused on revegetation, modification to the outlet structures, and the potential modification of the soil to allow for better filtration and nutrient removal.

ESTIMATED COSTS: The estimated cost for the installation of approximately six tree box units throughout the complex would likely be between \$200,000 - \$300,000. Depending on the amount of work that would be required to enhance the two detention basins to maximum efficiency, a ballpark estimate of the cost would be between \$50,000 - \$100,000. In total, if six tree box units are installed and both basins are retrofit, an estimated range of cost would be between \$350,000 - \$400,000.

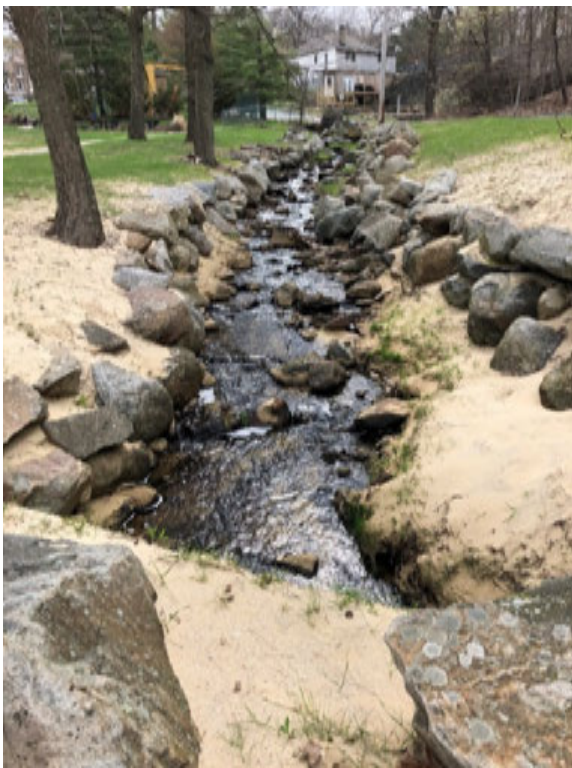
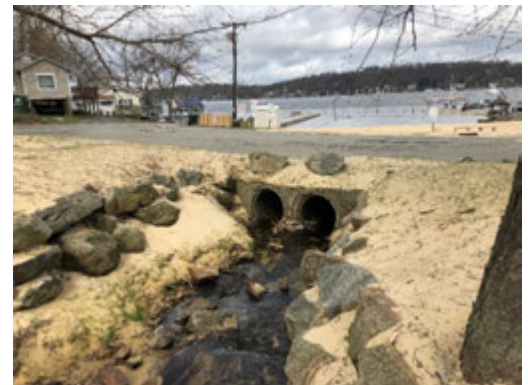
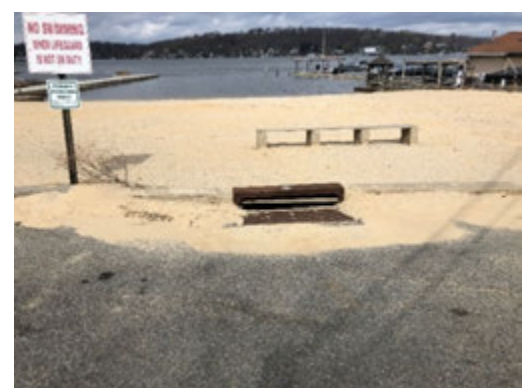
SITE 13: ARTHUR R. ONDISH MEMORIAL BEACH (40.9288, -74.6380)

There is a stream just uphill from the beach that runs through a culvert before it travels under the parking lot, eventually discharging into the lake. The streambanks in this area are lined with rip rap for erosion control but lack vegetation and are covered with sand at points. There is a curbside storm drain on the opposite side of the parking lot from where the stream enters the culvert. An investigation into the hydrology of the stream and associated discharge into Lake Hopatcong revealed that this stream drains a substantial portion of the upstream neighborhood. Thus, this location is a strong candidate for upgrades to the stormwater infrastructure.

RECOMMENDED MEASURES: There are multiple stormwater structures already in place in the parking lot that could potentially be retrofitted with nutrient reducing structures. The parking lot, between the culvert and the curbside storm drain, would be an ideal candidate for the implementation of a three chambered nutrient separating baffle box. This MTD would likely capture and treat a large majority of the stormwater from the surrounding neighborhood before it is discharged back into Lake Hopatcong just on the other side of the park. In addition to the MTD, the curbside drain could be retrofitted with a tree box bioretention system. The tree box would be located between the MTD and the lake, effectively capturing and treating excess surface flow that bypasses the MTD. Additionally, the streambanks should be cleared of sand and vegetated, creating shoreline buffers to capture and treat additional stormwater runoff. Also, if riprap is still used, it should be replaced with large, natural rock. Finally, the creation of a floodplain adjacent to the stream may be a potential option depending on land ownership. There is an existing baffle box near this project site in which additional filter media (e.g. Biochar) can be added to the system to increase phosphorus removal.

ESTIMATED COSTS: Depending on the amount of construction that would be required to install the three chambered baffle box in the parking lot, a ballpark estimate for the implementation of the MTD would be between \$150,000 - \$200,000. The estimated cost to install one tree box bioretention system would be approximately \$50,000. In total, if a three chambered baffle box and one tree box unit are installed in the parking lot, the estimated cost would likely be somewhere between \$200,000 - \$250,000.

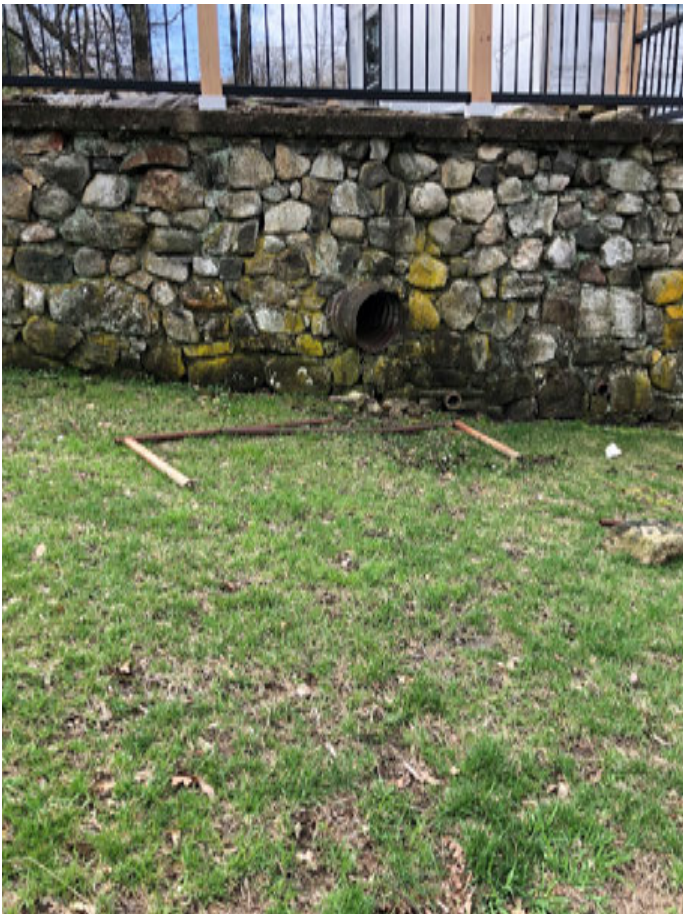
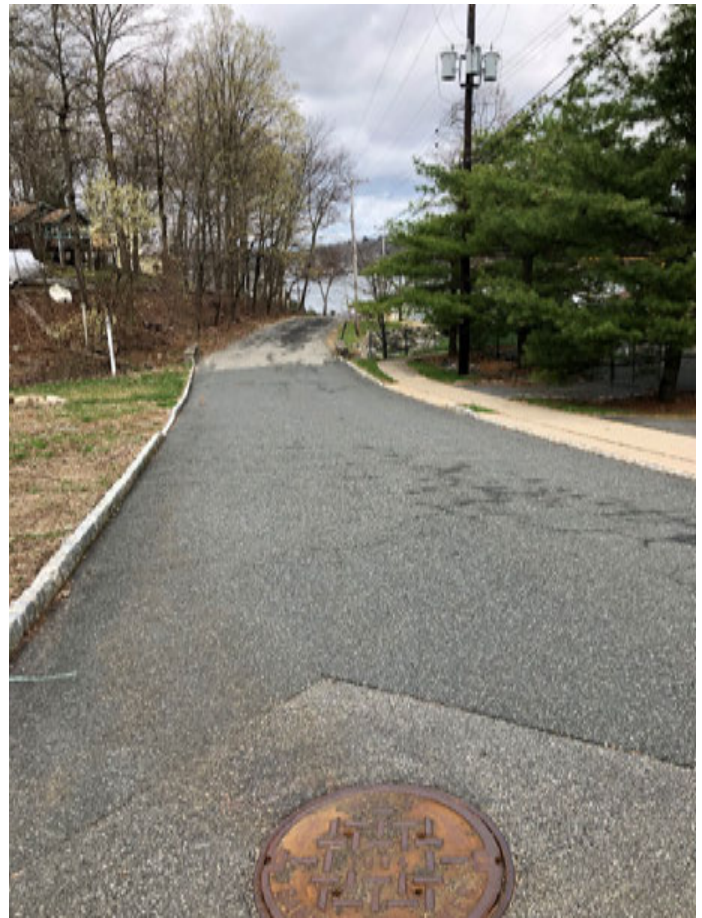
SITE 15: EDITH M DECKER SCHOOL (40.9343, -74.6291)

RECOMMENDED MEASURES: Due to the relatively large size of the parking lot and multiple stormwater structures, this site is an ideal candidate for multiple BMPs and/or MTDs, coupled with some vegetated buffers and breaking up the impervious surfaces. The grassy area in the middle of the parking lot could potentially be constructed into a bioretention / rain garden. This would require further investigation into the drainage pattern of stormwater through the parking lot. Additionally, an MTD with filter media could be installed in one of the large catch basins located between the parking lot and stream to capture and treat stormwater from the parking lot before it is discharged into the stream. There is also a smaller catch basin on the south side of the parking lot that was covered in sediment during the site visit. This storm drain could also be retrofit with a small MTD with filter media to capture and treat additional stormwater before it is discharged back into the creek.

ESTIMATED COSTS: The estimated cost range for the design and installation of a rain garden in the center of the parking lot would likely be in the range of \$15,000 - \$25,000. A cost estimate for the installation of two Aqua-Guardians and associated vegetated buffers would be between \$30,000 - \$45,000. Thus, the total cost for implementation is estimated to cost between \$45,000 and \$70,000.

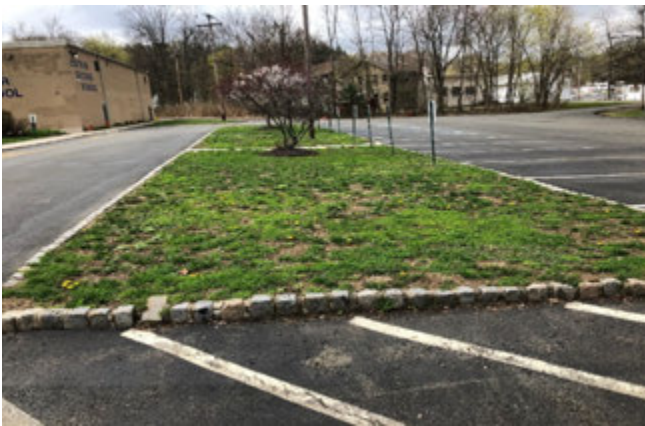
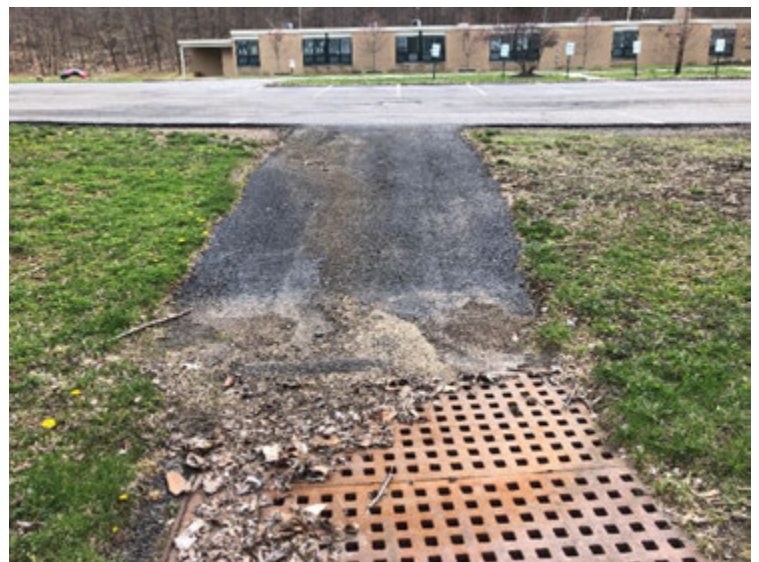
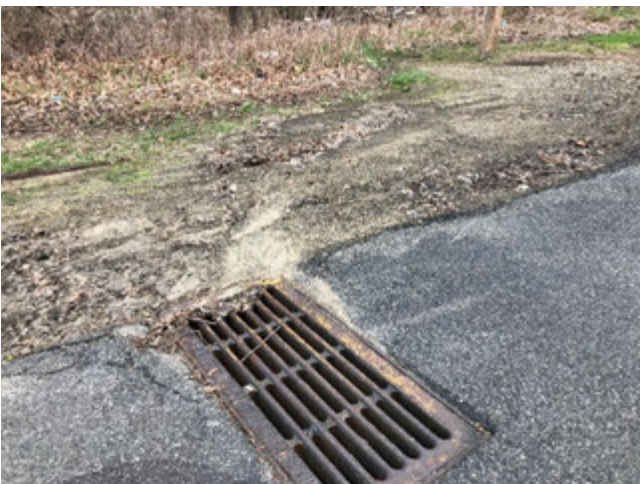
SITE 16: HOWARD BLVD (IN FRONT OF EDITH M DECKER SCHOOL) (40.9340, -74.6298)

RECOMMENDED MEASURES: Somewhere between the culvert and Lake Hopatcong would be an ideal location for a three chambered nutrient separating baffle box with up flow filter. This MTD would capture and treat a large portion of surface runoff from the surrounding neighborhood before it enters Lake Hopatcong. Both of the catch basins located on Howard Blvd could also be retrofitted with small MTDs and filter media (such as Biochar), which would allow for the surface runoff from Howard Blvd to be captured and treated before it is discharged back into the lake.

ESTIMATED COSTS: A ballpark estimate for the installation of a three – chambered baffle box and associated small MTDs with filter media would be in the range of \$300,000 - \$400,000.

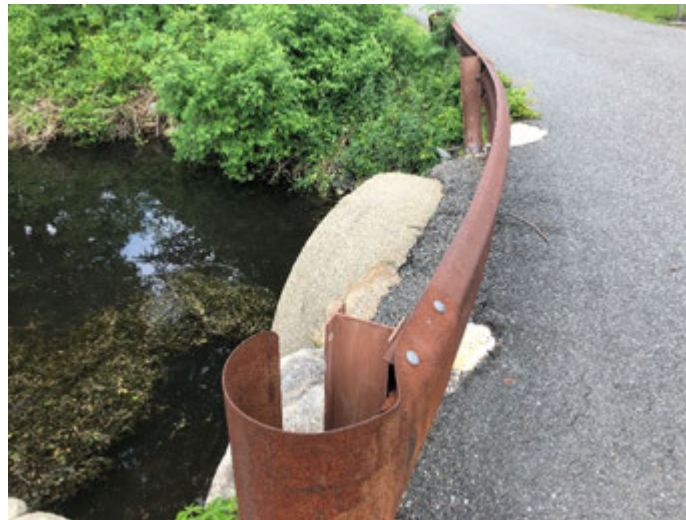
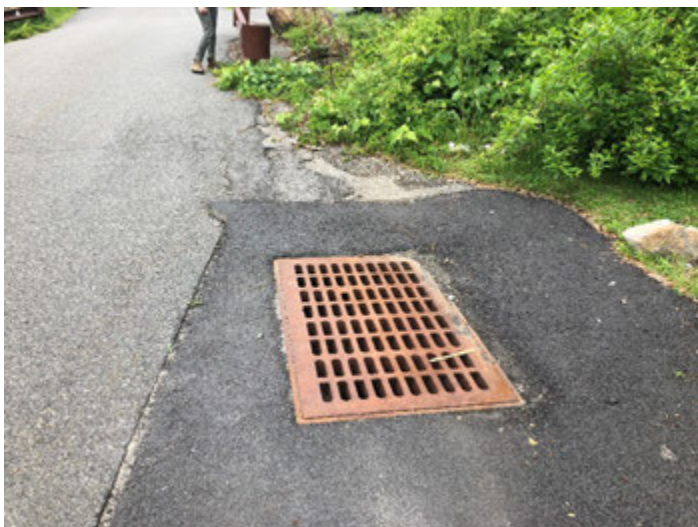
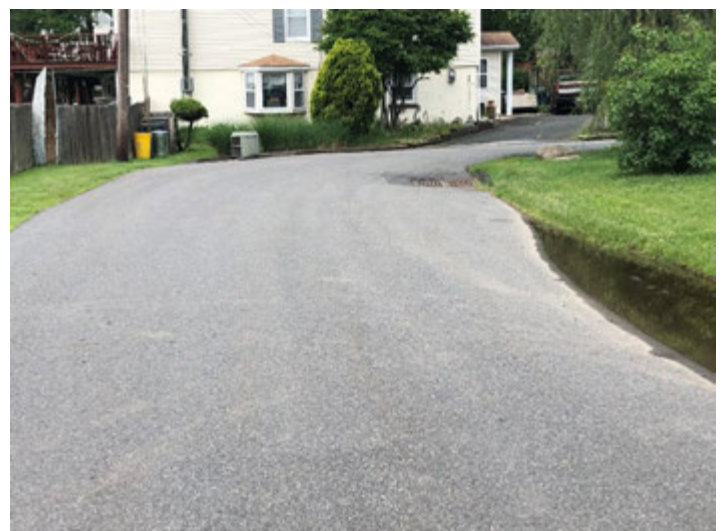
SITE 18: ALABAMA AVENUE AND NEW JERSEY AVENUE (40.9721, -74.6301)

RECOMMENDED MEASURES: The large catch basin located just before the lake is an ideal candidate for the implementation of a three chambered nutrient separating baffle box. It seems as though there is already existing stormwater infrastructure in place under the road that would make the installation of a large MTD relatively straight forward. This catch basin would be the best location for the MTD because it is the closest to the lake and would capture and treat the largest volume of stormwater.

ESTIMATED COSTS: Depending on the amount of construction that would be required to install the three chambered baffle box at the end of New Jersey Avenue, a ballpark estimate for the implementation of the MTD would be between \$150,000 - \$200,000.

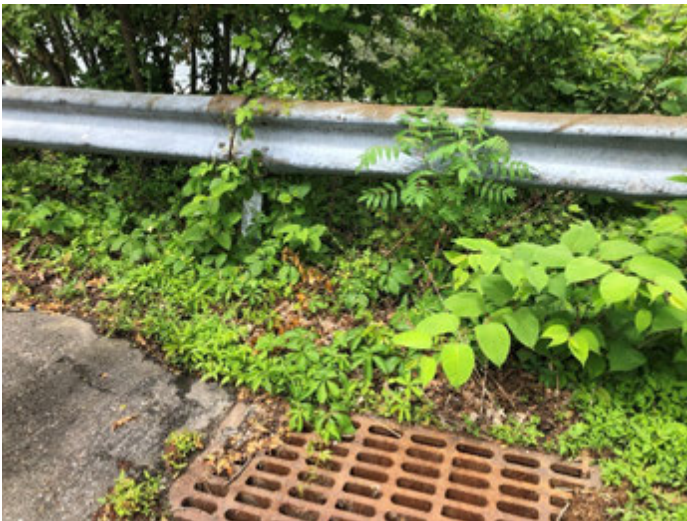
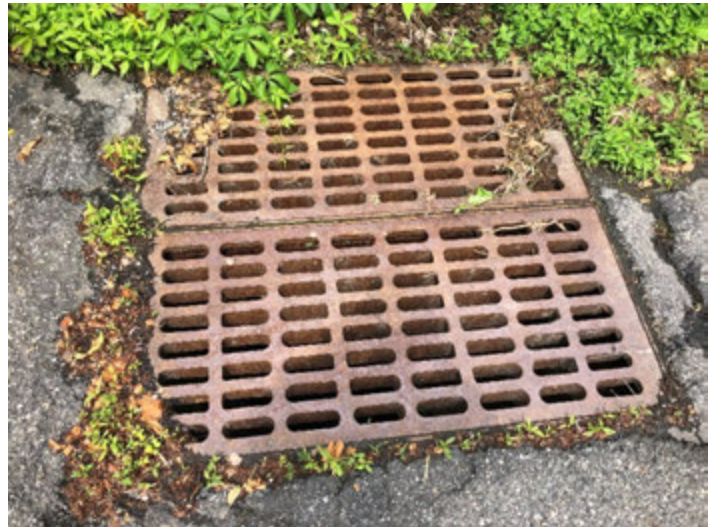
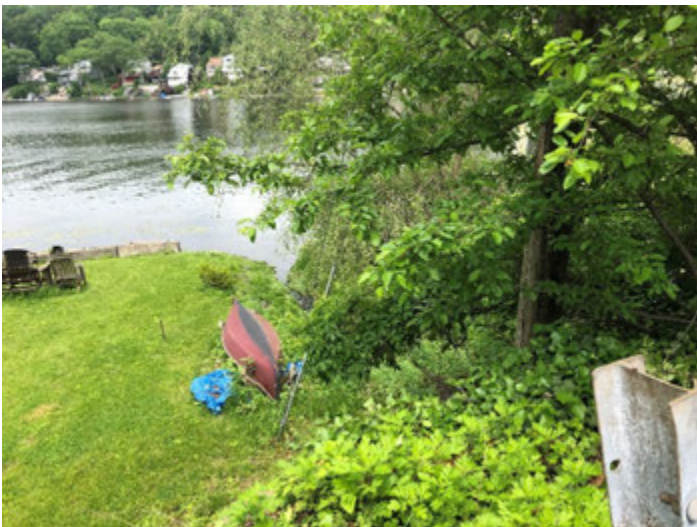
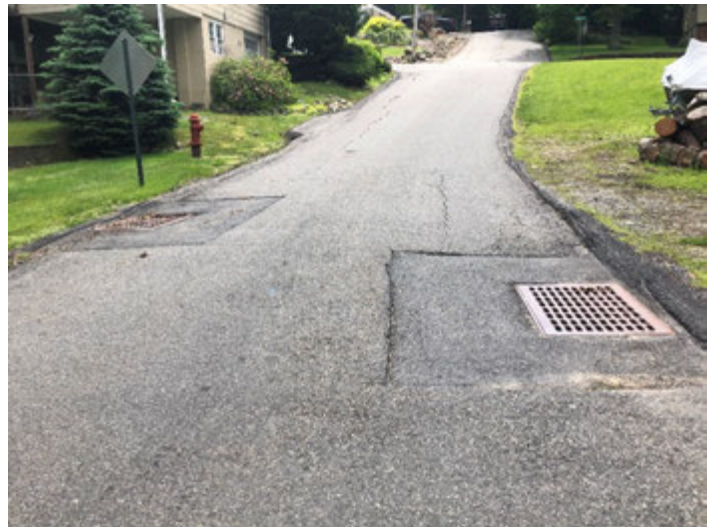
SITE 19: NEW JERSEY AVENUE (40.9656, -74.6288)

RECOMMENDED MEASURES: The catch basin on Ohio Street would be a good candidate to be retrofit with a small MTD and filter media to aid in the removal of phosphorus and suspended sediment from the stormwater. However, some additional, on-site engineering assessments should be conducted to determine the feasibility of some stabilization of the existing stormwater conveyance system.

ESTIMATED COSTS: The installation of a small MTD with filter media is estimated to cost \$15,000.
