UPPER MUSCONETCONG RIVER WATERSHED IMPLEMENTATION PLAN

MORRIS AND SUSSEX COUNTIES, NEW JERSEY

NOVEMBER 2020

PRINCETON HYDRO, LLC
1108 OLD YORK ROAD, SUITE 1
P.O. BOX 720
RINGOES, NJ 08551
908-235-5660

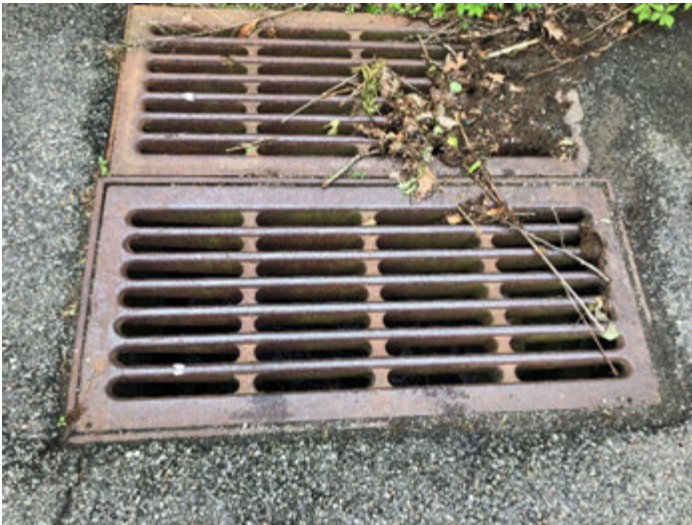
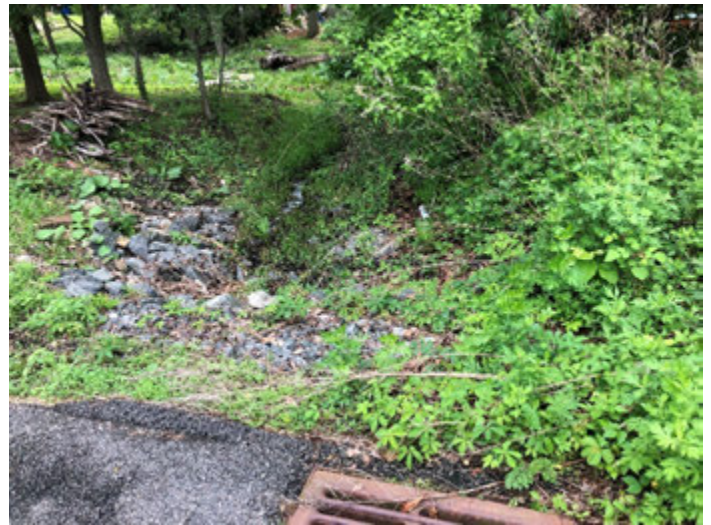
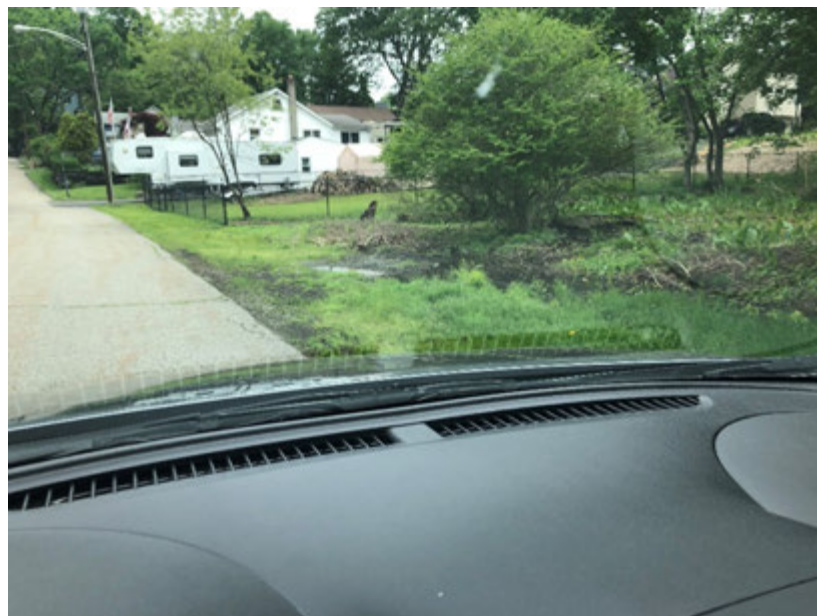
SITE 20: BRADY ROAD AND NORTH LAKESIDE AVENUE (40.9632, -74.6222)

RECOMMENDED MEASURES: An MTD, possibly a three-chambered baffle box, could be installed between two inlets or along the pipe system, not in an existing inlet, located in the parking lot just to the west of Brady Road. This catch basin is relatively large and receives runoff from the small stream and the surrounding streets. This MTD would likely capture and treat a large volume of the stormwater from the surrounding area before it is discharged back into Lake Hopatcong just on the other side of the road.

ESTIMATED COSTS: Depending on the amount of construction that would be required to install the three chambered baffle box on Brady Road, a ballpark estimate for the implementation of the MTD would be between \$150,000 - \$200,000.

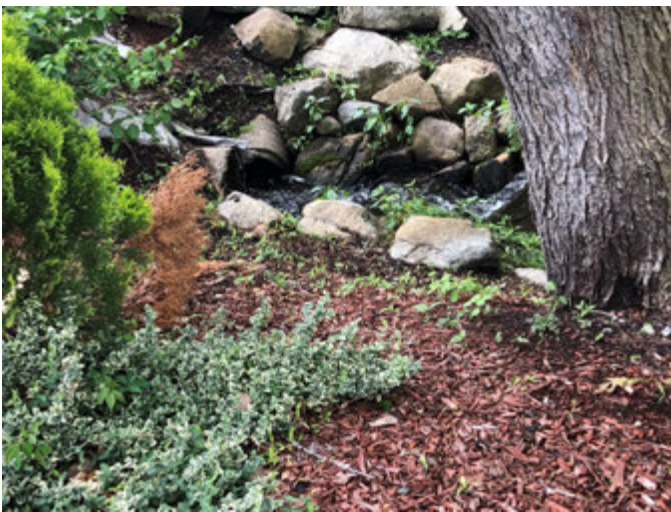
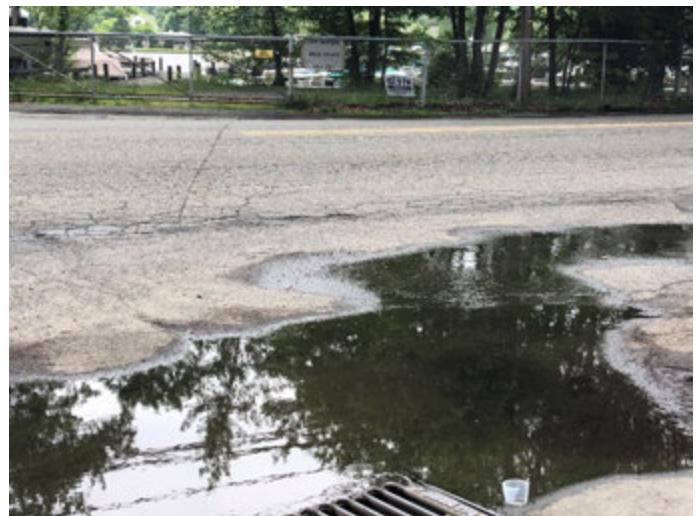
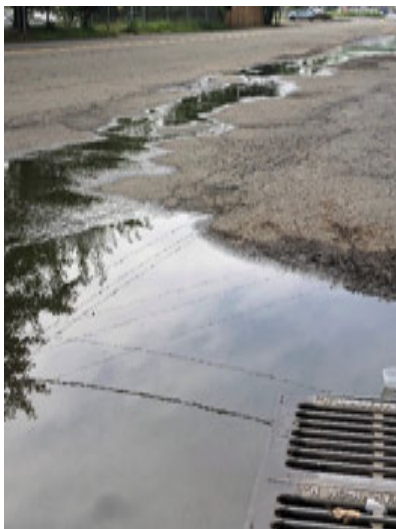
SITE 21: OAKWOOD ROAD AND SHORE ROAD (40.9839, -74.6169)

RECOMMENDED MEASURES: The large catch basin located at the end of the road is an ideal candidate for the installation of a small MTD with filter media, like Biochar. It seems as though there is already a large storm sewer system in place under the road that would make the installation of an MTD relatively straight forward. This catch basin would be the best location for the MTD since it is the closest to the lake and would capture and treat the largest volume of stormwater.

ESTIMATED COSTS: The installation of a small MTD with filter media is estimated to cost \$15,000.

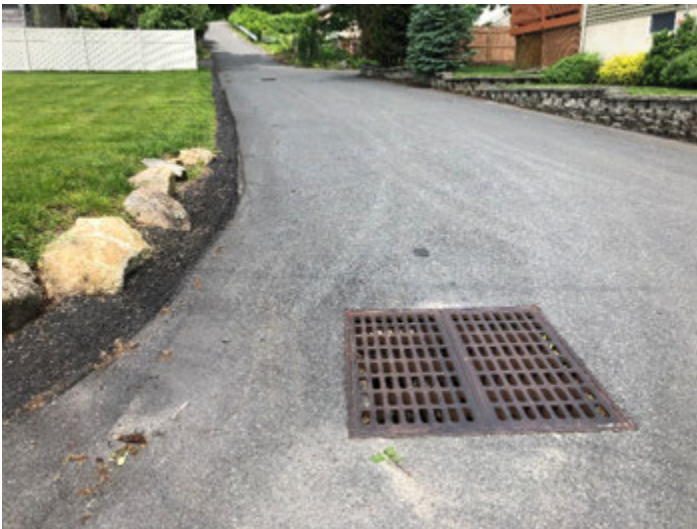
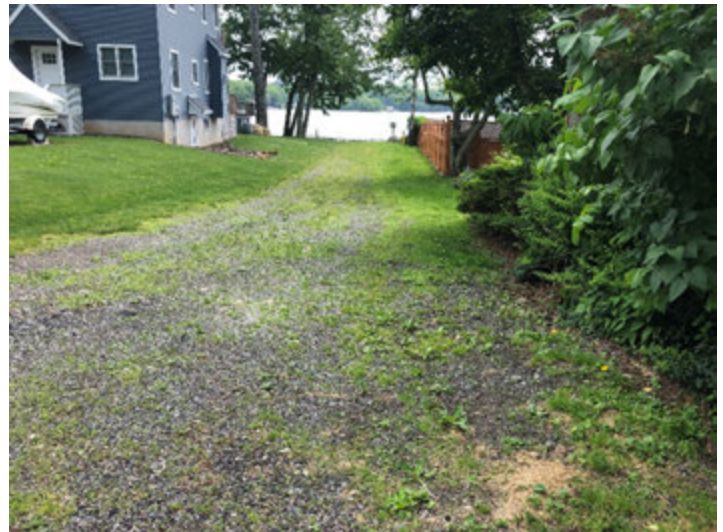
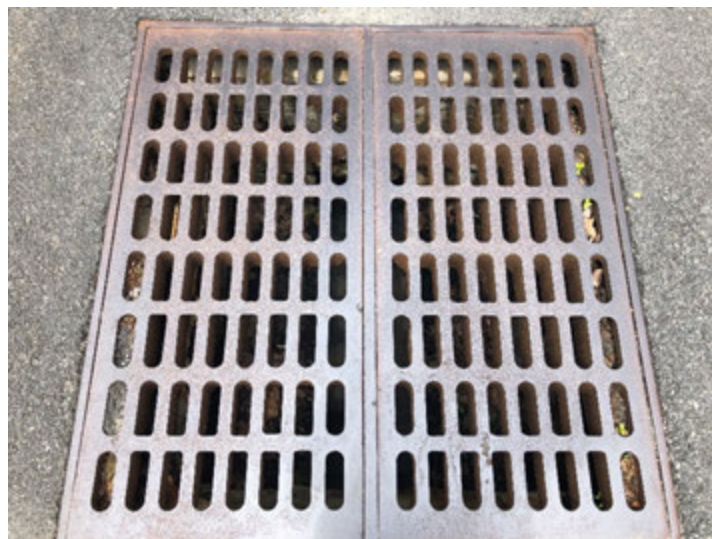
SITE 22: QUARRY STREAM / PROSPECT POINT ROAD (40.9867, -74.6163)

RECOMMENDED MEASURES: In addition to what is decided between NJDEP, the quarry, and The Commission, there are currently two curbside storm drains located in close proximity, although it has been noted that these drains have been assessed in the past and were not fit for filter media. Also, a stormwater pond on the quarry property may require some maintenance and possible upgrades to maximize its pollutant removal capacity.

ESTIMATED COSTS: Currently (October 2020) under discussion among the quarry, NJDEP and the Commission.

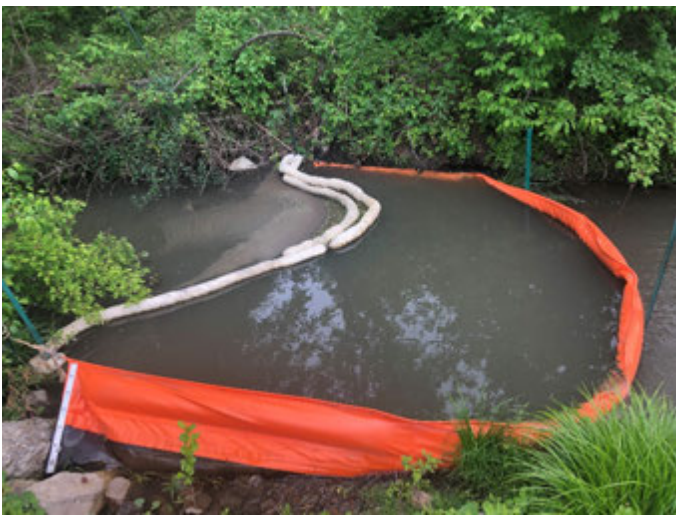
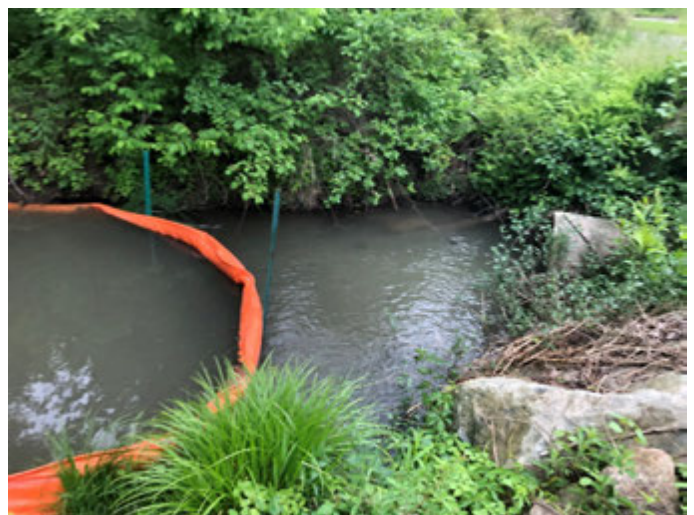
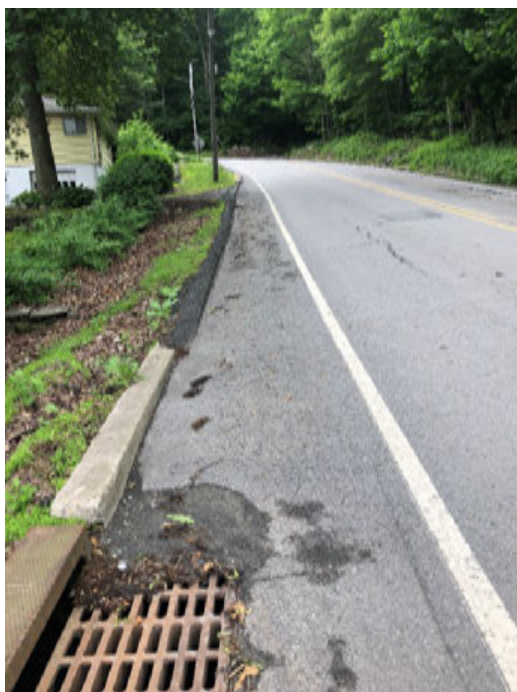
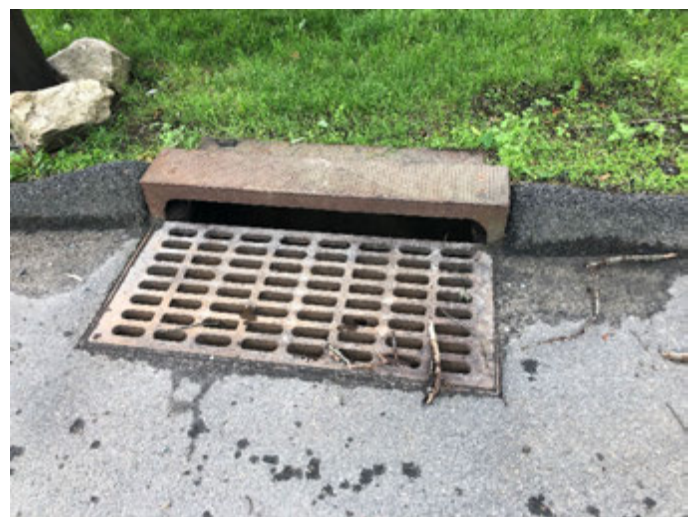
SITE 23: LORETTACONG DRIVE AND RT 181 INTERSECTION / STREAM CROSSING (40.9879, -74.6117)

RECOMMENDED MEASURES: The curbside storm drains here are all good candidates to be retrofit with tree box tree boxes and/or small MTDs. The tree boxes would allow for a large portion of the stormwater from the road to be treated by the nutrient reducing media before the water is discharged into either the creek or the lake.

ESTIMATED COSTS: The estimated cost to install two tree box bioretention systems would be approximately \$75,000.

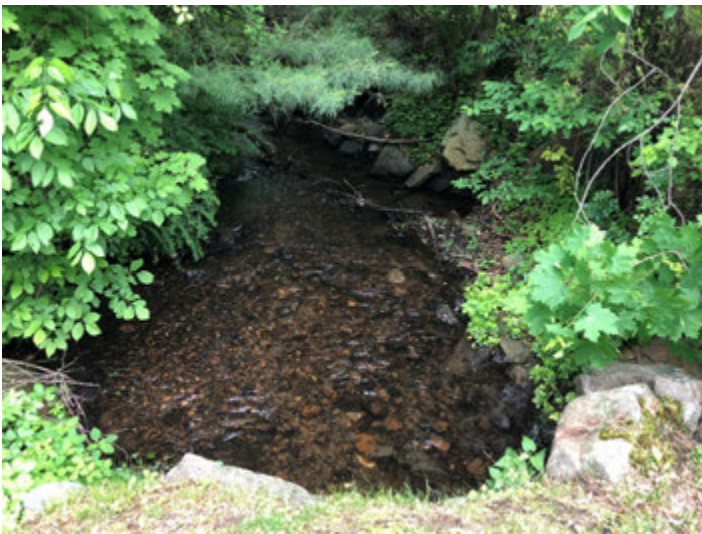
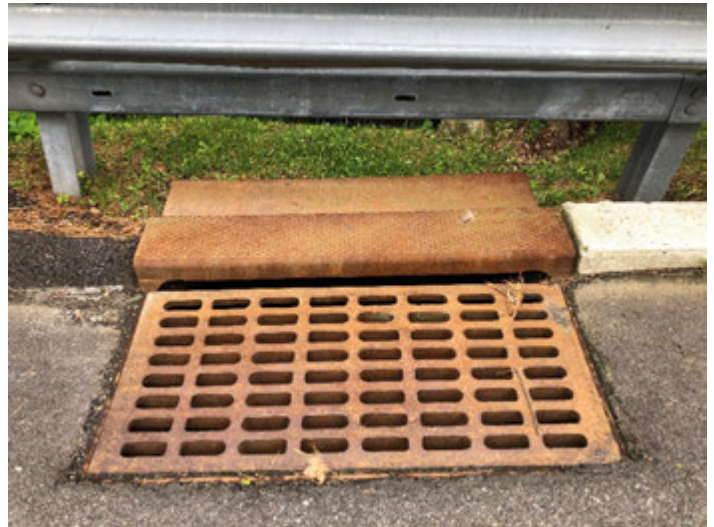
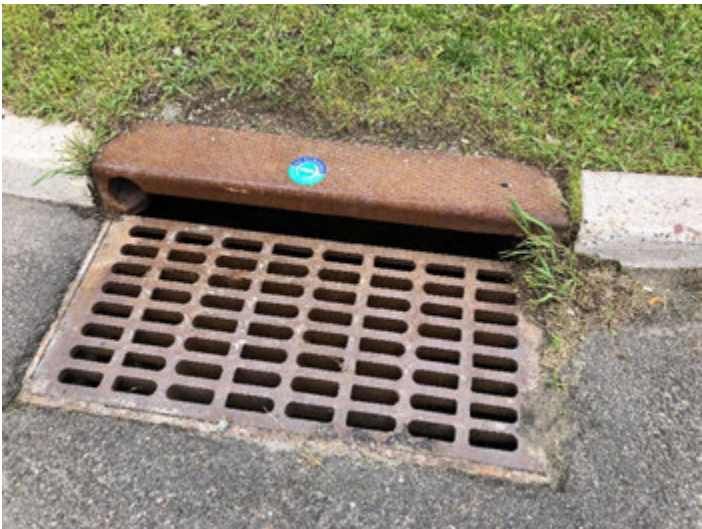
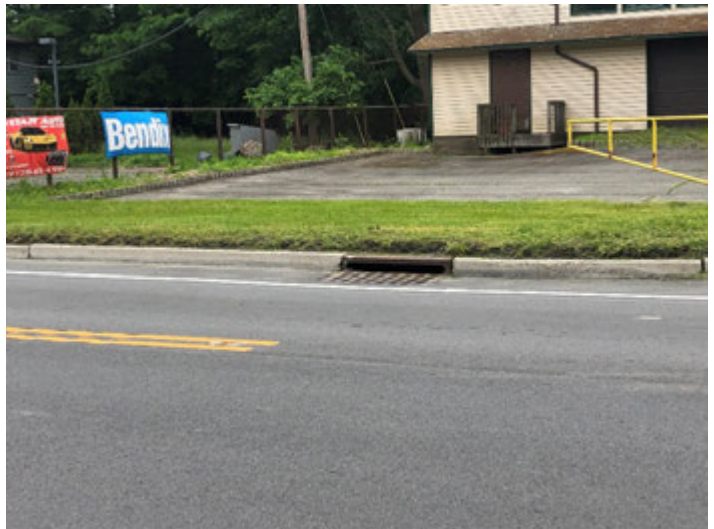
SITE 24: LORETTACONG DRIVE / LAKE WINONA STREAM CROSSING (40.9888, -74.6063)

The stream that drains Lake Winona passes under Lorettacong Drive at this site before it empties into Lake Hopatcong. There is a catch basin located just southeast of the stream crossing on Lorettacong Drive that was flowing during the site visit.

RECOMMENDED MEASURES: The catch basin located next to the stream is a good candidate to be retrofit with a small MTD with filter media. This catch basin appears to be the terminal catch basin that receives stormwater from the entire street, including other basins up the road.

ESTIMATED COSTS: The installation of a small MTD with filter media is estimated to cost \$15,000.

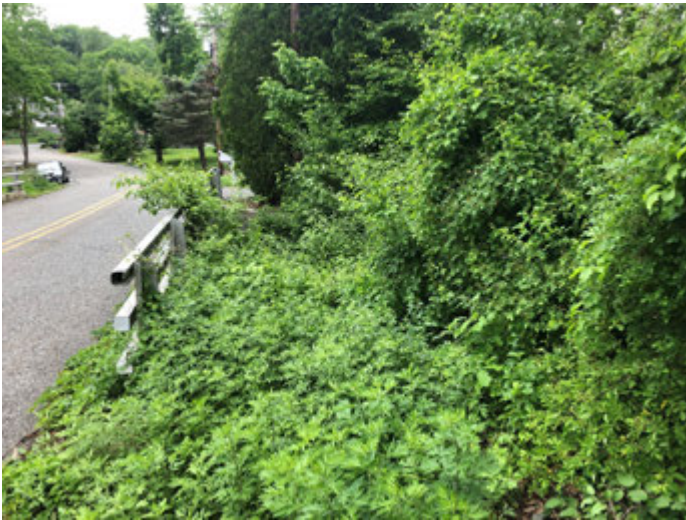
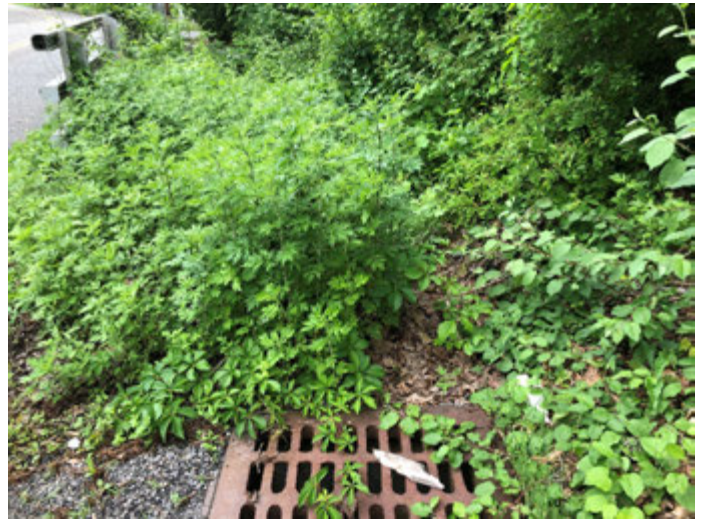
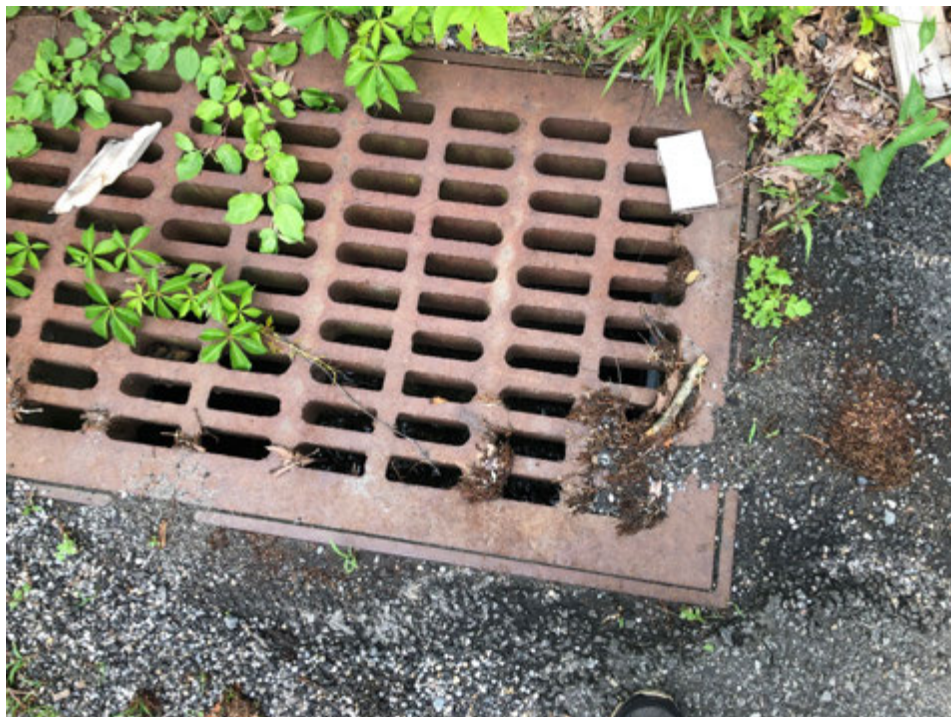
SITE 25: ALPS LANE (40.9805, -74.6091)

RECOMMENDED MEASURES: The large catch basin located just before the lake is an ideal candidate for the implementation of a three chambered nutrient separating baffle box. It seems as though there is already a large storm sewer system in place under the road that would make the installation of a large MTD relatively straight forward. This catch basin would be the best location for the MTD because it is the closest to the lake and would capture and treat the largest volume of stormwater. In addition, an engineering assessment should be conducted to determine the feasibility of roadside vegetated swales.

ESTIMATED COSTS: Depending on the amount of construction that would be required to install the three chambered baffle box at the end of Alps Lane, a ballpark estimate for the implementation of the MTD would be between \$150,000 - \$200,000. Note this does not include any roadside vegetated swales or other potential green infrastructure.

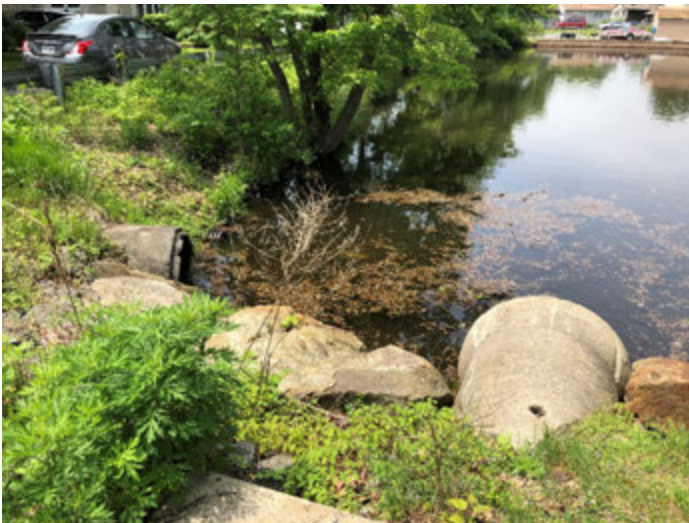
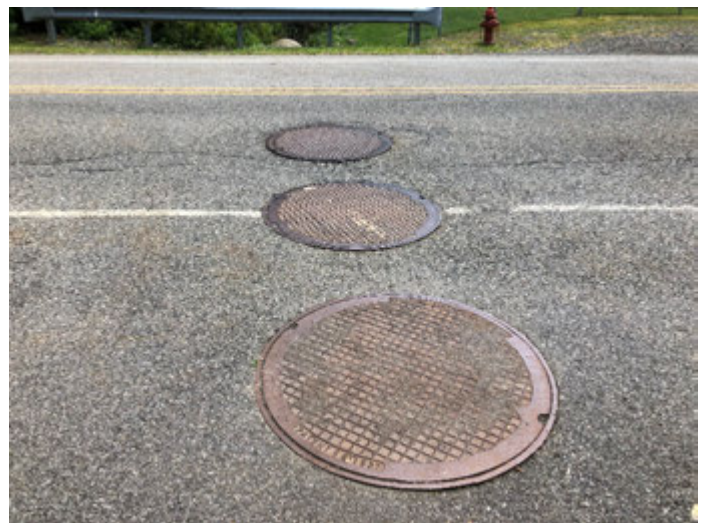
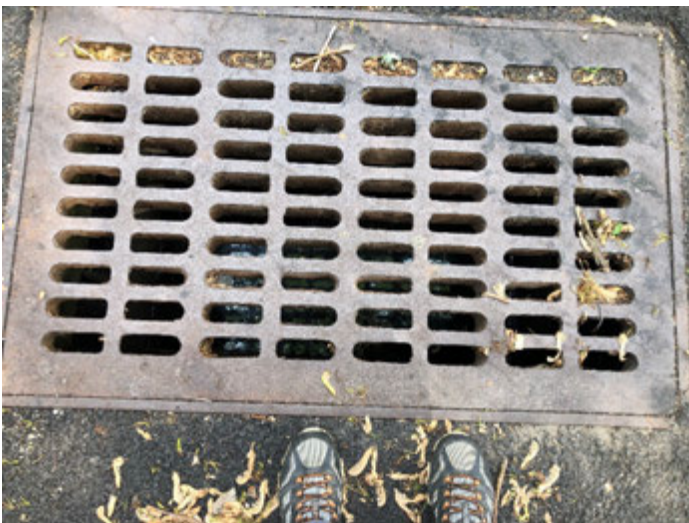
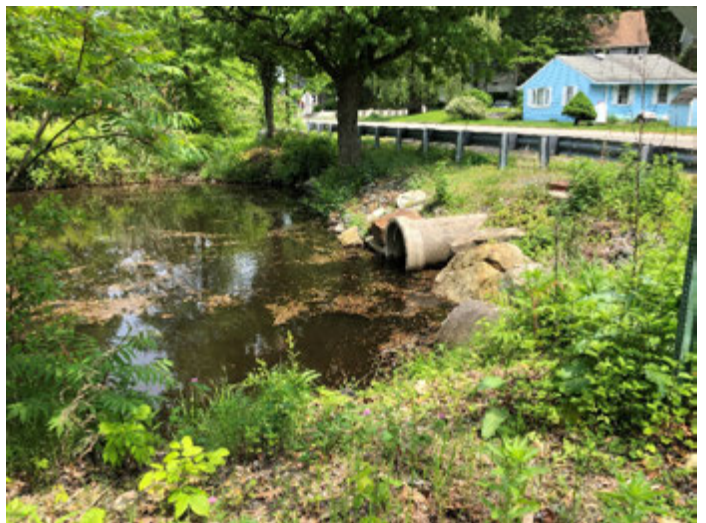
A small stream passes under East Shore Road through a culvert at this site. There are currently three storm drains above the culvert on East Shore Road. In addition, there is a catch basin located just west of the outflow pipe, on Benedict Drive. Also, it should be noted that a three-chambered baffle box system was installed along the road here as part of a previous grant to the Lake Hopatcong Commission.

RECOMMENDED MEASURES: East Shore Road above the culvert is an ideal candidate for the installation of a three chambered nutrient separating baffle box. Thus, one was already installed as part of the previous grant. However, the existing phosphorus removal capacity of the existing baffle box may be substantially increased if some additional filter media (e.g. Biochar) is added to the system. Additionally, the channel may benefit from some stabilization efforts and the possible expansion of the pooled area that is backwater from the cove.

ESTIMATED COSTS: The cost of installing new filter media into the existing baffle box would be minimal. However, additional engineering site-assessments would be necessary to provide an estimate for the costs to conduct additional stabilization efforts and expand the pooled area. A VERY preliminary estimate to stabilize the existing channel is \$100,000 and \$150,000 and does not include any work on the pooled area.

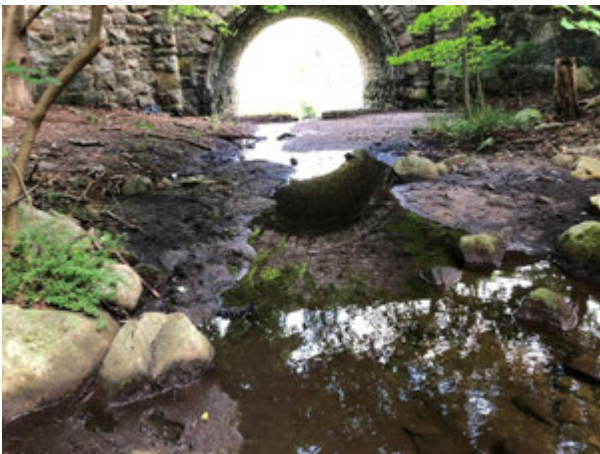
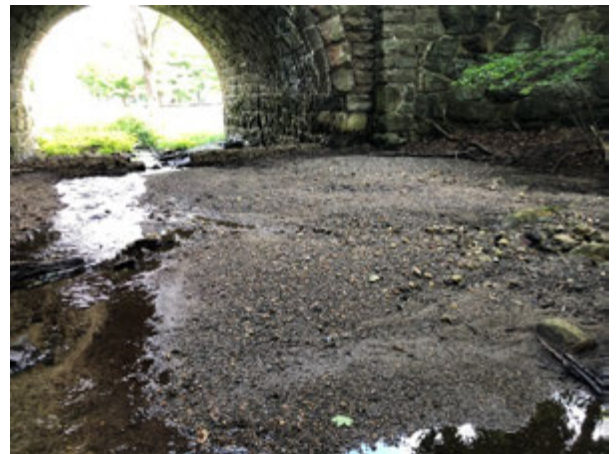
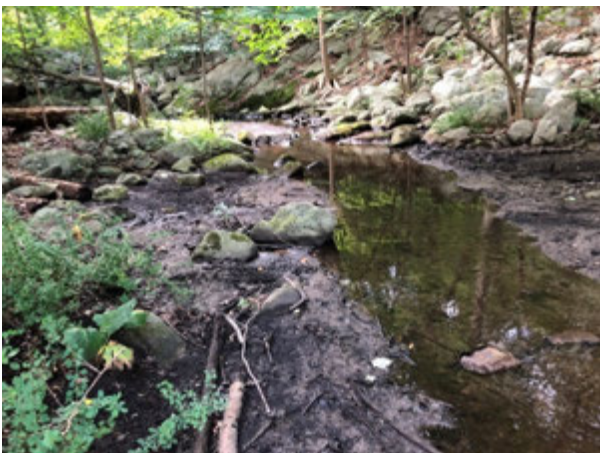
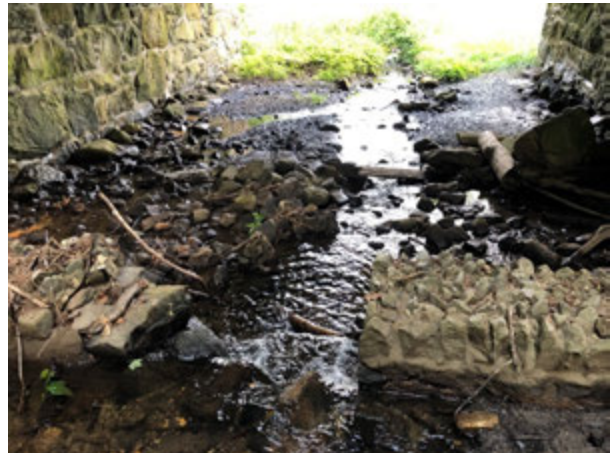
There is a small un-named tributary that flows through Memorial Park before traveling under a bridge located on Altenbrand Avenue and eventually through Arthur R. Ondish Memorial Beach and into Lake Hopatcong. There is a small rock-weir located under the bridge that funnels the stream through an opening only a few feet in width. There is extensive sedimentation occurring along the right bank just upstream of this structure. In addition to the sedimentation, there is a lack of a defined stream channel for approximately 50 feet directly upstream of the structure. It is likely that the water gets backed up behind the small rock-weir during times of heavy streamflow causing the deposition of sediment along the right side of the stream. The sediment in this location during the time of the site visit was very soft and loose and is likely easily eroded and transported downstream into Lake Hopatcong.

RECOMMENDED MEASURES: Ideally, the first recommended measure at this site would be the removal of the rock-weir to allow for the natural flow of the stream and to reduce the severity of the sedimentation. If the structure is in place to prevent flooding downstream, we still recommend addressing the sedimentation issues occurring upstream. The streambanks should be enhanced to allow water to flow down a defined path and through the rock-weir rather than spreading out and transporting the loose sediment that is located upstream of the structure. The streambanks should be stabilized and vegetation should be enhanced in this location in order to hold the streambank sediment in place, decreasing the amount of sedimentation occurring here.

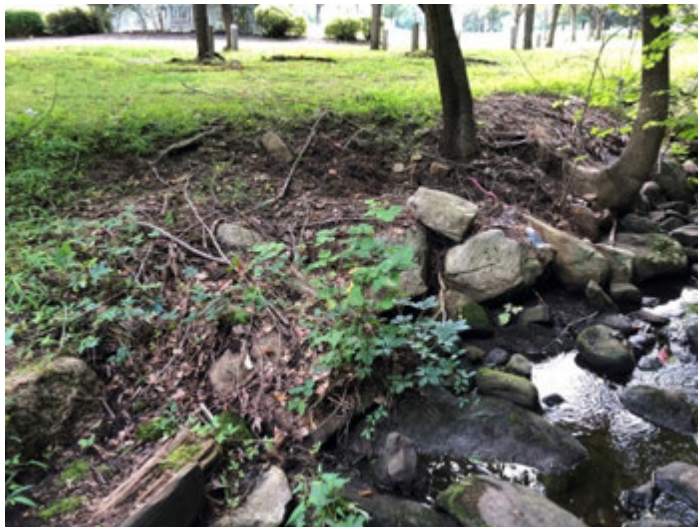
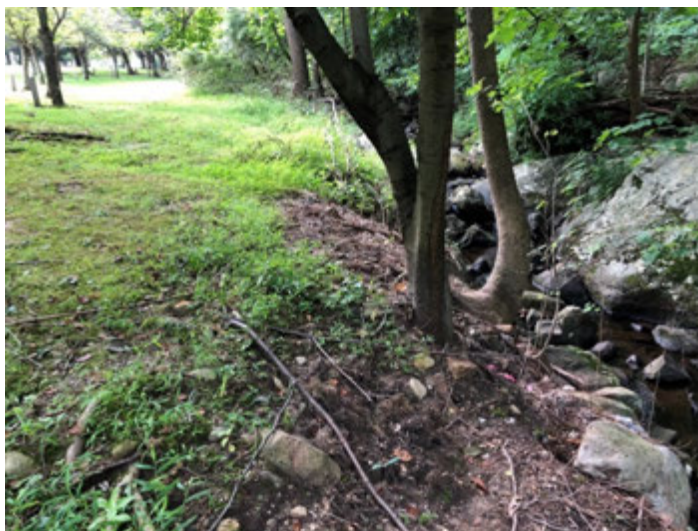
SITE 29: MEMORIAL PARK NEAR NORTH GLEN AVENUE (40.9265, -6363)

This streambank site is located upstream of Site 28 and is located in Memorial Park. This stream reach travels through the open section of the park and the majority of the right bank lacks a vegetative buffer. The few sections along the stream that have a small vegetative buffer are covered in the invasive Japanese stilt grass (*Microstegium vimineum*). In addition to the lack of a vegetative buffer, there is a section of roughly 25 linear feet along the right bank that is eroding. Specifically, the upper section of the streambank is widening, exposing tree roots and loose sediment.

RECOMMENDED MEASURES: Vegetation should be planted along the right bank of the stream in order to sequester some of the nutrients in the stormwater runoff from the park. In addition to the buffer, the section along the right bank that is currently eroding could be graded back to a gentler slope in order to allow the water to flood the adjacent floodplain without causing the bank to erode. Such an increase in conductivity would mitigate the flooding through infiltration and/or evapotranspiration. The toe of the bank currently has some rocks in place for bank protection, but the upper part of the bank is exposed and eroding. If the upper bank continues to erode, some of the trees can become dislodged and fall across the stream, causing further erosion in the streambed through a process known as head cutting.

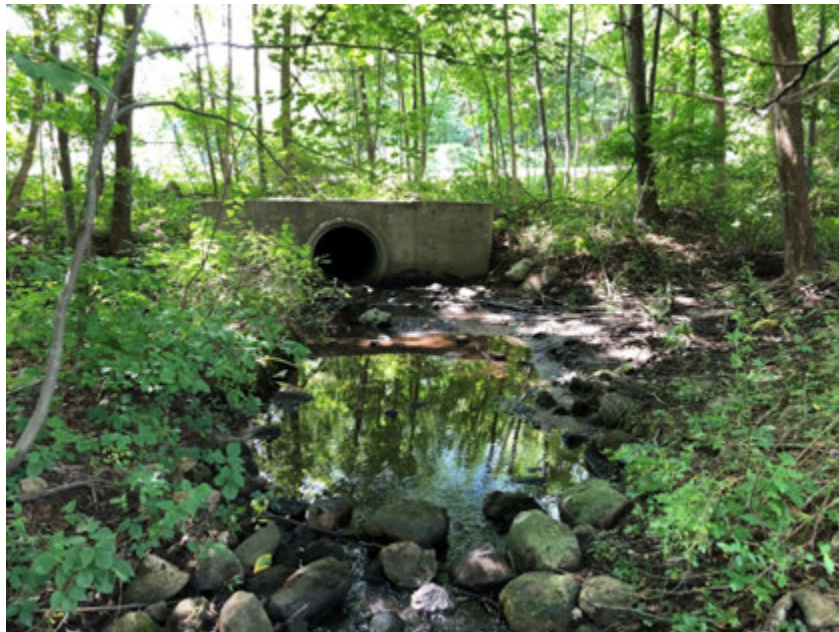
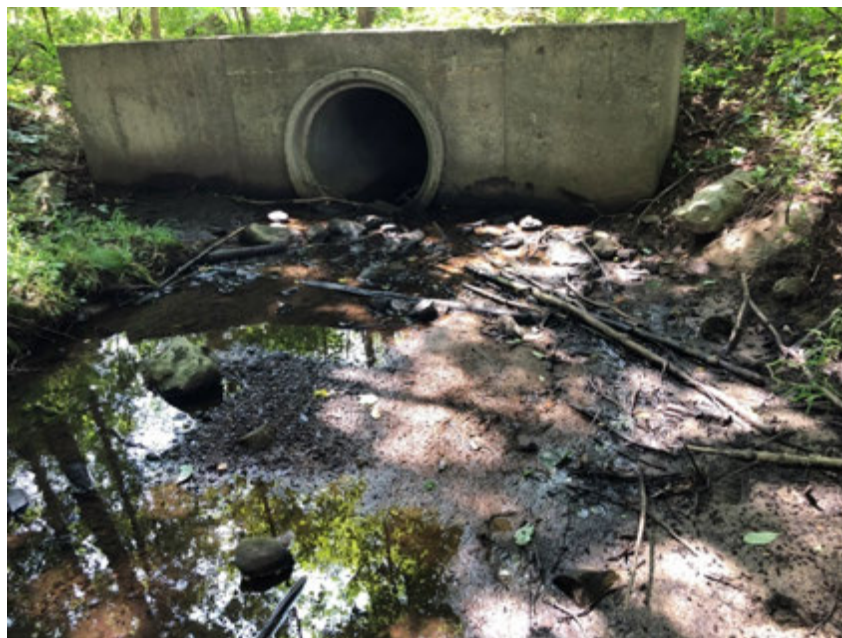
SITE 30: UPSTREAM OF EDITH M. DECKER ELEMENTARY SCHOOL (40.9350, 74.6290)

There is a small un-named tributary that flows through a culvert before traveling across the front of the Edith M. Decker Elementary School property just east of Howard Boulevard. The stream had very minimal flow during the site visit and most of the water was collecting in a small pool upstream of the culvert. The stream channel began to lose its structure along the right bank beginning approximately 25 feet upstream of the culvert and sedimentation along the right bank was occurring.

RECOMMENDED MEASURES: The right streambank should be enhanced to allow water to flow down a defined path and through the culvert rather than spreading out just upstream of the structure. The streambanks should be stabilized and vegetation should be enhanced in this location in order to hold the streambank sediment in place, decreasing the amount of sedimentation occurring here. In addition to enhancing the streambank, replacing the current culvert with a larger one would allow for more natural streamflow and aquatic organism passage during periods of heavier flow.

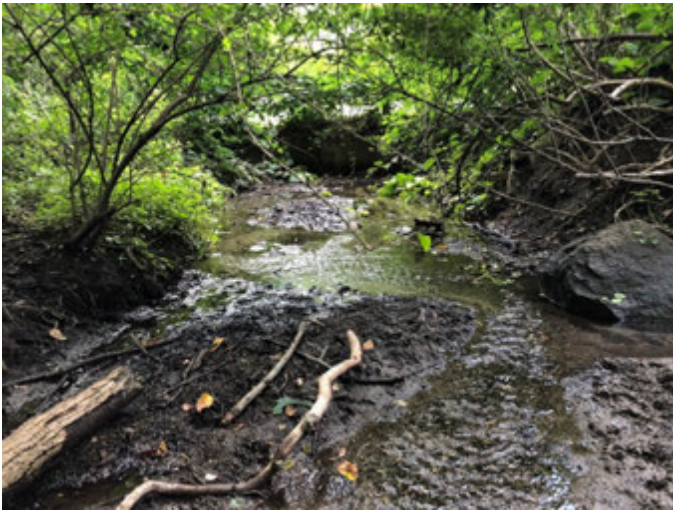
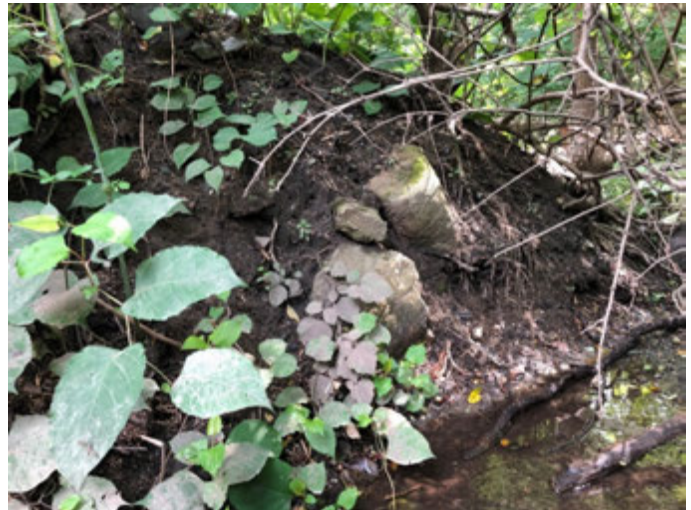
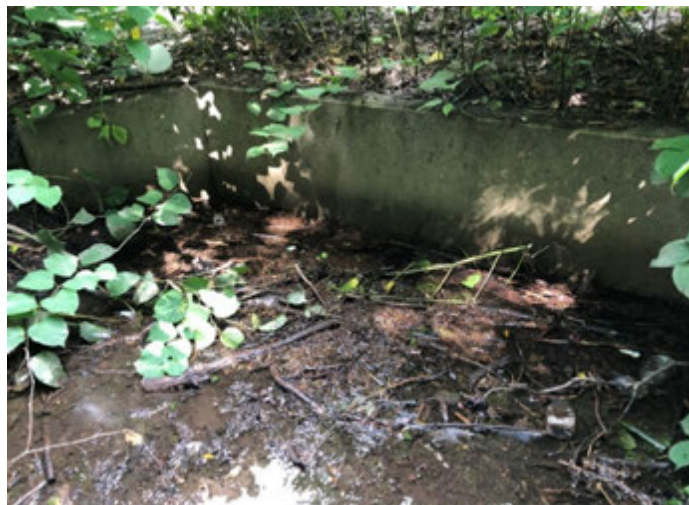
Located just upstream of Mount Arlington Blvd. is a small un-named tributary that travels through a culvert and under Mt. Arlington Blvd. The stream had very low flow during the site visit but extensive erosion and sedimentation was observed, indicating much heavier flows during storm events. Extensive bank scouring and widening was observed along the right bank, especially just upstream of the culvert. A few localized patches of sedimentation were also present in this relatively short stream reach. The culvert opening was barely visible during the site visit and the water was starting to pool up just upstream of this location; this is likely causing some of the sedimentation issues in this stream reach. The blocked culvert may also be a sign of an undersized culvert and should be further evaluated as such.

RECOMMENDED MEASURES: The opening to the culvert should be cleared of all debris to allow for the natural flow of the stream and to reduce the severity of the sedimentation. In addition to clearing the culvert, the right bank of the stream could use some bank stabilization to prevent the bank scouring and widening that was observed. The streambanks were also lacking proper, native vegetation; this should be addressed to stabilize the banks and prevent further erosion and the associated TP and TSS release into the water. If further evaluation of the culvert after removing the debris reveals what appears to be an undersized culvert, replacing it with a larger size would allow for more natural streamflow and aquatic organism passage during periods of heavier flow.

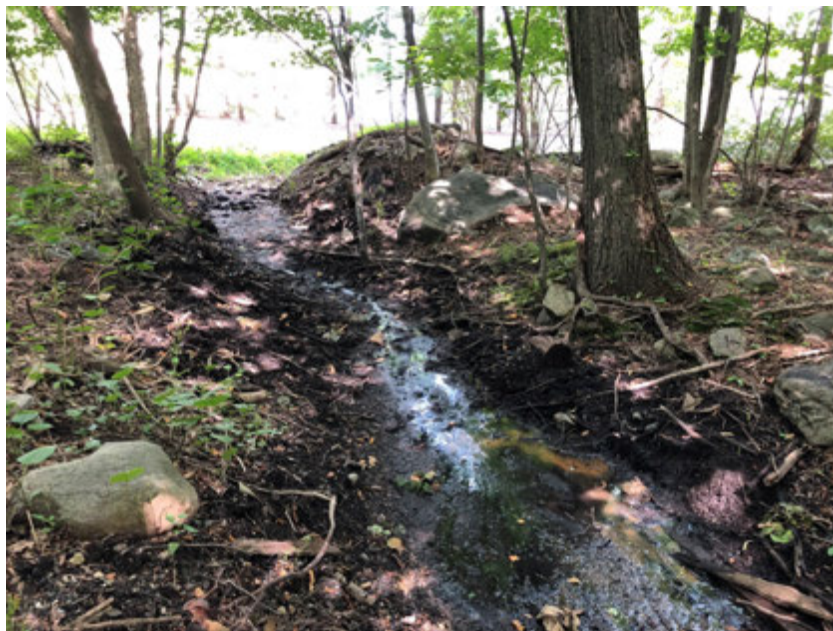
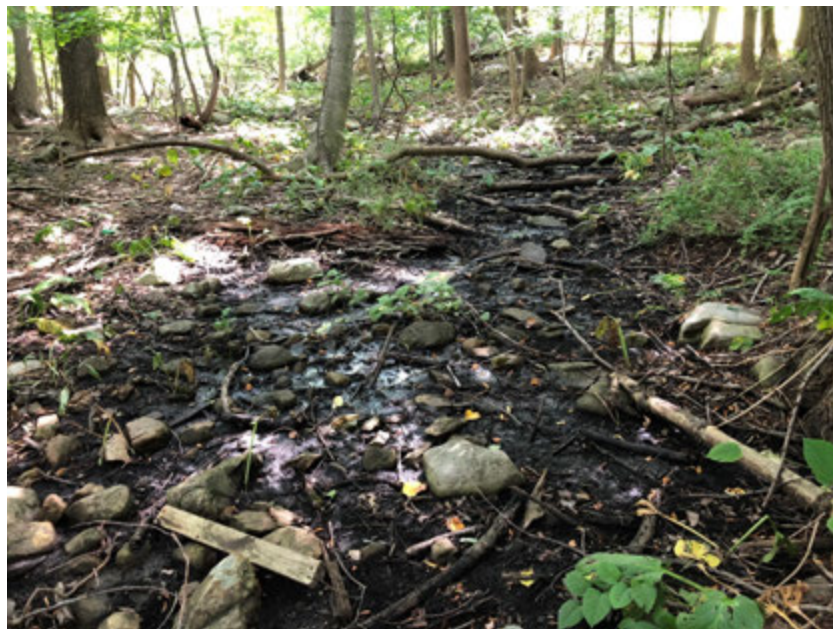
SITE 32: INTERMITTENT STREAM SOUTH OF KING ROAD (40.9189, -74.6462)

There is a small intermittent stream that drains the wetland area between Mt. Arlington Boulevard and King Road; this small stream drains along King Road before connecting with the larger stream mentioned in Site 31. This intermittent stream had no defined streambanks and the sediment was extremely muddy and loose; a Princeton Hydro scientist sunk in over 1 foot into the streambed during the site visit. A small amount of pooling along King Road was observed during a site visit in March during a relatively dry period.

RECOMMENDED MEASURES: Because this site is located in a wetland area and appears to be a small headwater stream, this area could benefit from wetland type plantings, such as skunk cabbage (*Symplocarpus foetidus*), in order to better stabilize the soil and increase nutrient sequestration. In addition to the wetland plantings, the placement of some larger rocks or small boulders could benefit the area by diffusing the flow, allowing for increased contact time and reduced kinetic energy and erosion.

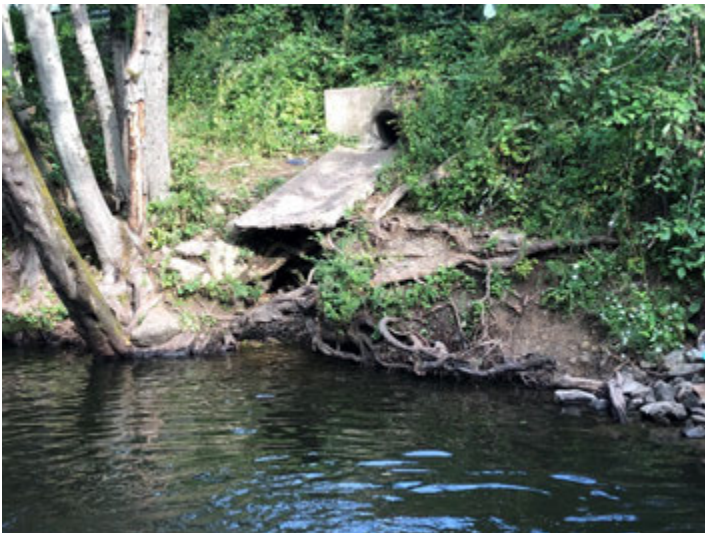
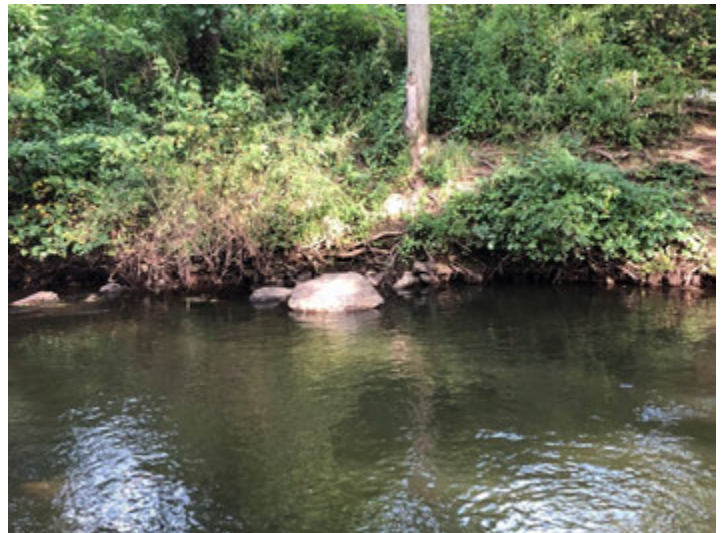
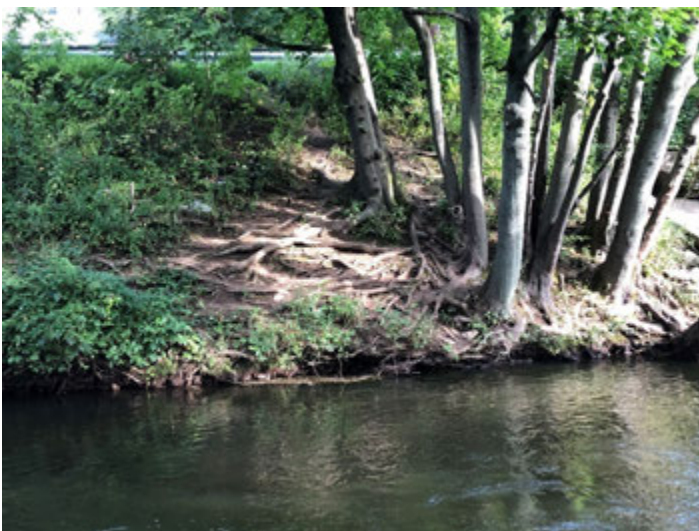
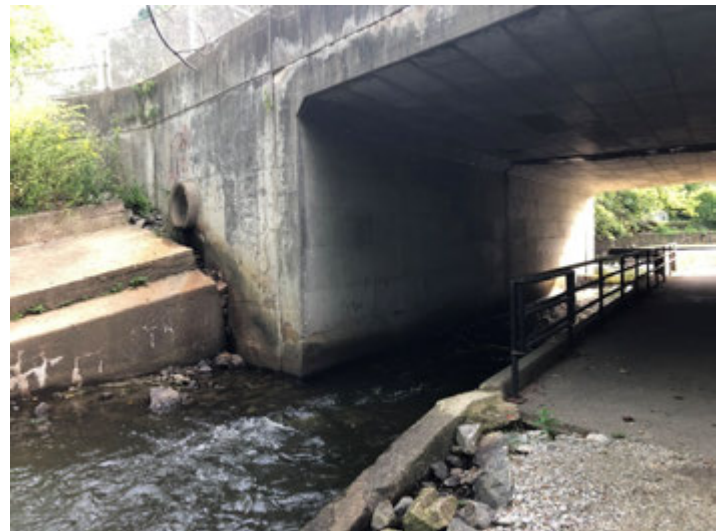
SITE 33: MUSCONETCONG RIVER (DOWNSTREAM OF LAKE HOPATCONG DAM) (40.9170, -74.6660)

The right bank of the Musconetcong River is eroding just downstream of the dam and overhead bridge located adjacent to Hopatcong State Park. There is approximately 30 feet of severe erosion occurring along the right bank where undercutting and bank scour are evident; large tree roots are exposed. The river is channelized just upstream of this location which is likely increasing the velocity of the water before it reaches the right bank. In addition to the erosion caused by the river water, there is an outfall pipe along the right bank that drains onto a small piece of concrete. The right bank under the pipe is receding backwards a few feet past the rest of the already eroding right bank.

RECOMMENDED MEASURES: The majority of the erosion at this site is occurring along the bottom of the right bank and restoration measures should be focused on streambank toe protection. Lining the bottom of the streambank with rocks and stones will provide protection against the erosional forces currently affecting the right bank. The concrete slab that is currently collecting the drainage from the outfall pipe should also be removed and a small drainage path should be lined with rocks all the way down to the river to prevent the severe undercutting that is occurring. Some minor bank re-grading may be necessary at this location to accommodate the toe protection.

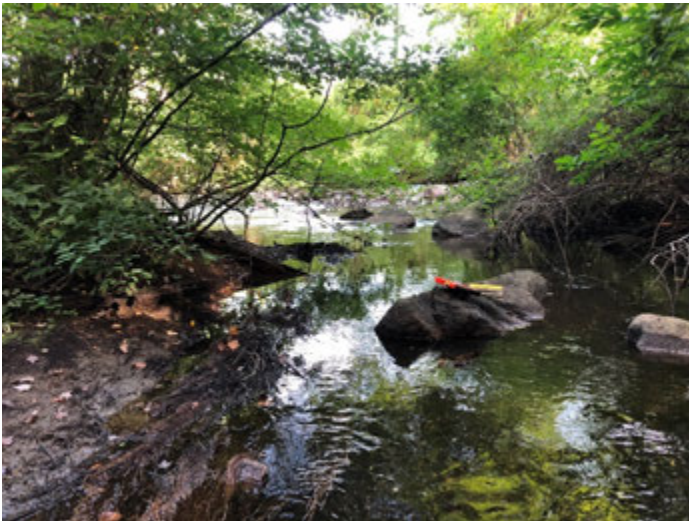
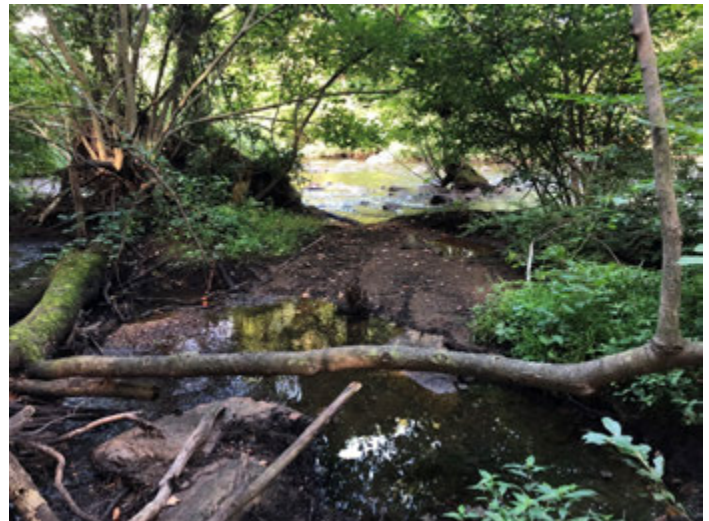
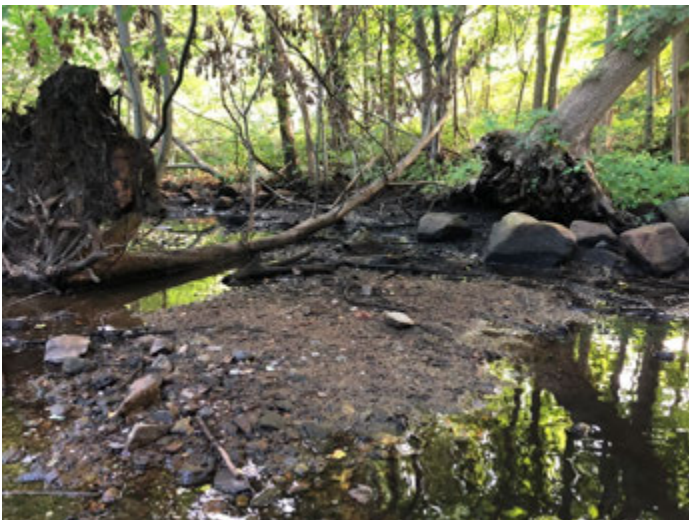
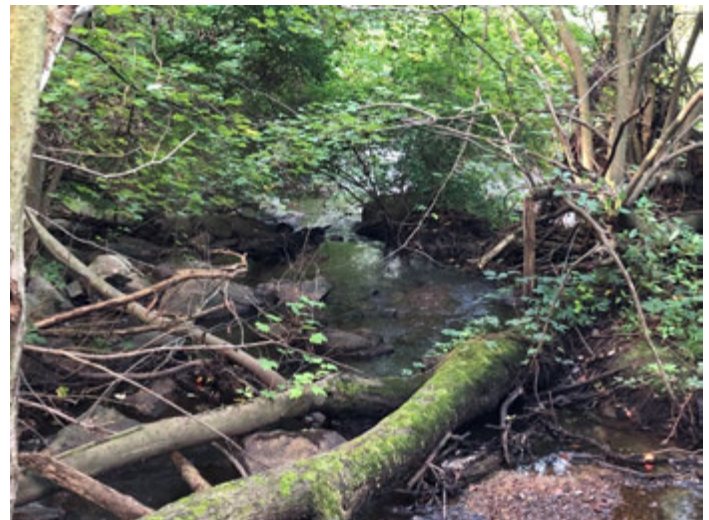
SITE 34: MUSCONETCONG RIVER SIDE CHANNEL (40.9168, -74.6661)

Just downstream of Site 36 is a side channel that has formed along the left bank of the Musconetcong River. It is difficult to tell if this side channel broke off of the main river through continued erosion along the left bank, or if a substantial amount of sediment has built up over time creating an island that split the river up. Nonetheless, extensive sedimentation is occurring in multiple locations along this side channel. In addition to the sedimentation, a number of large trees have been uprooted here; these trees were likely dislodged during storm events rather than continued erosion along the streambank because the elevation is relatively flat. The sediment is very loose and muddy throughout this whole area and there are loose logs and tree branches scattered throughout.

RECOMMENDED MEASURES: One option for addressing the erosion and sedimentation issues at this location could involve stabilizing the left bank of the main river and the small island with rooted vegetation in order to better hold the streambanks in place. Additionally, the dislodged and toppled trees in the side stream should be removed to prevent the trees from being transported down river during periods of heavy flow to prevent any potential headcuts or other erosional issues that may form.

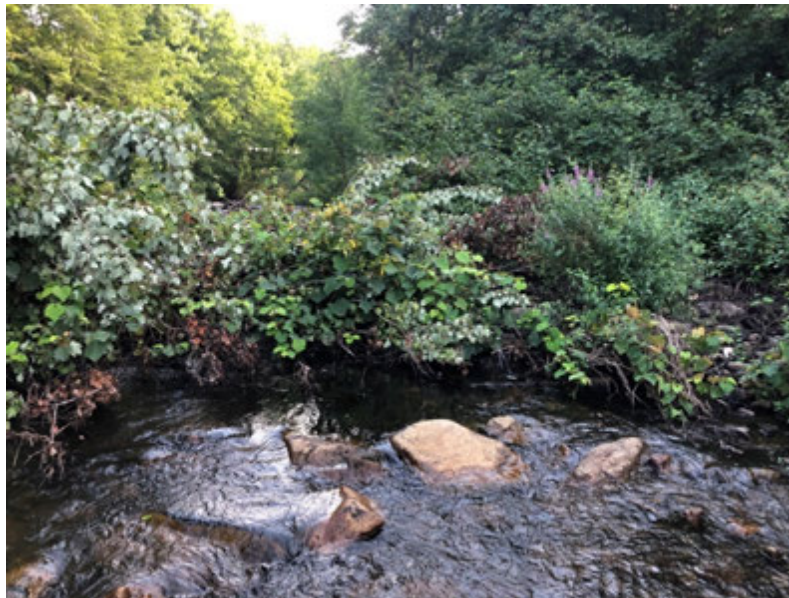
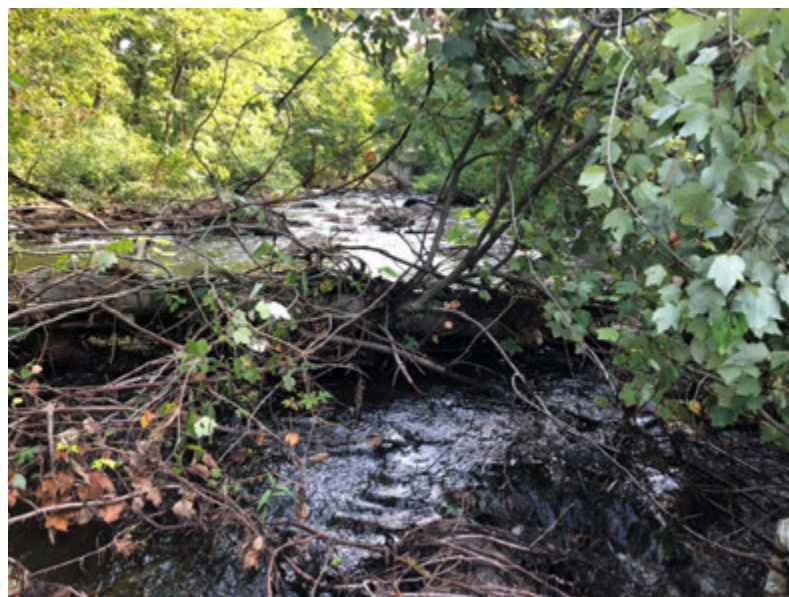
SITE 35: MUSCONETCONG RIVER (MAIN CHANNEL) (40.9165, -74.6666)

Just downstream from Site 37 in the main channel of the Musconetcong River is a fallen tree that is lying across the entirety of the river. There were vines and vegetation growing across the tree over the river, so more than likely this tree has been in this location for some time. It appeared as though the river was flowing just under the tree for the most part during the relatively low flow of the river, but this tree may cause issues during periods of heavier flow. The tree may cause a large volume of water to be diverted out of the main channel during periods of heavier flow and also has the potential to lead to streambank erosion by creating a headcut.

RECOMMENDED MEASURES: Princeton Hydro recommends removing this fallen tree from the main channel of the river in order to prevent any potential erosion issues that may occur either directly in the river bed or along the streambanks if the tree causes a large volume of water to be diverted to the sides. An alternative option to completely remove the tree involves cutting it into smaller pieces with a chainsaw which could serve a similar purpose. If the second option is pursued, select pieces of the tree could be removed to allow for a more natural flow, which would still leave a few pieces of the tree in the river for natural fish and macroinvertebrate habitat.
