UPPER MUSCONETCONG RIVER WATERSHED IMPLEMENTATION PLAN

MORRIS AND SUSSEX COUNTIES, NEW JERSEY

NOVEMBER 2020

PRINCETON HYDRO, LLC
1108 OLD YORK ROAD, SUITE 1
P.O. BOX 720
RINGOES, NJ 08551
908-235-5660

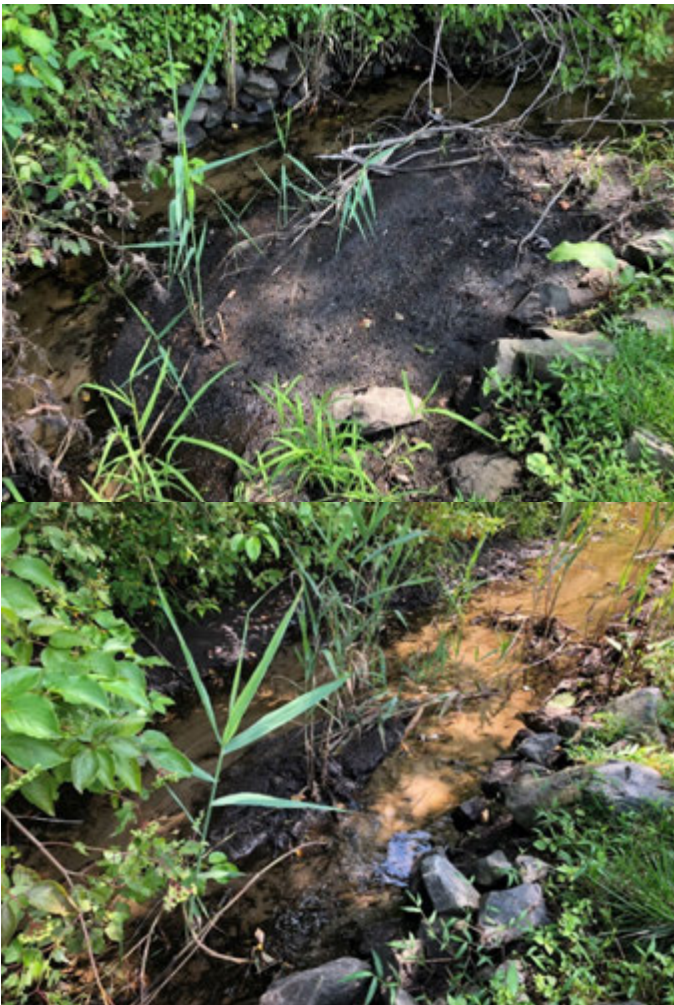
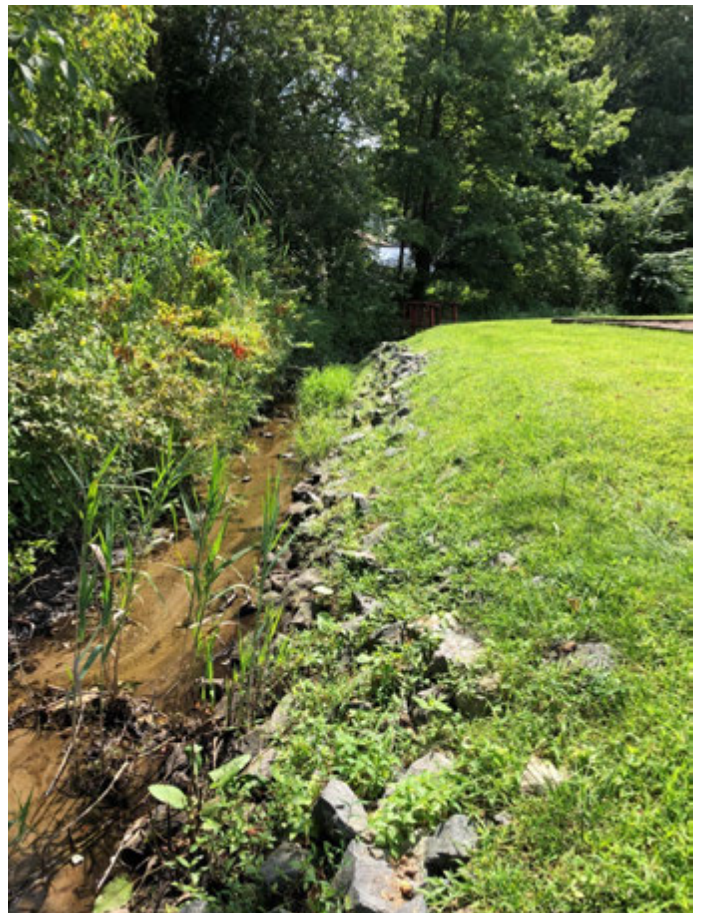
A small un-named stream passes through East Shore Park before traveling through a culvert under East Shore Road and into Lake Hopatcong. The entire left bank of the stream lacks a vegetative buffer; this is the side of the stream that is open to the park. The stream was flowing very low during the site visit but there was an excessive amount of sedimentation occurring just upstream of the culvert. The sediment accumulation was sufficient enough in the center of the stream to support the growth of phragmites (*Phragmites australis*). There was a 30-foot stretch along the lower right bank that was eroding and is the likely source of sedimentation; the sediment was loose here and lacked any vegetation or toe protection. Most of the remaining streambank on either side of the stream was stabilized with either vegetation or rocks.

RECOMMENDED MEASURES: Although the left bank was stabilized with rocks along the entire stream reach, we recommend re-grading and a vegetative buffer to help slow the rate of runoff from the park and to sequester additional nutrients. In addition to the buffer, the right bank should be stabilized where the erosion was occurring to prevent additional sedimentation. Because the erosion was mainly occurring along the bottom of the right bank, toe protection through the placement of rocks or stones may be sufficient. In addition to stabilizing the right bank, the upstream culvert could be evaluated for proper sizing; an undersized culvert could be causing some of the sedimentation issues by not allowing for natural passage of water during periods of heavier streamflow.

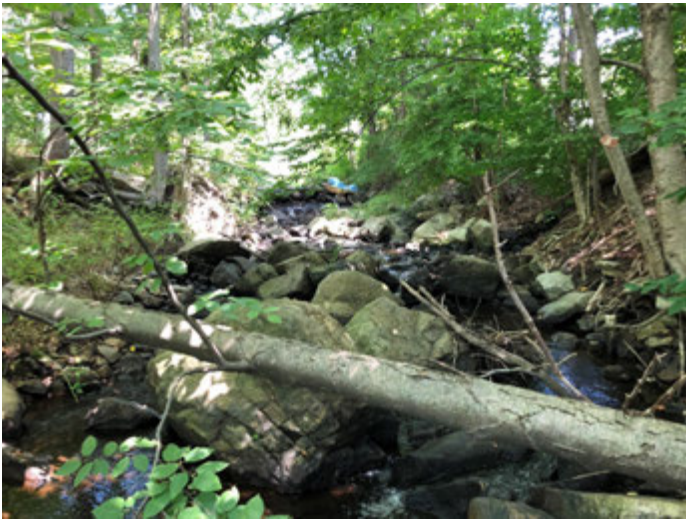
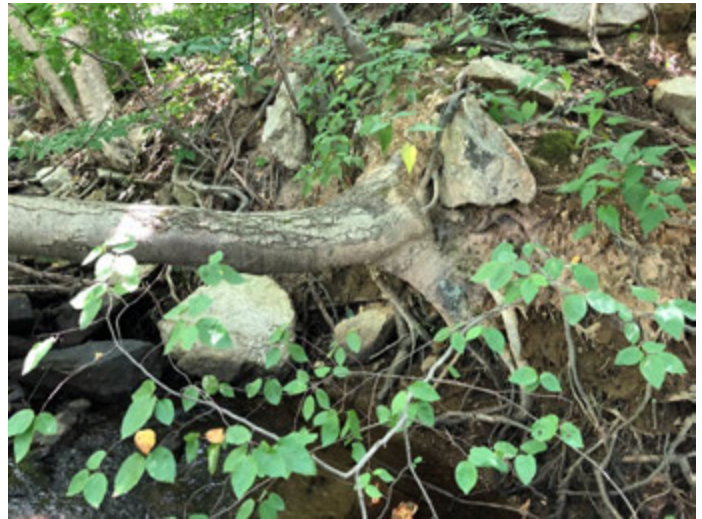
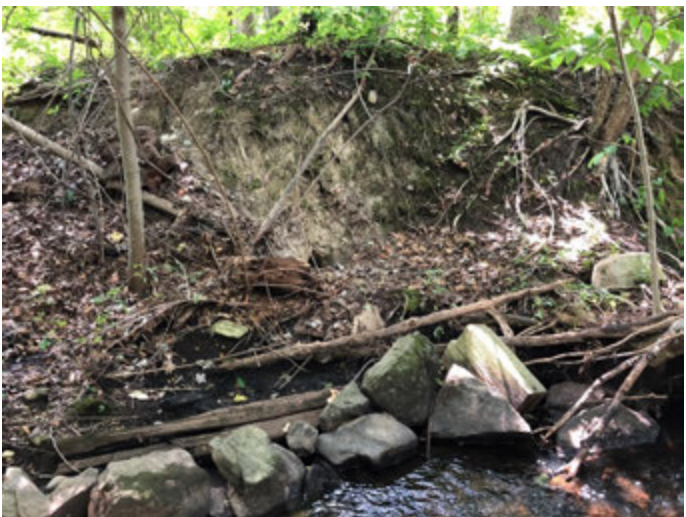
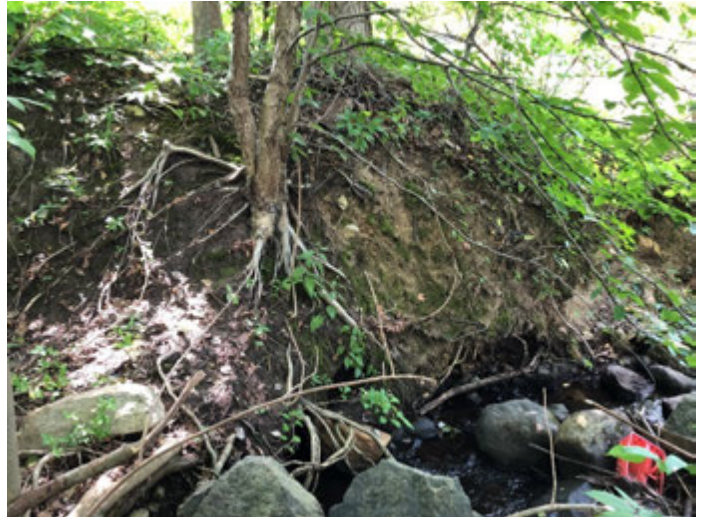
SITE 37: OUTLET OF LAKE WINONA (40.9888, -74.6062)

An un-named stream between the outlet of Lake Winona and Lake Hopatcong is only approximately 150 feet in length but the erosion is extensive and the most severe that was observed during field assessments. The water was flowing relatively slowly during the site visit. The streambanks on both sides varied between approximately 6 – 10 feet in height along the stretch and severe erosion was evident to the top of the bank in multiple locations. Extensive widening and bank scouring were observed on both the right and left bank. Large tree roots were exposed and multiple trees have the potential to become dislodged from the streambank; some trees had already been dislodged and fallen across the stream. It is important to note that there are residential properties located adjacent to each streambank with houses located relatively closely to each bank.

RECOMMENDED MEASURES: Although accessibility may be difficult in this location without access to through private properties, this location should be a priority due to the extent of the erosion. Because of the close proximity to residential properties, restoration measures may be limited here. At a minimum, we recommend protecting the streambanks from further erosion through the placement of riprap or gabion walls. If possible, the streambanks should be regraded and stabilized in place of riprap, but space is likely limited here. It is important to address this erosion to reduce the amount of TP and TSS entering Lake Hopatcong but also to protect the structures on the adjacent properties. This site may also be a candidate for grade control to slow down the streamflow; the streambed is approximately 6 feet lower than Lake Winona and this drop occurs abruptly as the water drains from Lake Winona.

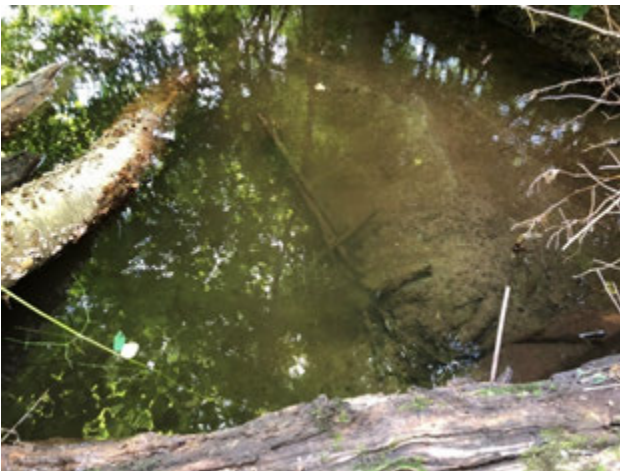
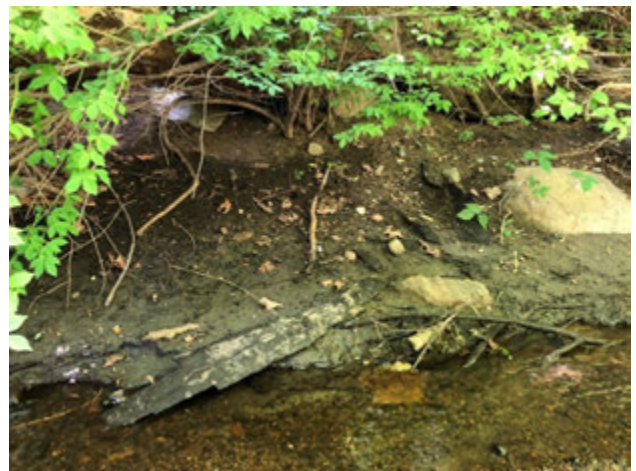
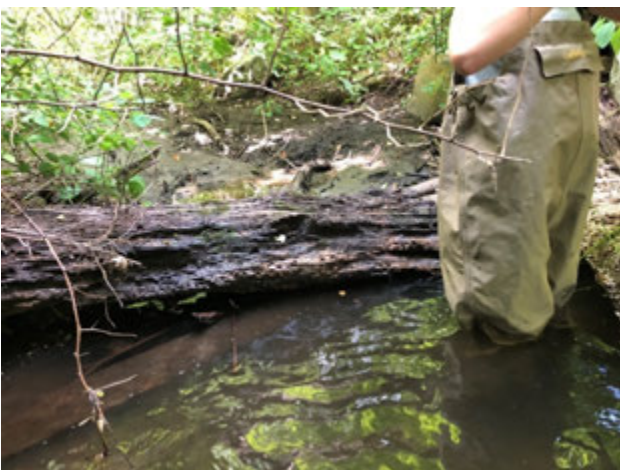
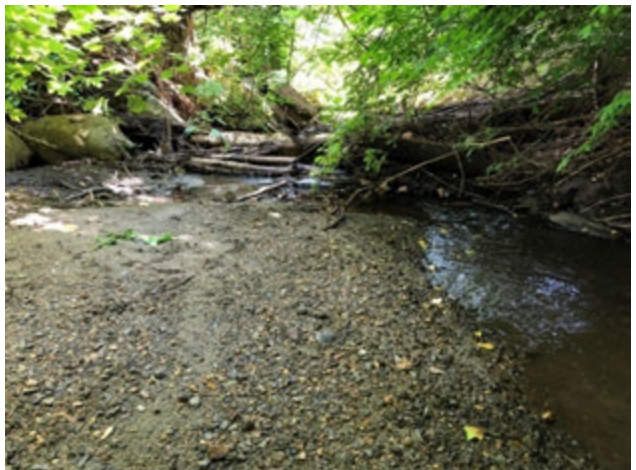
SITE 38: UPSTREAM OF LORETTACONG DRIVE (40.9880, -74.6117)

An un-named stream that drains a small lake located in Willow Lake Day Camp travels south before flowing through a culvert and under Lorettacong Drive before entering Lake Hopatcong. The stream reach just upstream of the culvert is showing signs of minor streambank / streambed erosion and associated sedimentation. A large tree has fallen across the stream causing headcut erosion; the streambed is more than a foot deeper downstream of the fallen tree. This is causing sediment that is eroded from the streambed to be transported downstream and into Lake Hopatcong. An excessive amount of sedimentation is also accumulated just upstream of the fallen tree; this sediment is likely transported downstream during periods of heavy flow. Most of this sedimentation is a result of eroding streambanks upstream of the fallen tree.

RECOMMENDED MEASURES: The first course of action at this location should be the removal of the fallen tree from the streambed. This tree is directly leading to streambed erosion downstream and the removal will be the first step in addressing this erosion. Minor grade control may also be necessary at the location of the removed tree to address the headcut; there is already over a foot of elevation change between the upstream and downstream portions of the streambed. In addition to addressing the fallen tree and associated headcut, minor bank stabilization upstream should also be considered to address additional erosion and sedimentation that was observed. This can be done by re-grading the right bank at the location of erosion or through the placement of riprap; the length of streambank that is eroding is not very long and the placement of riprap may be sufficient. It should be noted that the removal of a fallen tree or tree limb from a waterway in New Jersey does not require a Division of Land Use Regulation Permit, though it is encouraged to contact the local municipality to see if a plan for debris removal has already been implemented. More information on this matter can be found at the DLUR website found at: <https://www.nj.gov/dep/landuse/emergencies.html>

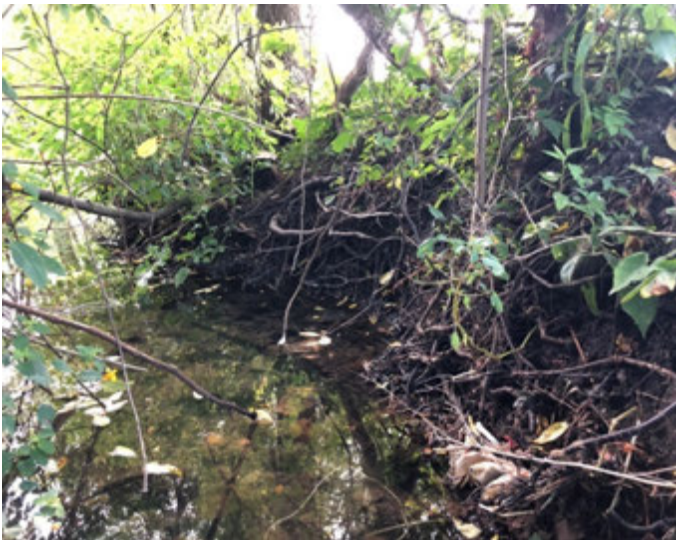
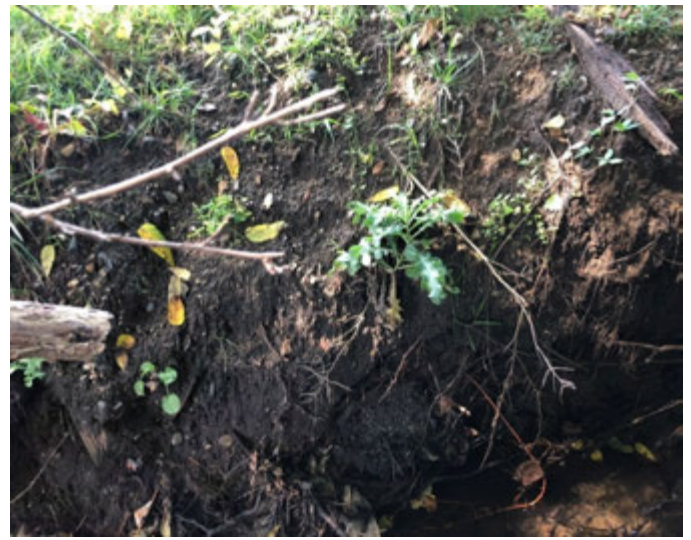
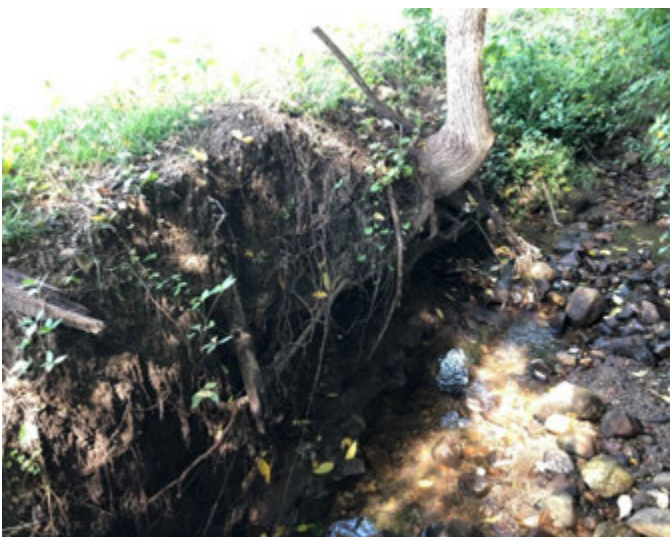
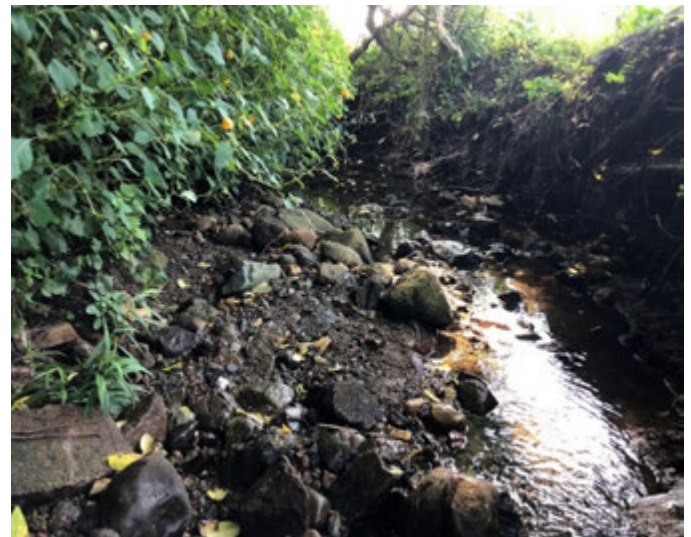
There is a small drainage stream located off of Holiday Drive that receives runoff from the surrounding neighborhood and discharges into Ingram Cove. Extensive erosion was observed along both banks during the site visit, including bank scour and severe undercutting; erosion along the right bank was more severe than the left bank. The sediment along the right bank was exposed and extremely raw, and excessive sedimentation was occurring along the streambed. The inlet of this drainage stream in Ingram Cove was also probed for sediment accumulation; sediment deposition was measured at approximately 2.5 feet compared to approximately only 0.5 feet a few feet away from where the stream enters the cove.

RECOMMENDED MEASURES: The right bank of this stream is an ideal candidate for bank stabilization to help address the severe erosion and sedimentation that is occurring. Due to the severe undercutting that is occurring along the right bank, the streambank should be regraded to a gentler slope to allow for floodplain connectivity. Once re-graded, the streambank toe can be further stabilized with riprap or another stabilization method that will allow the bank to absorb the impact of the stormwater without eroding.

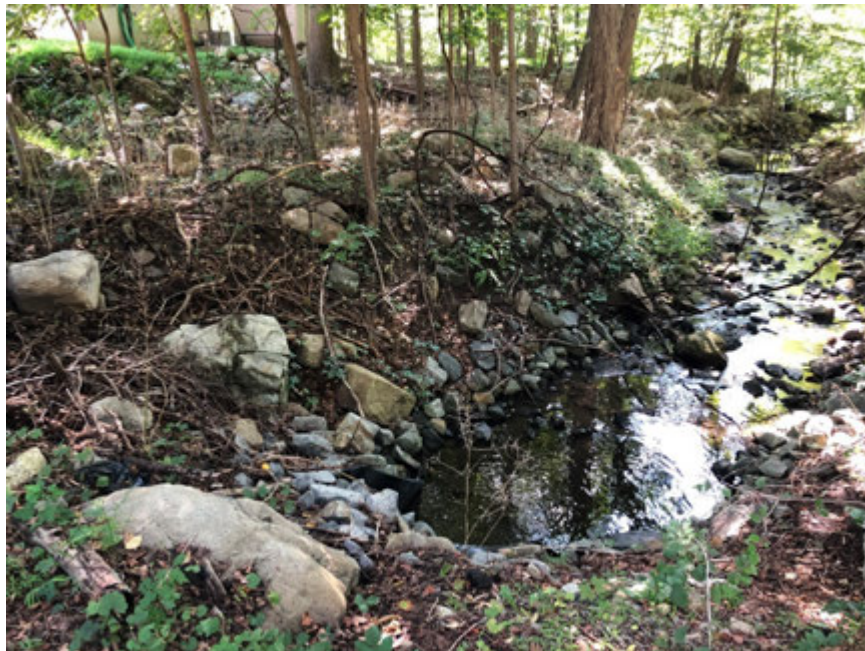
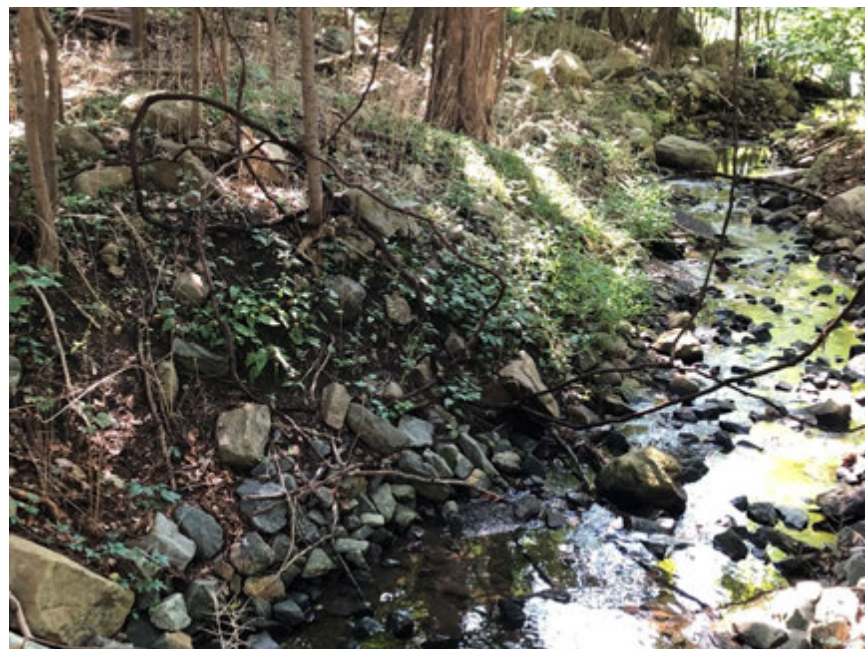
SITE 40: CRESCENT COVE STREAM (SOUTH OF DUPONT AVENUE) (40.9411, -74.6622)

This site is just upstream of the Crescent Cove Beach Club parking lot and just south of Dupont Avenue. It appears as though the stream reach of this un-named tributary has been modified with rocks along the base of the streambanks to minimize erosion. Although there are currently rocks present for erosion prevention, there are a few spots along both the left and right streambank without any rocks that appear to be eroding, though not severe.

RECOMMENDED MEASURES: It would be beneficial to reassess the entirety of both streambanks and place more rocks along the base of the streambanks for erosion protection. It appears some of the rocks that were placed along the stream have become dislodged and have fallen into the stream bed; replacing the small rocks with a larger size may serve a better purpose here and further reduce erosion.

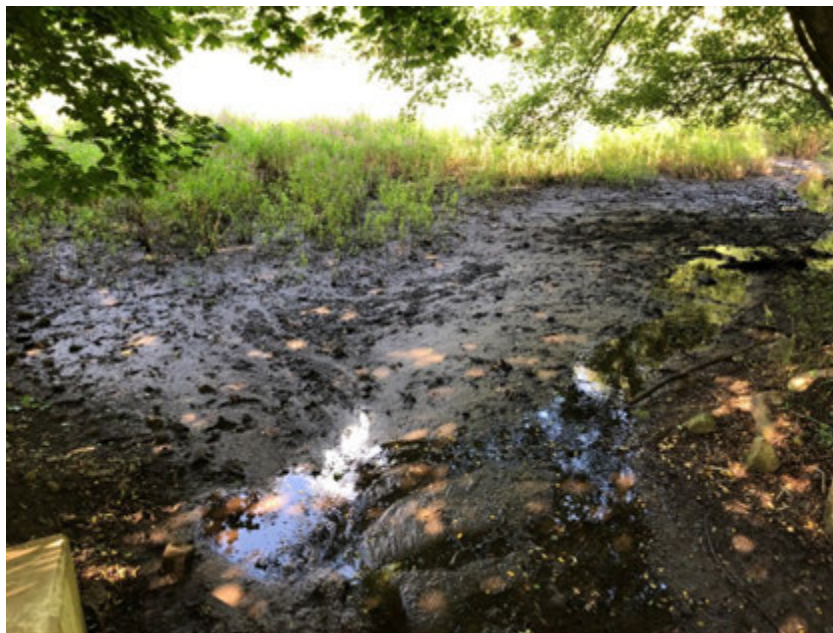
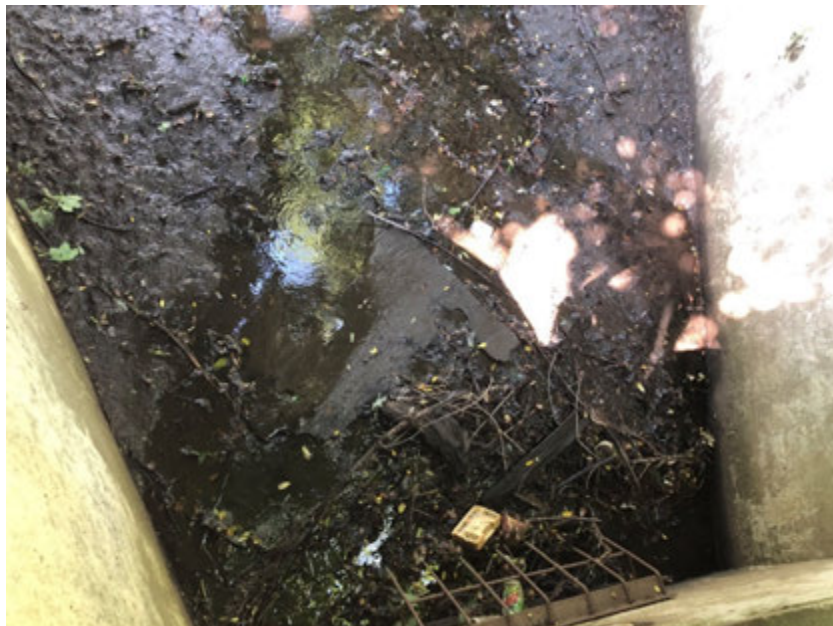
SITE 41: WETLAND NEAR CRESCENT COVE (40.9402, -74.6626)

There is a wetland just west of the Crescent Cove Beach Club parking lot that drains into a culvert that travels under Crescent Road and into Crescent Cove. There is a small drainage path that travels through the wetland before discharging into the culvert. The stream flattens out and loses structure just upstream of the culvert; excessive sedimentation was observed in this location during the site visit. The sedimentation gets excessively worse as the drainage path approaches the culvert, and the culvert has a thick layer of muck and organic material building up before the culvert opening.

RECOMMENDED MEASURES: This site could benefit from extending the wetland type plantings, such as skunk cabbage (*Symplocarpus foetidus*) and other native vegetation, closer to the culvert opening in order to better stabilize the soil and increase nutrient sequestration. In addition to the wetland plantings, the placement of some larger rocks or small boulders could benefit the area by diffusing the flow, allowing for increased contact time and reduced kinetic energy and erosion and the associated sedimentation.

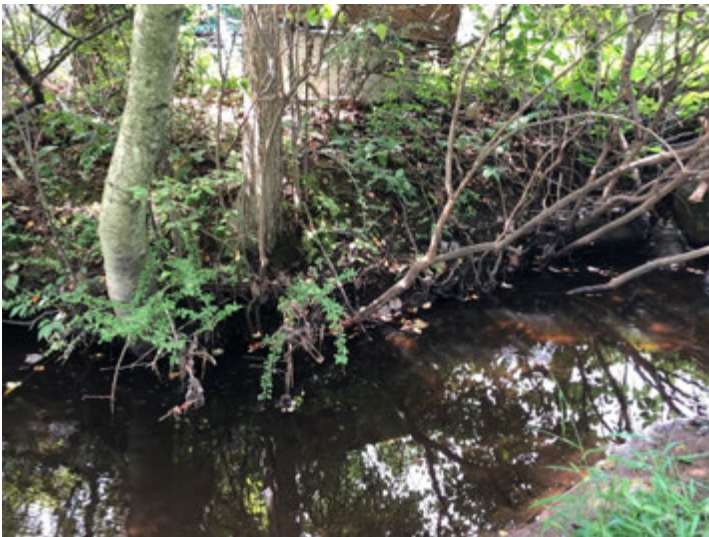
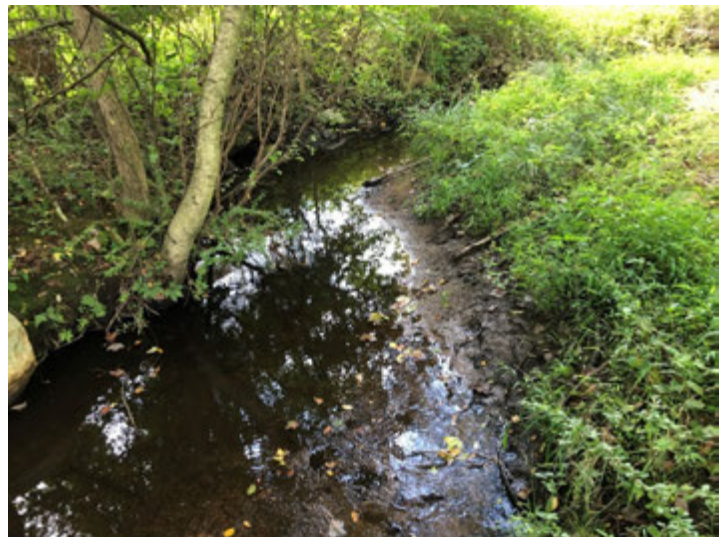
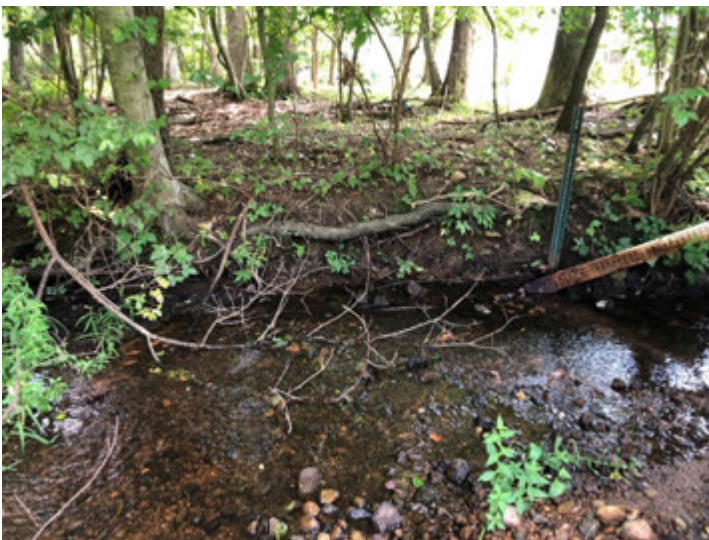
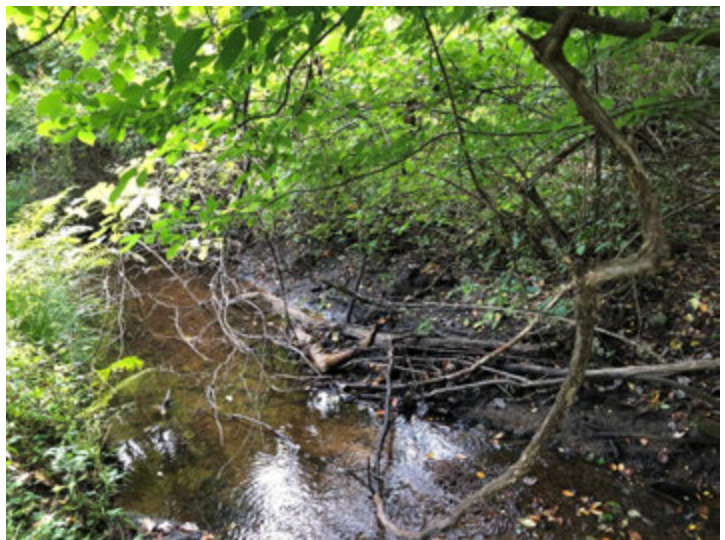
SITE 42: JAYNES BROOK (NORTH OF KENTUCKY AVENUE) (40.9745, -74.6301)

Jaynes Brook is one of the major tributaries of Lake Hopatcong, and empties into the lake in Henderson Cove. This stream reach is located near the mouth of the stream, just north of Kentucky Avenue. The stream is located on private property and access would need to be granted for any restoration measures. The stream was flowing relatively slow during the site visit, but signs of minor erosion were evident. Specifically, undercutting and bank scour were observed along the left bank with sediment accumulating mainly along the right bank.

RECOMMENDED MEASURES: The majority of the erosion at this site is occurring along the bottom of the left bank and restoration measures should be focused on streambank toe protection. Lining the bottom of the streambank with rocks and stones will provide protection against the erosional forces currently affecting the left bank. Because the stream is located on private property and the extent of erosion is relatively small, it is likely not feasible or necessary to regrade the stream here.

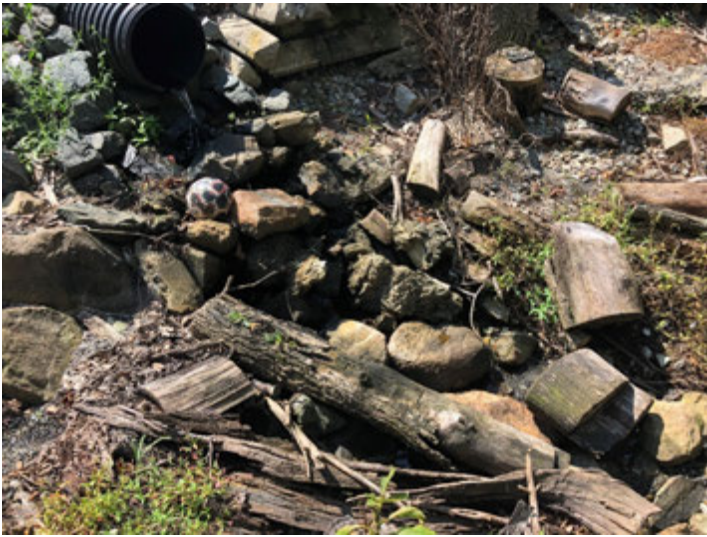
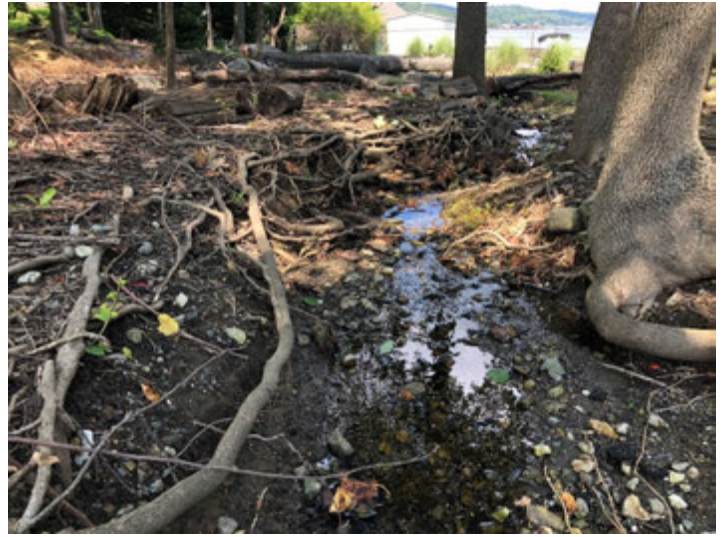
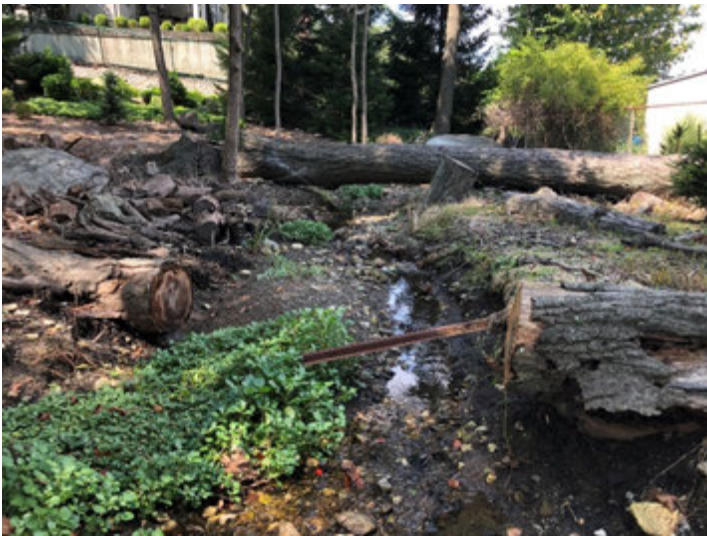
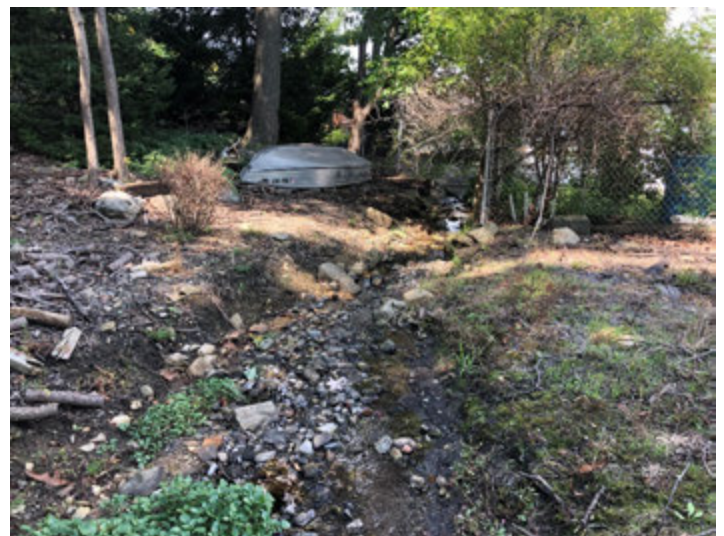
SITE 43: DRAINAGE STREAM IN WITTEN PARK (40.9554, -74.6477)

There is a drainage stream located in Witten Park that receives runoff from the surrounding neighborhood through two outfall pipes before discharging into Byram Bay. Extensive erosion was observed along both banks during the site visit, including bank scouring and severe undercutting. Both streambanks were void of any vegetation along the entire reach, and the entire park was comprised of mostly loose dirt and gravel. Tree roots were visible along both banks down the entire stream reach, and there was sediment accumulating in multiple locations. Both outfall pipes are located a few feet higher in elevation than the stream, and the water travels down scattered rocks before entering the main channel. The bigger pipe located just above the mainstream had a small flow of water during the time of the site visit.

RECOMMENDED MEASURES: This site should be a priority for restoration measures due to the extent of erosion that is occurring, and the location in a public park with easy access from a main road. This site would be an ideal location for the implementation of a Regenerative Stormwater Conveyance System (RSC). An RSC is comprised of a series of riffles, pools, native vegetation and an underlying sand and woodchip media that is designed to treat, detain, and convey stormwater in an efficient manner. Not only would an RSC address the severe erosion that is currently occurring, but it would also treat the stormwater from the surrounding neighborhood, decreasing the TP and TSS concentrations through infiltration. RSC's can be designed in multiple ways to fit the local ecosystem and has the potential to turn this park into an aesthetically pleasing location for the community.

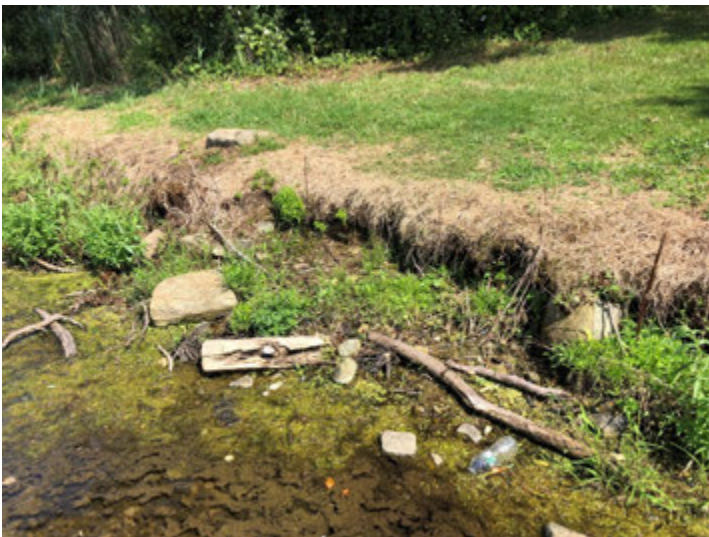
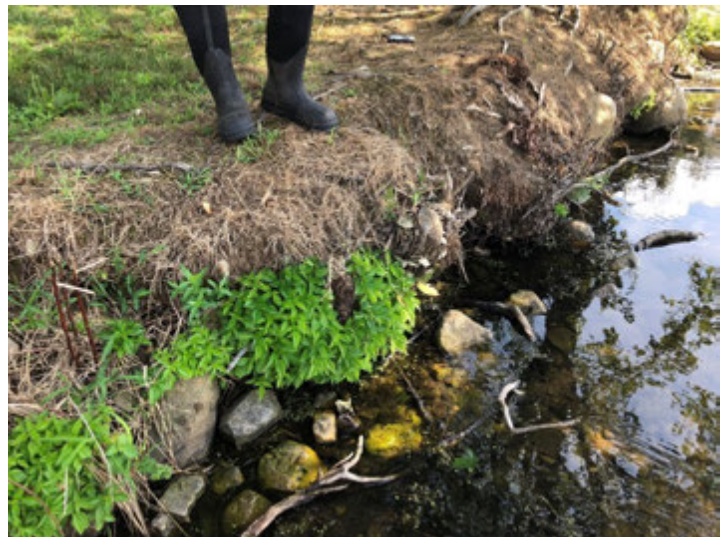
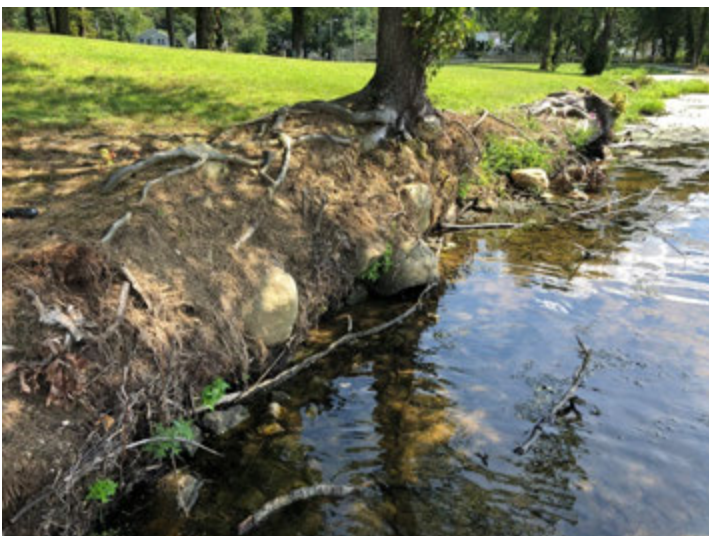
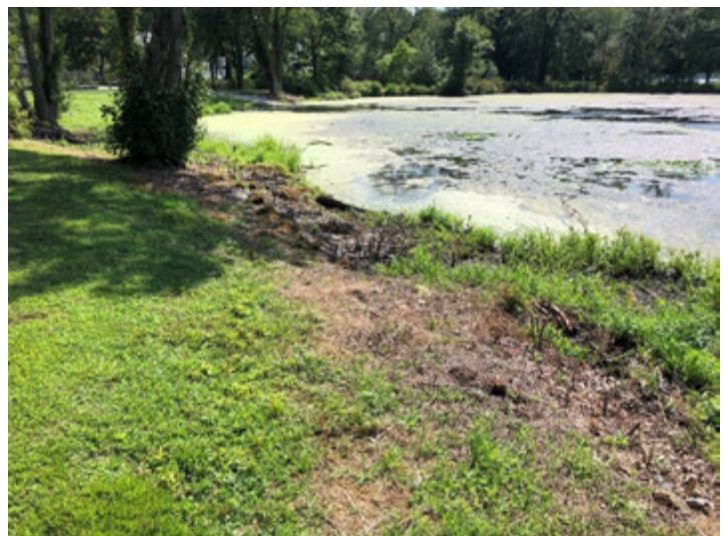
The entire shoreline of Lake Musconetcong at River Saint Row / Port Morris Park lacks a vegetative buffer. In addition to the lack of a shoreline buffer, the shoreline in the eastern section of the park is showing signs of erosion. The erosion along the shoreline is primarily occurring along the lower portion of the shoreline, creating some undercutting and bank scour. The tree roots of a large tree located along the shoreline in this section are also exposed.

RECOMMENDED MEASURES: A vegetative shoreline buffer in this location would provide multiple benefits, including decreased shoreline erosion and increased assimilation of nutrients from stormwater runoff. In addition to a shoreline buffer, this site would also benefit from the placement of rocks or stones along the lower bank of the shoreline to prevent further undercut erosion that was evident.

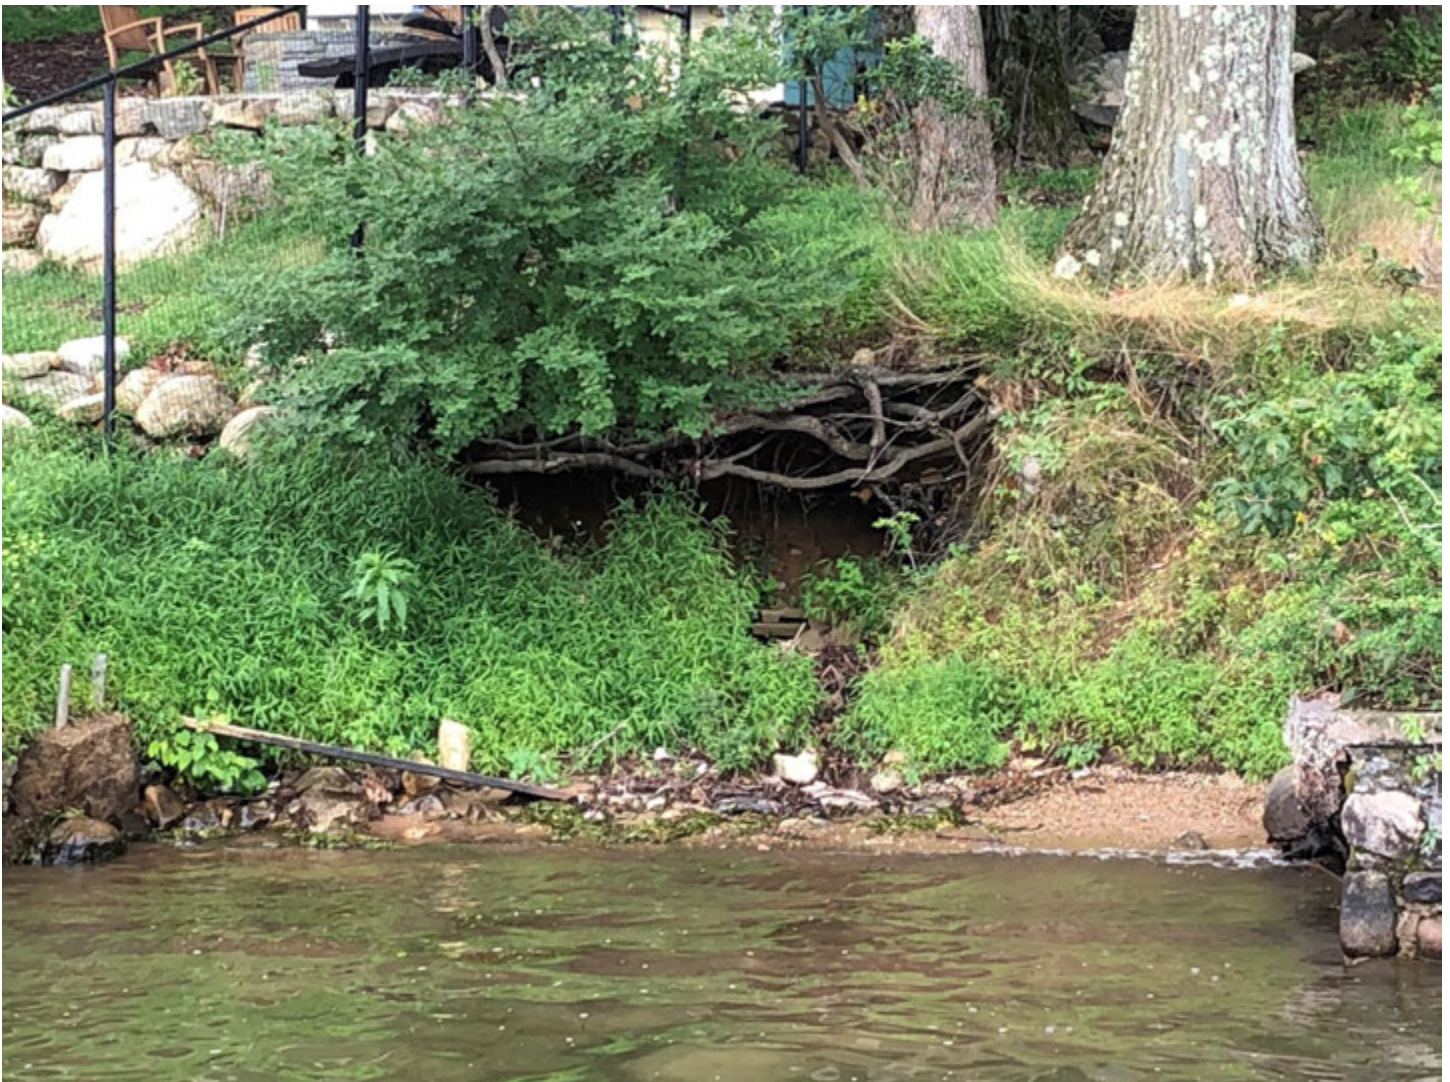
SITE 45: LAKE HOPATCONG (SOUTH OF ARTHUR J. ONDISH MEMORIAL BEACH) (40.9277, -74.6416)

RECOMMENDED MEASURES: The extent of erosion in this localized section of shoreline was severe and should be addressed. The section of shoreline that has been undercut beneath the trees should be filled and further protected against erosion with the placement of riprap or another shoreline protection method.

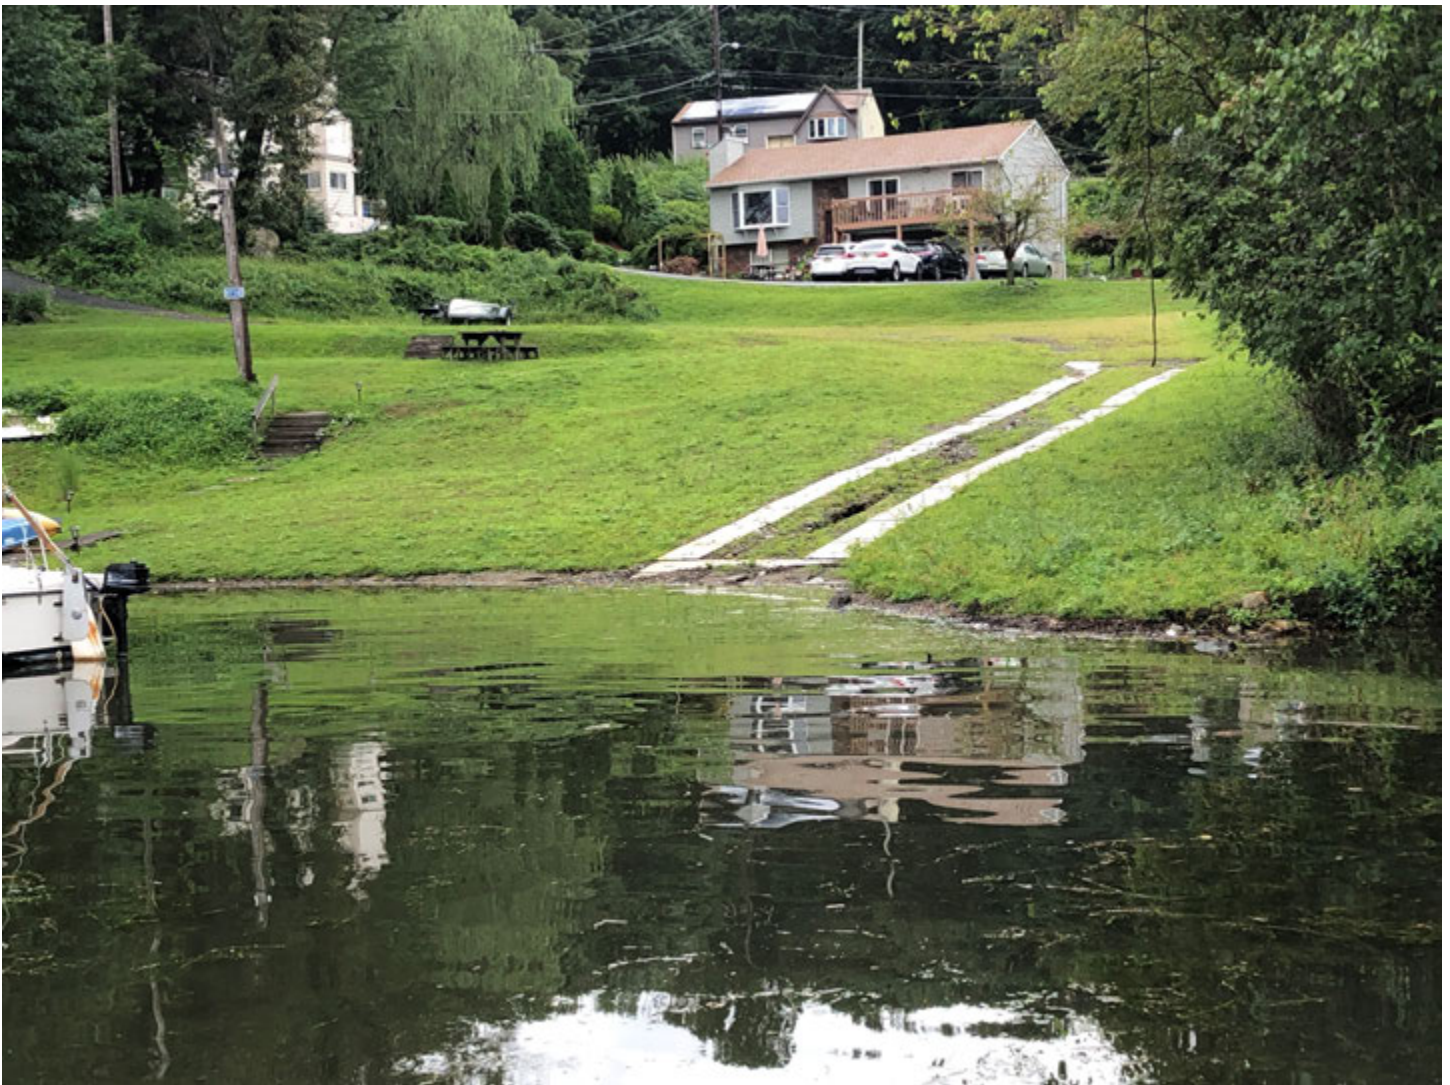
This site is the shoreline of Lake Hopatcong in Ingram Cove directly adjacent to the drainage stream referenced in Site 40. The slope of the property directly behind the shoreline is relatively steep, and the shoreline lacks vegetation. The erosion along this shoreline is minimal, but the lack of any type of shoreline buffer should be addressed. At a minimum, a shoreline buffer of 20 to 50 feet wide should be installed along the sections of the shoreline not used for launching boats.

RECOMMENDED MEASURES: A vegetative shoreline buffer in this location would provide multiple benefits, including the prevention of potential shoreline erosion and increased filtration of nutrients from stormwater runoff.

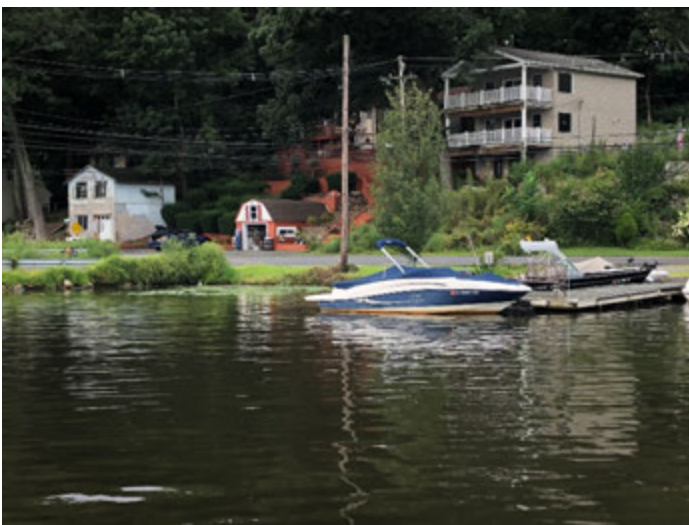
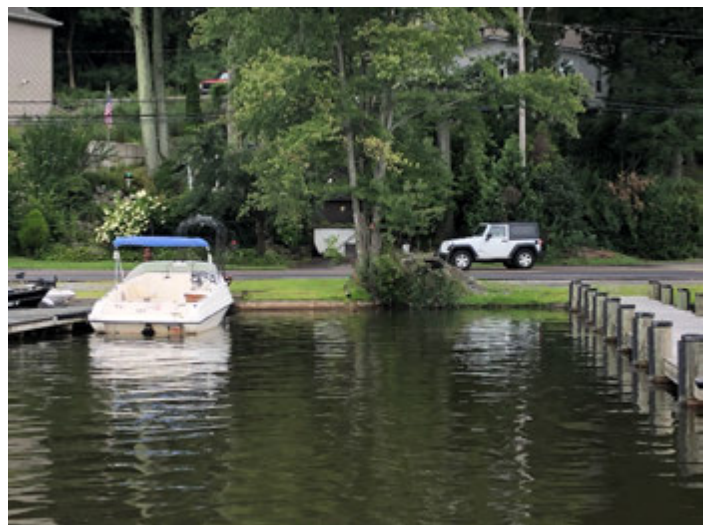
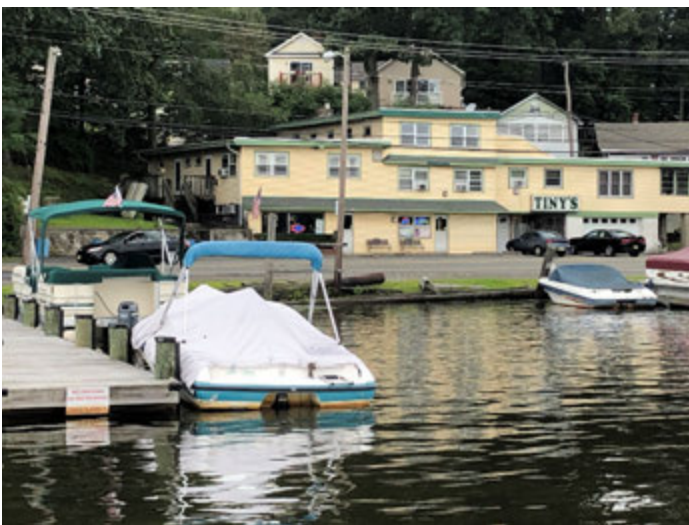
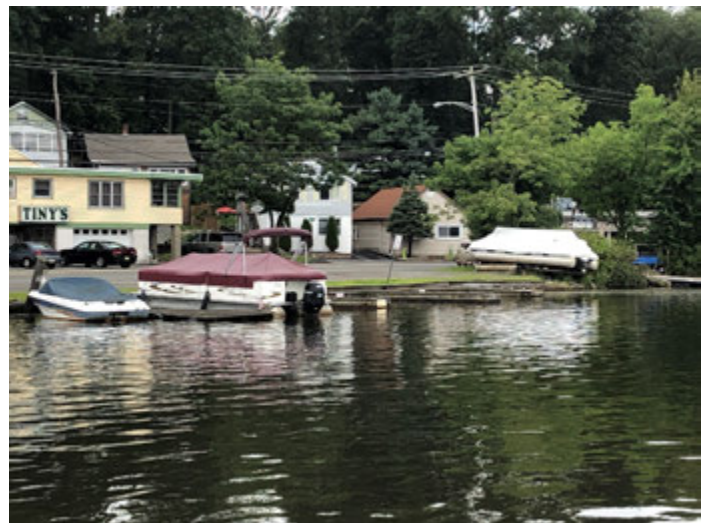
SITE 47: LAKE HOPATCONG SHORELINE (BEEBE MARINA) (40.9623, -74.6222)

This stretch of shoreline runs parallel to Brady Road, and the lake is only separated from the road by a few feet of mowed grass. The shoreline here lacks any type of vegetative buffer that would act as a nutrient filter for any stormwater that drains from Brady Road.

RECOMMENDED MEASURES: A vegetative shoreline buffer in this location would provide multiple benefits, including the prevention of potential shoreline erosion and increased filtration of nutrients from stormwater runoff. Brady Road is a relatively busy road located close to the shoreline here, and a shoreline buffer would help filter out any pollutants that would be carried into the lake from stormwater runoff.

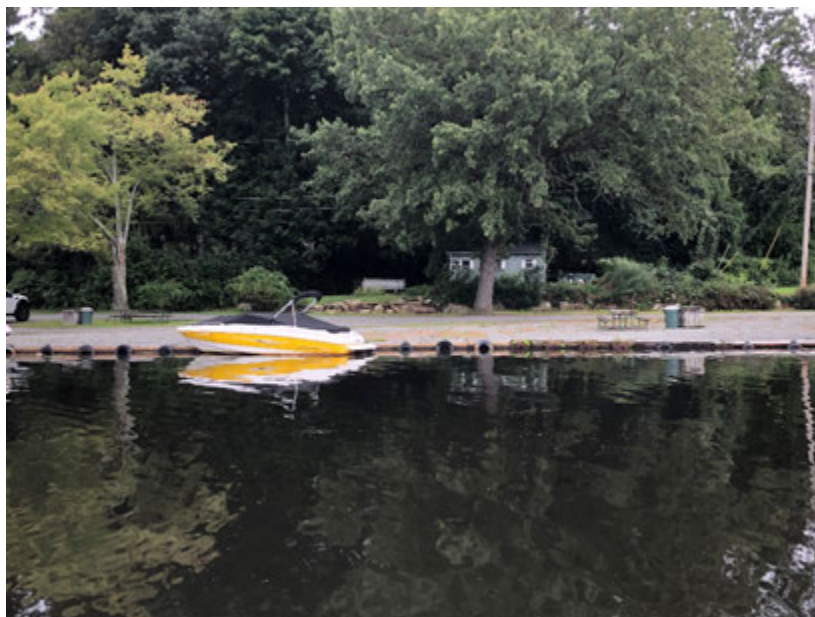
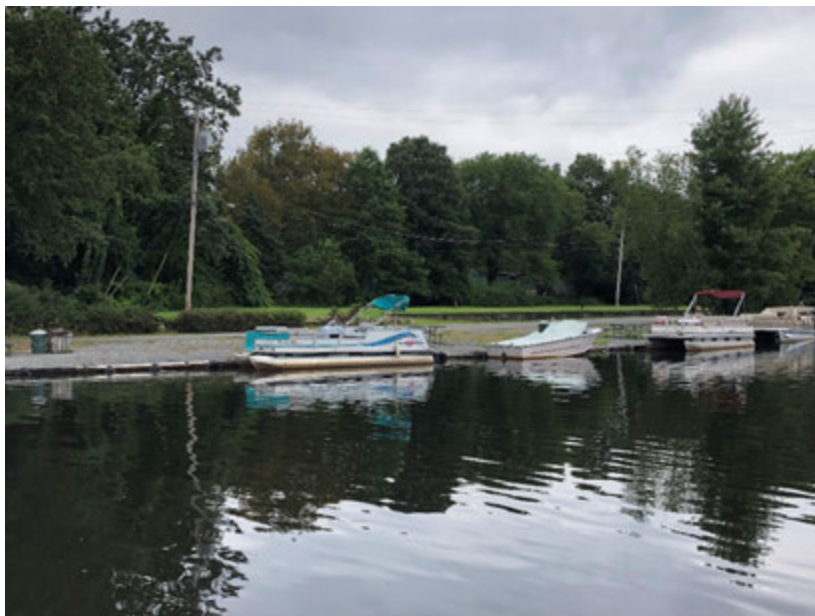
SITE 48: LAKE HOPATCONG (ALONG SIERRA ROAD) (40.9626, -74.6133)

This stretch of shoreline runs parallel to Sierra Road, and the lake is only separated from the road by a small gravel parking lot. The shoreline here lacks any type of vegetative buffer that would act as a nutrient filter for any stormwater that drains from Sierra Road. The parking lot between Sierra Road and the lake slopes down towards the lake, likely increasing the rate of stormwater flow from Sierra Road.

RECOMMENDED MEASURES: A vegetative shoreline buffer in this location would provide multiple benefits, including the prevention of potential shoreline erosion and increased filtration of nutrients from stormwater runoff. A shoreline buffer in this location would help filter out any pollutants that would be carried into the lake from stormwater runoff. In addition to a shoreline buffer, it would be beneficial to change the loose gravel parking lot to a grass area to prevent any loose gravel from entering the lake.
