UPPER MUSCONETCONG RIVER WATERSHED IMPLEMENTATION PLAN

MORRIS AND SUSSEX COUNTIES, NEW JERSEY

NOVEMBER 2020

PRINCETON HYDRO, LLC
1108 OLD YORK ROAD, SUITE 1
P.O. BOX 720
RINGOES, NJ 08551
908-235-5660

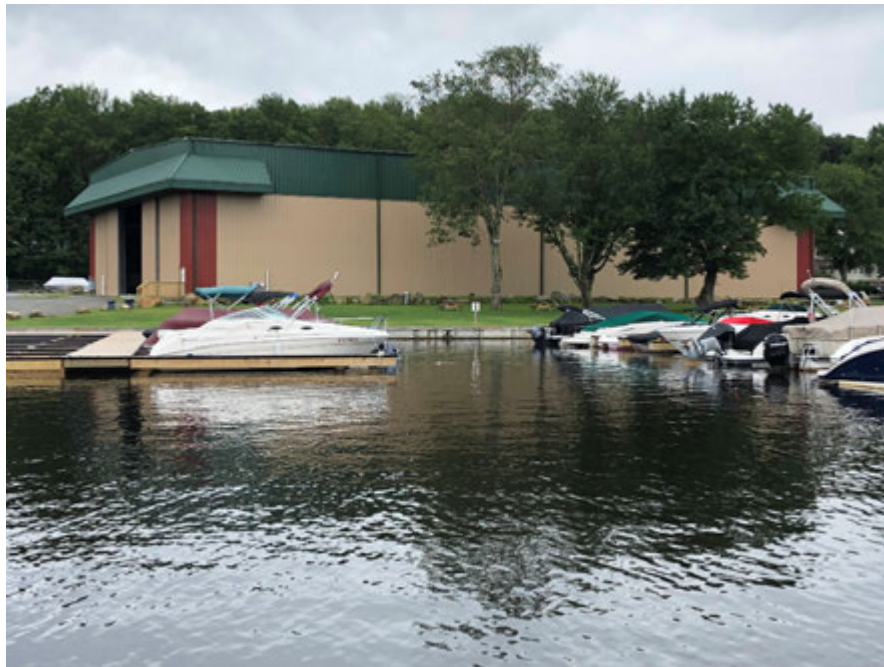
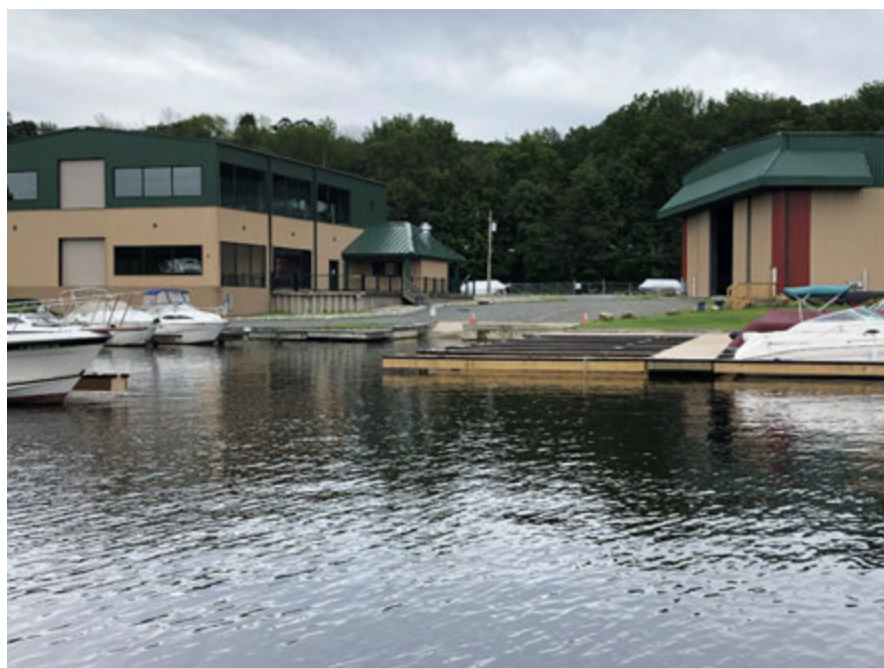
SITE 49: LAKE HOPATCONG (ALONG CALLAGHAN ROAD) (40.9614, -74.6142)

This stretch of shoreline runs parallel to Callaghan Road, but the lake is separated from the road by a boat shop and marina. The shoreline of the boat shop here lacks any type of vegetative buffer that would act as a nutrient filter for any stormwater that drains from the road or parking lot. There is a bulkhead in place to prevent erosion, but the property consists of mowed grass down to the shoreline.

RECOMMENDED MEASURES: A vegetative shoreline buffer in this location would provide multiple benefits, including the prevention of potential shoreline erosion and increased filtration of nutrients from stormwater runoff. A shoreline buffer in this location would help filter out any pollutants that would be carried into the lake from stormwater runoff that comes from the boat shop property.

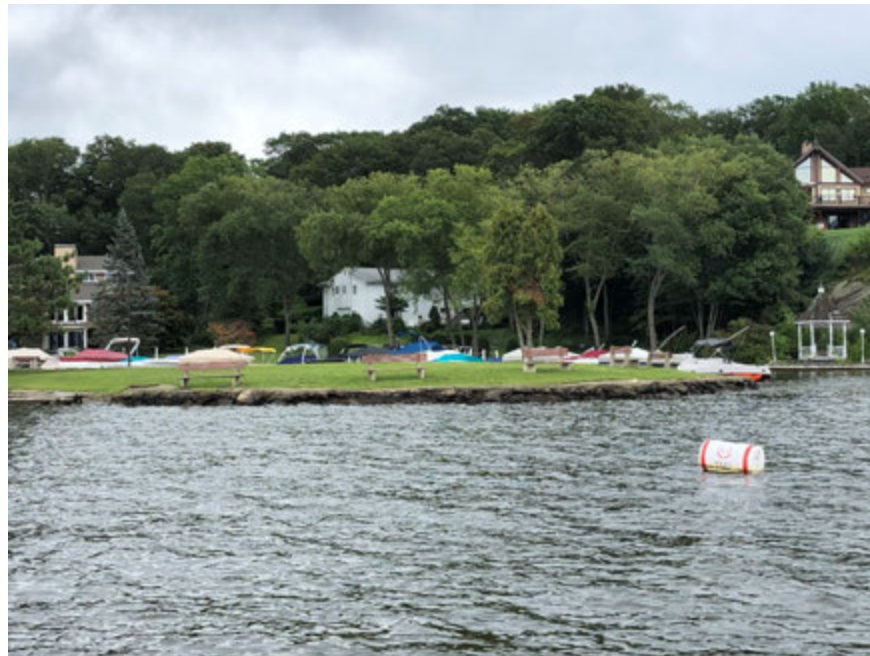
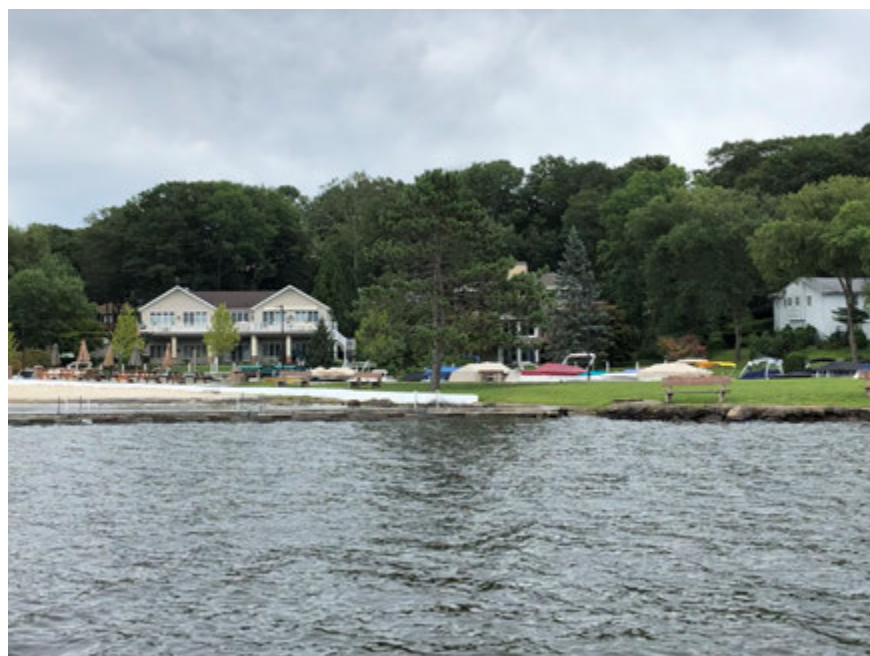
SITE 50: LAKE HOPATCONG (ALONG YACHT CLUB DRIVE) (40.9698, -74.6090)

This stretch of shoreline is located along Yacht Club Drive, but the lake is separated from the road by the Yacht Club. The shoreline of the Yacht Club here lacks any type of vegetative buffer that would act as a nutrient filter for any stormwater that drains from the road or parking lot. There is a bulkhead in place to prevent erosion, but the property consists of mowed grass down to the shoreline.

RECOMMENDED MEASURES: A vegetative shoreline buffer in this location would provide multiple benefits, including the prevention of potential shoreline erosion and increased filtration of nutrients from stormwater runoff. A shoreline buffer in this location would help filter out any pollutants that would be carried into the lake from stormwater runoff that comes from the Yacht Club property.

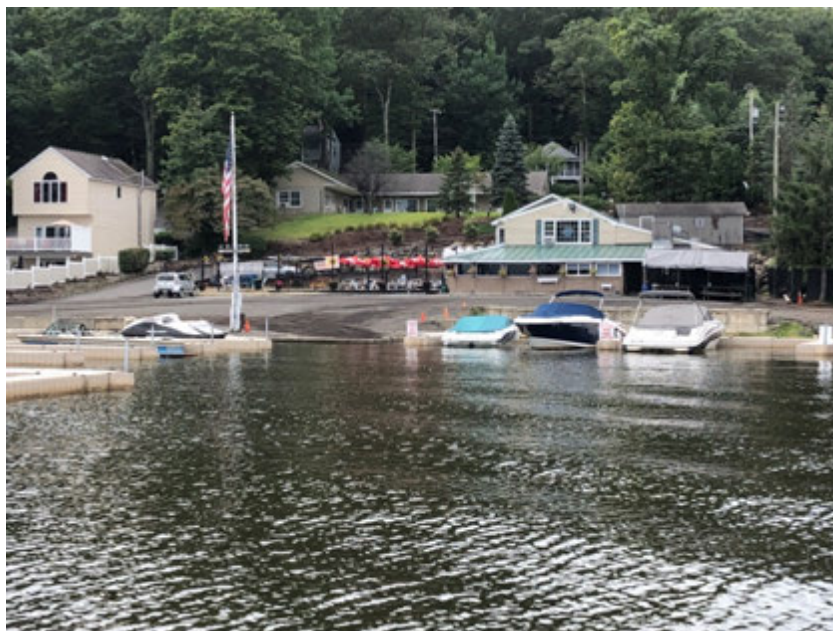
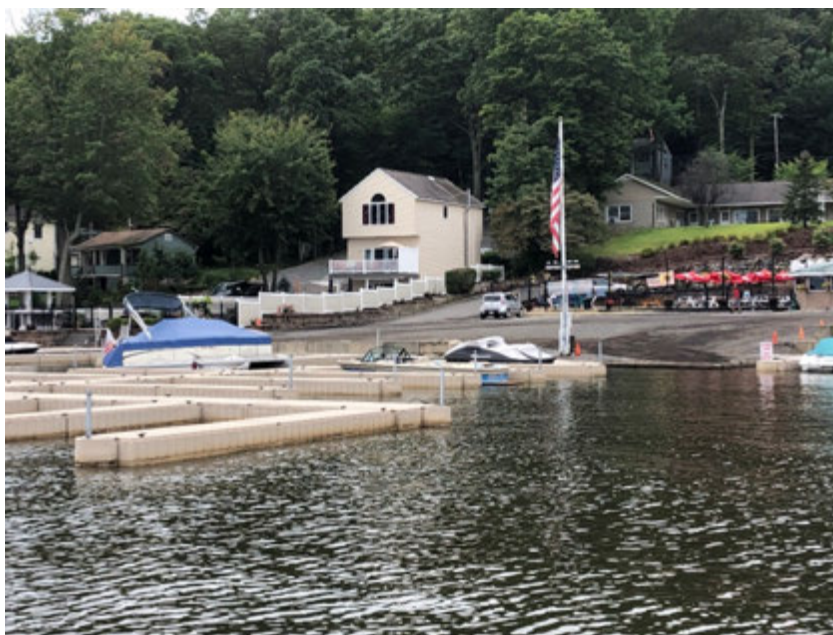
SITE 51: LAKE HOPATCONG (NEAR MASON STREET) (40.9815, -74.6164)

This stretch of shoreline is located along the parking lot of a restaurant/bar near Mason Street. The shoreline of the restaurant here lacks any type of vegetative buffer that would act as a nutrient filter for any stormwater that drains from the road or parking lot. In addition, the parking lot here appeared to be composed of loose material, either uncapped asphalt or dirt that can easily get carried into the lake with stormwater.

RECOMMENDED MEASURES: A vegetative shoreline buffer in this location would provide multiple benefits, including the prevention of potential shoreline erosion and increased filtration of nutrients from stormwater runoff. A shoreline buffer in this location would help filter out any pollutants that would be carried into the lake from stormwater runoff that comes from the restaurant property. In addition to the shoreline buffer, it is recommended that the parking lot be cleaned up or paved to prevent the loose material from entering the lake. Porous pavement should also be considered for the parking lot.

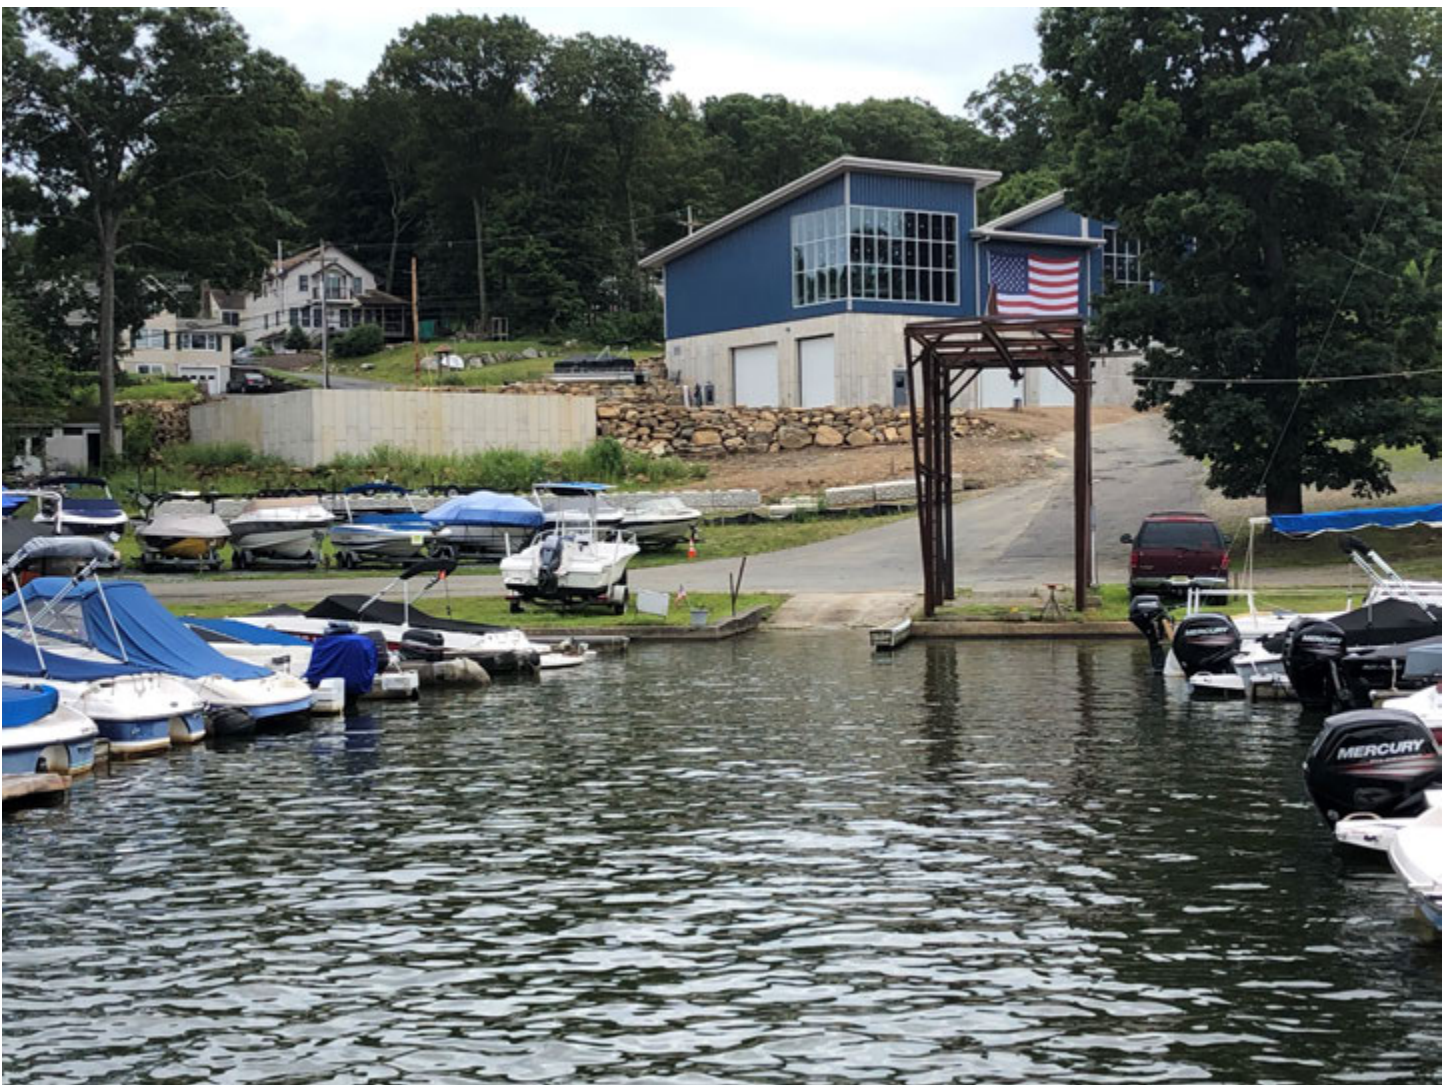
SITE 52: HOPATCONG (GREAT COVE) (40.9427, -74.6223)

This stretch of shoreline is located along the parking lot and downgradient of a new building being built in Great Cove. The property here is steep and mostly pavement, and the shoreline lacks any type of vegetative buffer that would act as a nutrient filter for any stormwater that drains from the road or parking lot.

RECOMMENDED MEASURES: A vegetative shoreline buffer in this location would provide multiple benefits, including the prevention of potential shoreline erosion and increased filtration of nutrients from stormwater runoff. A shoreline buffer in this location would help filter out any pollutants that would be carried into the lake from stormwater runoff that comes from the property.
